Advances in the Bonded Composite Repair of Metallic Aircraft Structure

VOLUME 2

Chapter 19. Bonded Repair of Acoustic Fatigue Cracking 531

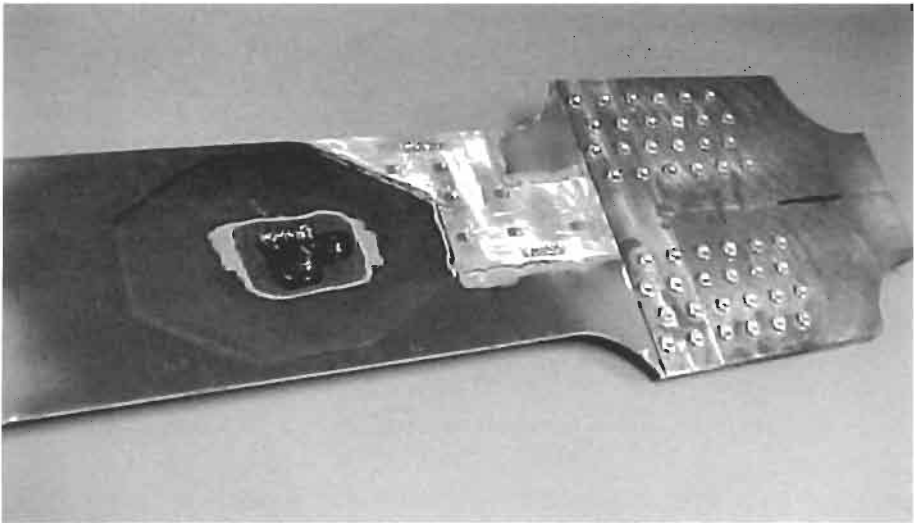
Fig. 41.5. Static and fatigue test specimen made from a C-141 wing plank with three doubler bonded composite repair.

With favorable initial results, a considerable amount of additional very detailed 3D FEA was accomplished (Figure 41.4) to further evaluate repair size, shape, stress reduction, and impact on surrounding structure. Results of the 3D analysis were very similar in many respects to the 2D shell FEA, but it was found to be more accurate, realistic and less conservative than the shell FEA. To validate the 3D FEA model, a segment of an actual wing plank was repaired to identically match the model (Figure 41.5), instrumented, and statically tested. Correlation between

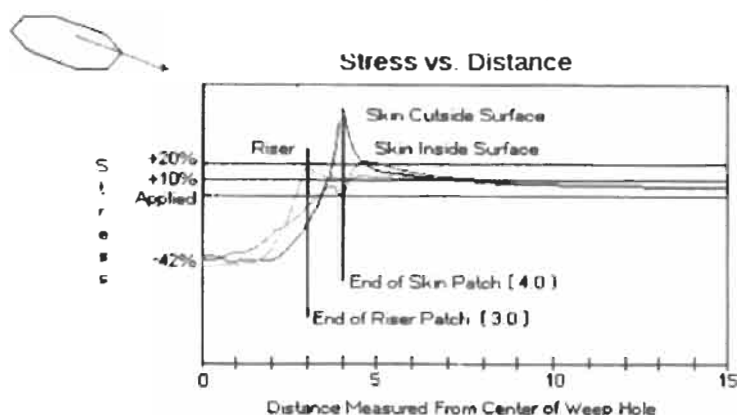
Fig. 41.6. Analysis of stresses in the wing plank at the ends of the bonded composite doublers.

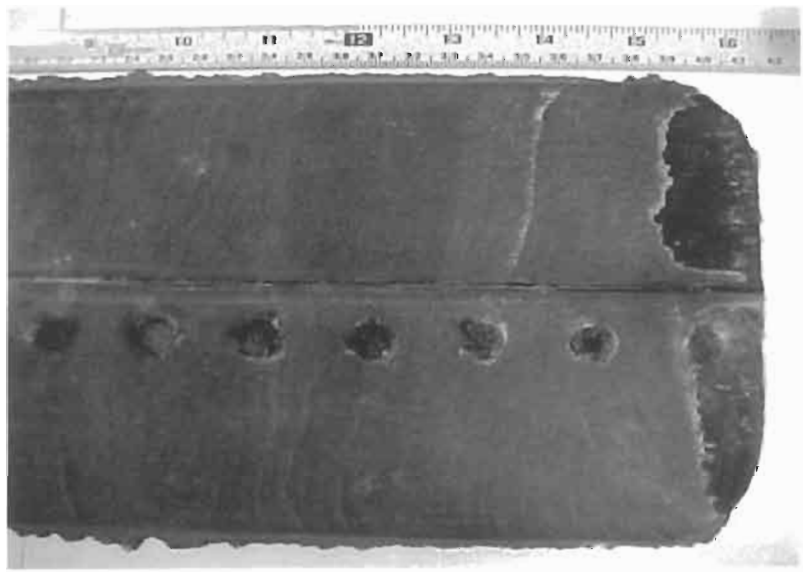
Fig. 41.7. Failed doubler near total adhesive failure.

To date, only one riser doubler set installed by WR-ALC has been known to have disbonded and that one was traced to human error and one external doubler installed by CTI required replacement due to some minor delamination. However, several doublers installed by LMAC have suffered near total delamination. The failures were near total adhesive failure at the adhesive to wing surface interface and are attributed to poor surface preparation of the metal surface (See

Figures 41.7–41.9). LMAC used a sulfuric acid/sodium dichromate paste etch in lieu of GBS. The failed wing and patch surface had noticeable corrosion products with severe corrosion pitting of the steel fasteners. Other LMAC installed doublers on the same aircraft or even in the same area of the wing were found still be firmly bonded.

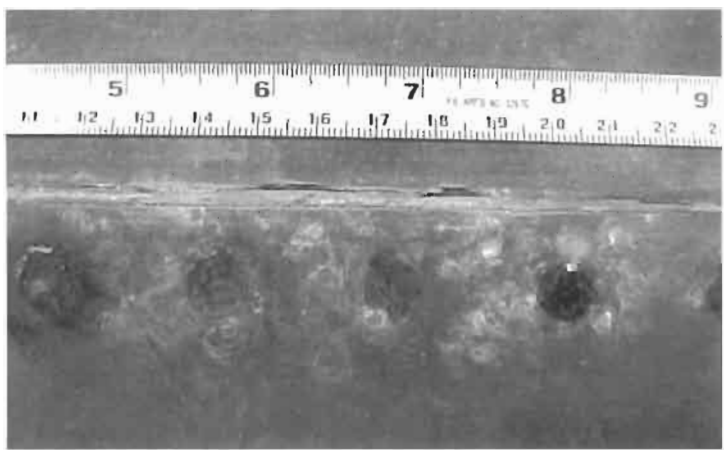
Fig. 41.8. Failed doubler showing adhesive failure and corrosion products residue.

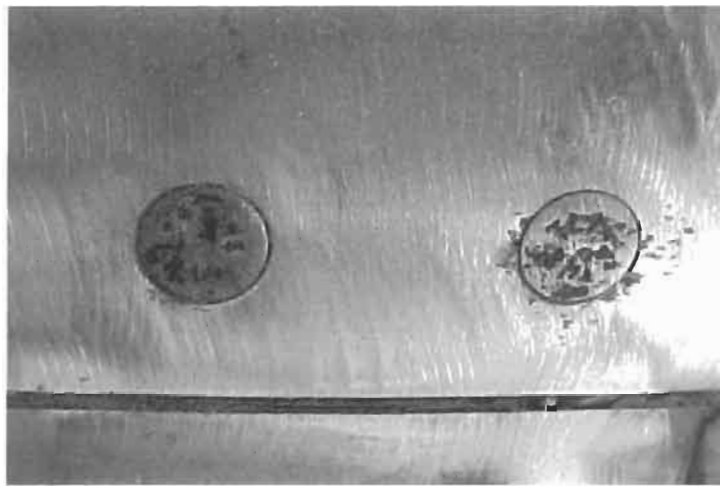
Fig. 41.9. Wing surface after removal of most of the corrosion, note panel joint and taper lock fasteners.

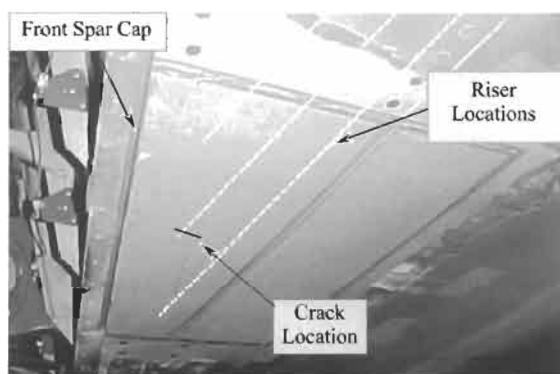
Fig. 41.10. Bonded composite repair over cracks in the lower wing skin of the C-141.

Boron composite repairs have also been used for repair of other cracks in the C-141 wings that normally would have required replacement of a whole wing panel or a very complicated metal repair. One particular repair that has been accomplished numerous times is for cracks in the lower wing planks at a riser run-out where the wing panels join with the lower fwd spar cap. The repair requires two doublers that are up to 810 mm long with a combined width of up to 310 mm and 22 plies thick. One of the repairs is shown in Figure 41.10.

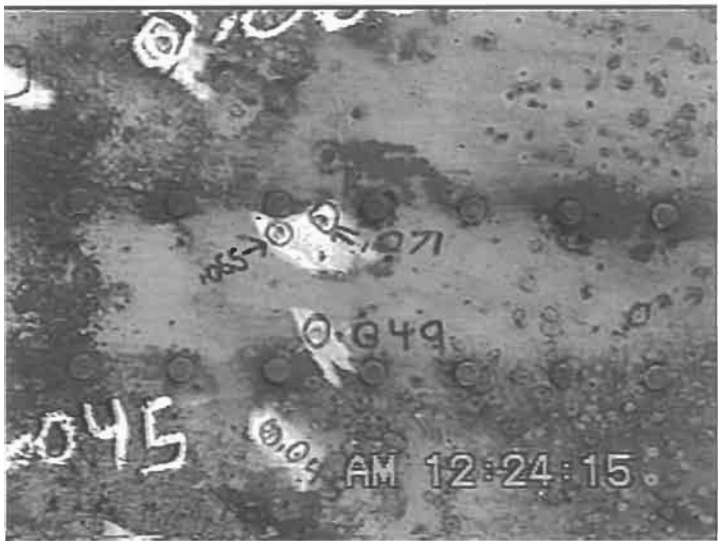
Fig. 41.11. Corrosion pitting damage in the lower wing skin of a C-130 aircraft, numbers refer to measured pit depths.

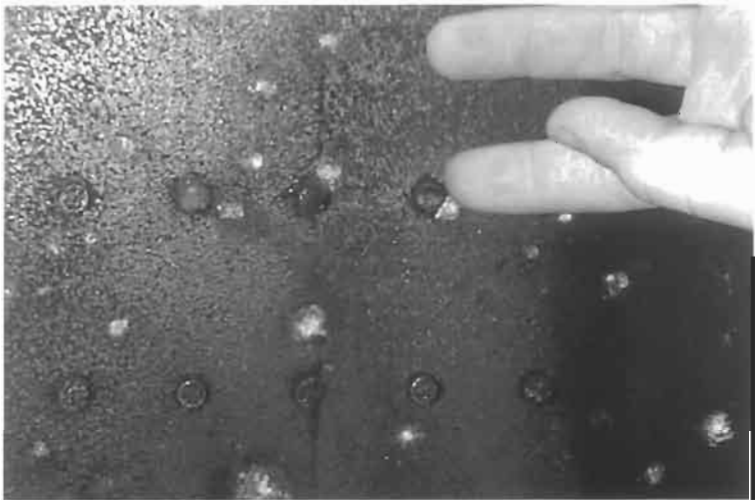
Fig. 41.12. Corrosion pitting damage in the lower wing skin of a C-130 aircraft after initial cleanup note pitting extending under the fastener head.

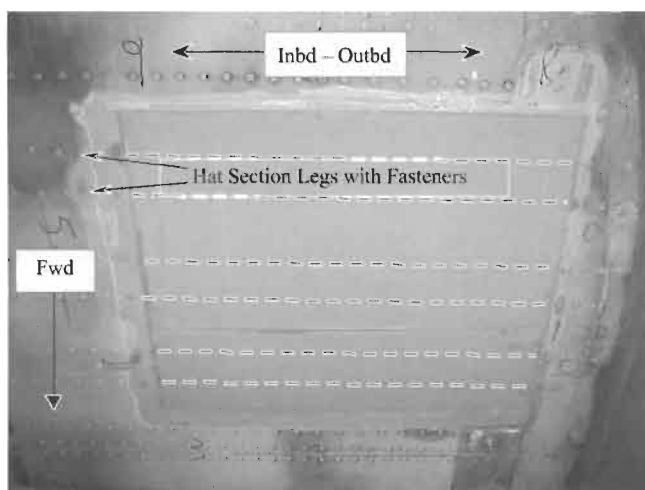
Fig. 41.13. An installed bonded repair doubler used to repair corrosion in the C-130 wing.

secondary bonding of pre-cured boron composite doublers over the corroded area. The ground-out areas are filled with additional adhesive prior to installation of the repair doubler. An installed doubler is shown in Figure 41.13. The doubler sizes vary up to 710 mm by 460 mm and up to eight plies thick. Over 130 repairs on over 80

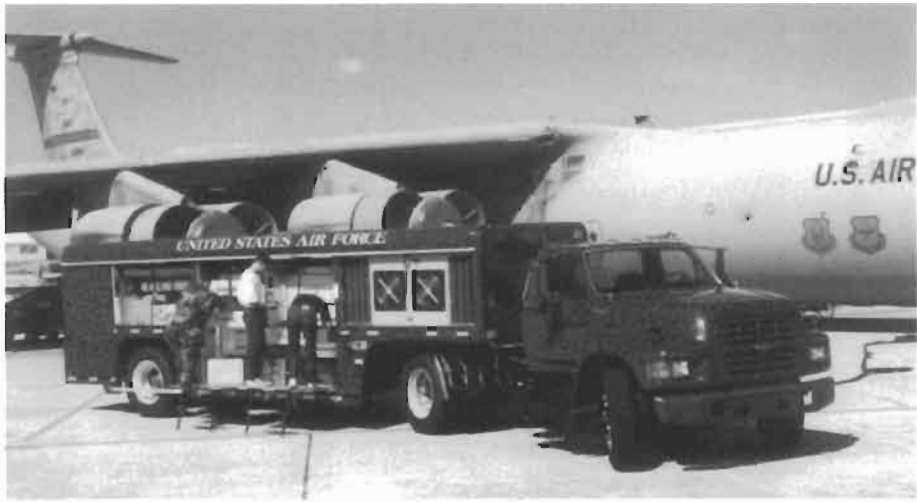
Fig. 41.14. WR-ALC mobile bonded repair trailer.

To better support the operational squadrons, WR-ALC has developed a mobile repair trailer that can accomplish all forms of bonded repairs in the field (Figure 41.14) with a depot field team. The trailer allows the depot to go to the aircraft wherever it may be and greatly reduces the schedule difficulties and cost incurred with having to return the aircraft to the depot for a bonded composite repair. The trailer is totally self-contained and requires only service stands from the field organizations. The depot field team is responsible for the whole repair, but relies on the operational squadrons for aircraft jacking, fuel and de-fuel operations and final painting. The trailer contains a diesel generator, filtered air compressor, freezer, bond controllers, thermography inspection equipment and all of the associated equipment and material to accomplish two repairs at a time. The trailer and tractor combination is 11 m long, 2.5 m wide, 2.5 m high and weighs 11111 kg and is air transportable by C-130/C-141/C5/C17 as well as over the road. The repair trailer approach has proven quite successful and saves the users approximately \$100000 per aircraft over having to fly the aircraft back to Robins AFB for one specific repair. WR-ALC currently has two units in operation. To date, the repair trailers have been used to accomplish over 115 repairs on over 73 C-

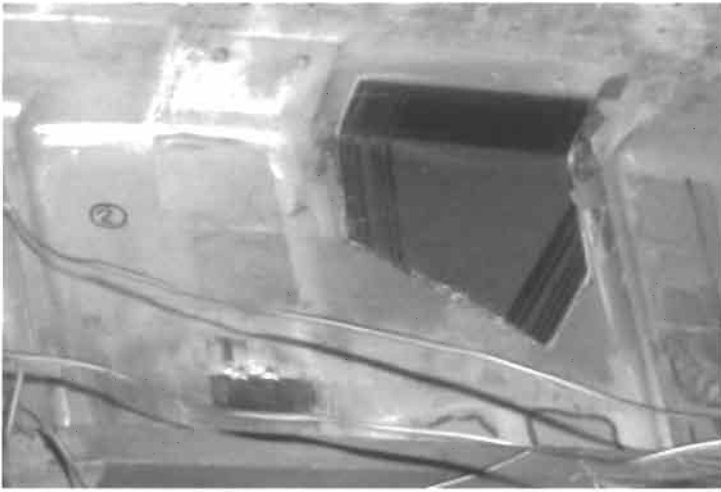
Fig. 41.15. Large C-141 fuselage main gear frame showing graphite/epoxy bonded doublers over a crack.

the point of fast fracture. Two “L” graphite doublers were then co-cure bonded on either of the web and up under the outer flange (Figure 41.15). Due to geometry constraints and the complex stress fields, the largest doubler that could be installed had a stiffness factor of only 0.54 in the direction of the crack growth. Fatigue testing was continued at the original load levels with a considerably slowed crack growth. In the interest of time and money the load level was doubled and additional fatigue testing was accomplished. Due to time constraints and concern for possible fatigue failure at the attachment end of the test fixture, it was decided to cease fatigue testing and accomplish a residual strength test. The load was tripled from the original with no failure. The flanges were then cut to a point to induce failure (Figure 41.16) with interlaminar failure of the doublers. At the point the fatigue testing was stopped, the bonded graphite/epoxy doublers had increased the fatigue life by 400%. The success of the test program was quite impressive and has lead to a follow-on effort to further explore the possibilities of bonded composite repairs as a repair option for actual problems on heavy substructure.

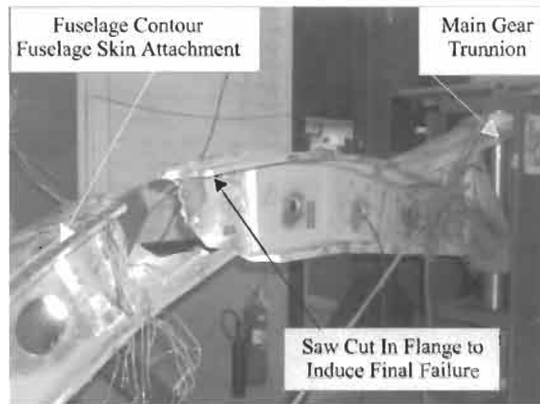
Fig. 41.16. C-141 fuselage main gear frame, as shown in the test fixture, after failure in the patch region after cutting of the top flange.

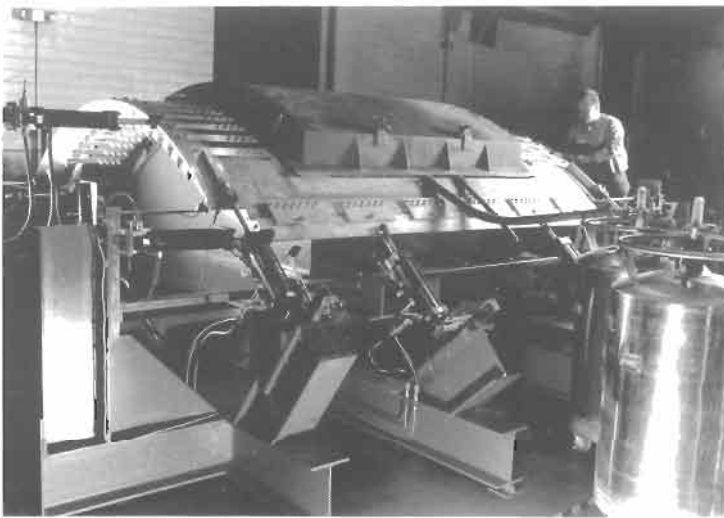
Fig. 41.17. Fuselage test fixture with 3.1 m by 3.1 m C-141 section installed for testing.

additional complex C-141 sections and two aft upper crown C-130 sections were obtained for possible future testing. One constant section C-141 section was instrumented and tested to a typical C-141 Ground-Air-Ground (GAG) flight spectrum cycle. Recoded stresses were compared to the predictions from a detailed FEA. It was found that the test fixture properly simulated inflight loading and the stresses in the center 1 m by 1 m section very closely approximated the predicted stresses.

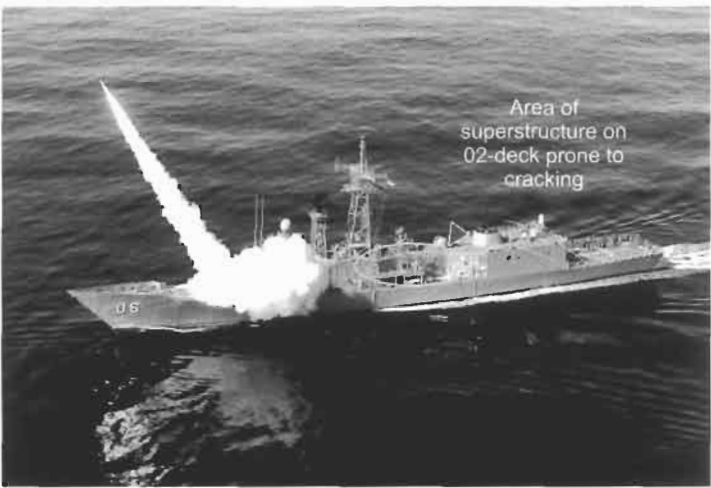
Fig. 42.1. RAN FFG-7 Adelaide class guided missile frigate.

There are six US designed FFG-7 class of guided missile frigates in service with Royal Australian Navy (RAN), Figure 42.1. The frigates have a steel hull with continuously welded aluminium alloy (5456) superstructure extending over about 55% of the ship's length. As a result, these aluminium structures receive a very significant proportion of the cyclic loading imposed on the hull as it flexes in a seaway, Figure 42.2. The superstructure breadth varies from 10.1 m forward to 7.3 m in the midship region and 14.3 m aft.

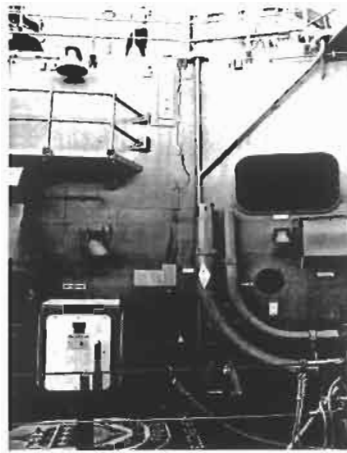
Fig. 42.3. Major crack at the knuckle (Frame 196).

longitudinal and deck butt joint, high overall nominal stress at the knuckle (2.6 times higher than at the 02-deck centreline) and stress concentration has lead to the initiation of fatigue cracks in aluminium [1–3]. Additionally, the “necking” of the superstructure aggravates the situation. In extreme sea-state conditions these cracks have the potential to cause a major superstructure failure, Figure 42.3.

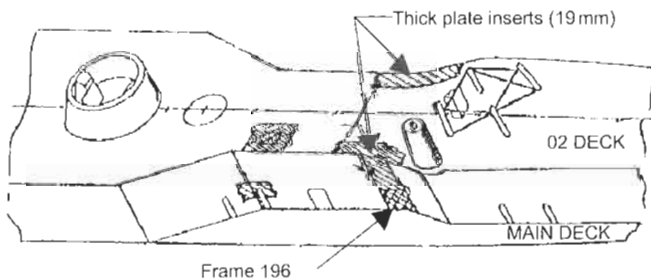
Fig. 42.4. Phase 1 fix for superstructure cracking.

of a larger radius at the superstructure knuckle (frame 196) in conjunction with thick plate inserts in areas of high stresses, Figure 42.4. In spite of these alterations the RAN vessels experienced further cracking thus it became obvious that the USN design will not provide long-term solution to the problem. This “setback” prompted the RAN to investigate alternative strengthening methods involving adhesively bonded advanced fibre composite reinforcements that have been successfully developed at the Defence Science and Technology Organisation (DSTO) Australia for the reinforcement or crack repair (“crack patching”) of aircraft structures [4–6]. The Royal Navy (RN) also reported successes in using adhesively bonded fibre composite for superstructure reinforcements of Type 21 frigate [7].

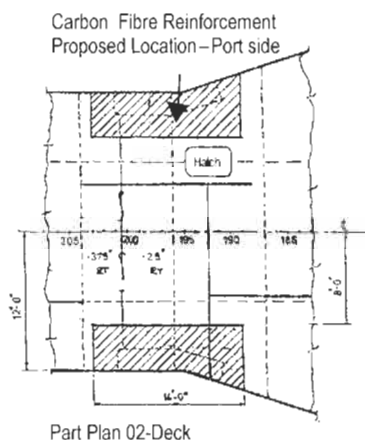
Fig. 42.5. Upper mid-ship region of aluminium superstructure, FFG-7 class frigate.

In practice to achieve the stress reduction of this magnitude a number of factors were considered. The research work conducted at DSTO involved extensive development of materials and processes since no appropriate codes or standards were available. The only guidelines were DSTO staff experiences with “crack patching” and adhesive bonding for aerospace applications, manufacturers data sheets and the RN experiences with composite reinforcement of Type 21 ships. Thus it was proposed to reinforce both the port and starboard sides with a composite demonstrator measuring 5 m × 1 m and comprising 25 plies (7 mm thick) unidirectional carbon fibre. The design also included a glass/resin polymer (GRP) protection layer to provide in-service protection to underlying CF reinforcement. The proposed locations of composite demonstrators relative to high stress concentration area are shown in the engineering drawing, Figure 42.5 (shaded area).

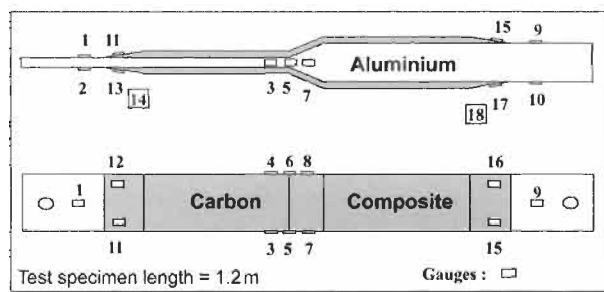
Fig. 42.6. Fatigue test specimen.

Composite fatigue performance – Various tests were conducted in the course of materials development which are described in greater detail elsewhere [9,10]. Still, the fatigue performance of composite reinforced aluminium specimens simulating ship deck reinforcement was considered to be the ultimate test. Two test specimens were produced each 1.2 m long and instrumented with 18 strain gauges, Figure 42.6.

Both sides of the specimen were reinforced to avoid bending in tension and in compression the anti-buckling plates were used to minimise aluminium buckling on load application. The FEA, static and the fatigue tests indicated about 50% reinforcement efficiency in the underlying aluminium metal [10]. Each specimen was tested at increasing load levels including the peak load of 91 kN (equivalent to ± 76 MPa peak service stress range [8]) for up to 90000 cycles. Although, the last 5000 cycles were tested at the level twice the peak load before the fracture of aluminium, there was no evidence of composite reinforcement failure. Non-destructive evaluation tests confirmed no debonding and there were no signs of degradation in the adhesive bondline. The other fatigue test specimen was assessed at 35 °C and the maximum load of 91 kN for 10^5 cycles without failure.

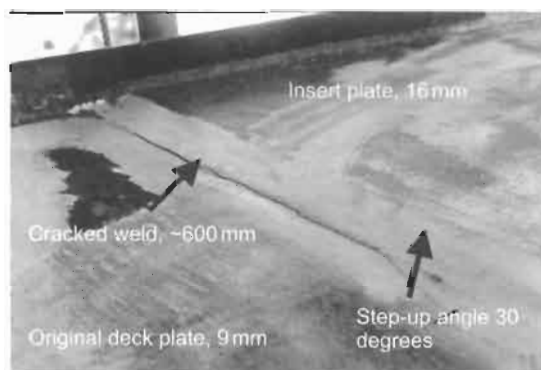
Fig. 42.7. Welded connection between 9 and 16 mm plate insert (Note the length of crack).

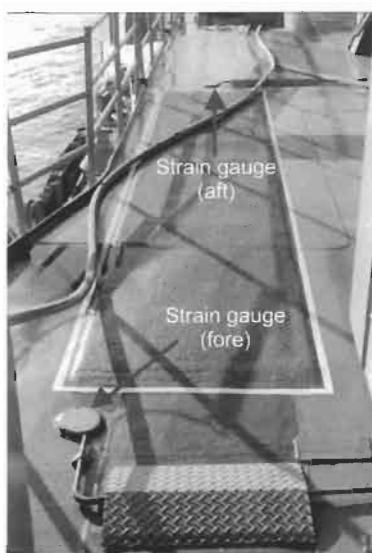
Fig. 42.8. CF reinforcement in service – starboard side.

Composite protection and surface finish – The fabrication procedure for GRP protective layer was identical to that used for adhesive bond layer and CF composite as given earlier. Original design allowed for an additional sacrificial edge protection thus extending an additional 100 mm in width and length to coincide with the size of adhesive bond layer (i.e. $5.2\text{ m} \times 1.2\text{ m}$). A standard navy surface protection applied by DSTO staff was a two-coat coverage of an epoxy-based primer. This was followed by a standard navy paint scheme that included the final non-skid layer applied to the walkway. At the time this coverage consisting of a multiple-coat of paint was considered appropriate and adequate. The final in-service appearance of a starboard reinforcement is shown in Figure 42.8.

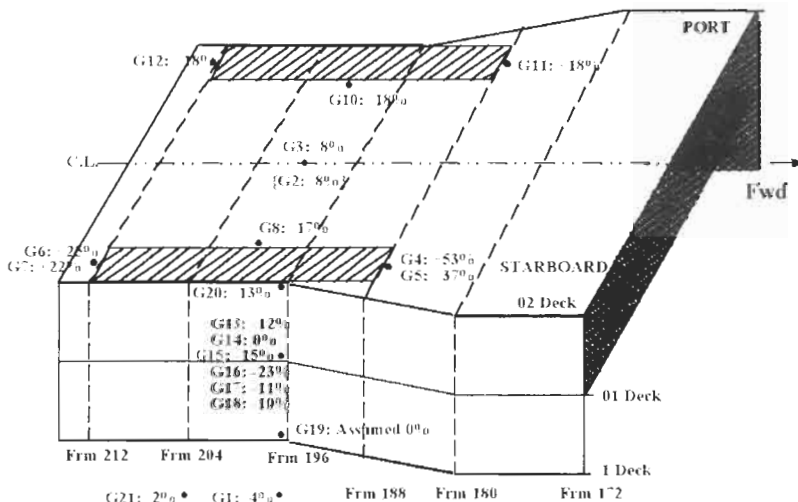
Fig. 42.9. Changes in strain intensity level after composite reinforcement (neck-down region).

For assessing the effectiveness of bonded composite reinforcements strain measurement trials were conducted before and after composite application to determine their effect on stress levels in the superstructure. Sea trials were conducted over time for given sea-states and ship speeds during alternating conditions of longitudinal hull bending (sagging and hogging). Strain output data were collected using a combination of uni- and multi-directional strain gauges installed at predetermined 02-deck locations including the sides to reach the main deck, Figure 42.9. Data analysis indicated up to 18% reduction in strain levels along the sides (Frames 188–212) and other areas between the composite reinforcements, however, there is a corresponding 20% increase in strain next to either end of reinforcements [17].

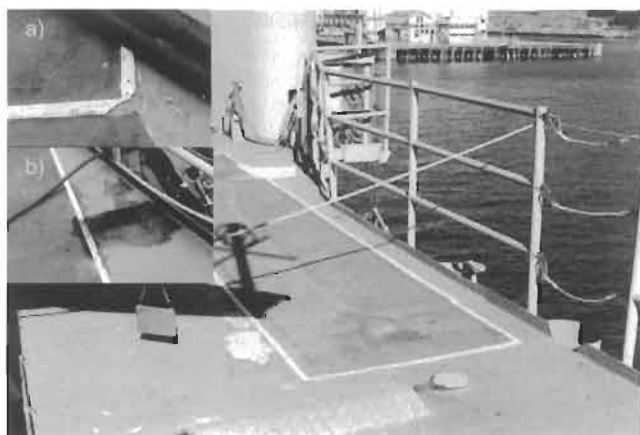
Fig. 42.10. Weathering of composite reinforcement (Starboard side) and typical damage inset (a) and (b).

Through-life maintenance – It is not surprising, given the exposure that the 02-deck experienced a local debonding of GRP protective layer at the GRP/aluminium interface. After about two years at sea the sacrificial edge area on both the port and starboard GRP composite developed untidy appearance basically due to failure of surface paint coating combined with the effect of water locks caused by undulated deck surface, Figure 42.10. The underlying CF composite was unaffected but if this condition were left unchecked the progressive debonding of adhesive layer would have compromised the integrity of both reinforcements. Water is known to be the most harmful environment for bonded joints. Bond deterioration is caused due to

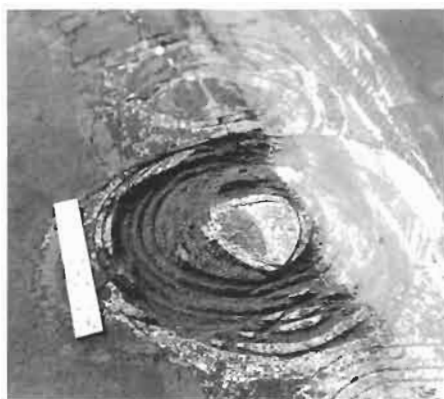
Fig. 42.11. Physical damage to CF composite.
