Environmentally Assisted Cracking: Science and Engineering

STP 1049

W. Barry Lisagor, Thomas W. Crooker, and Brian N. Leis, editors

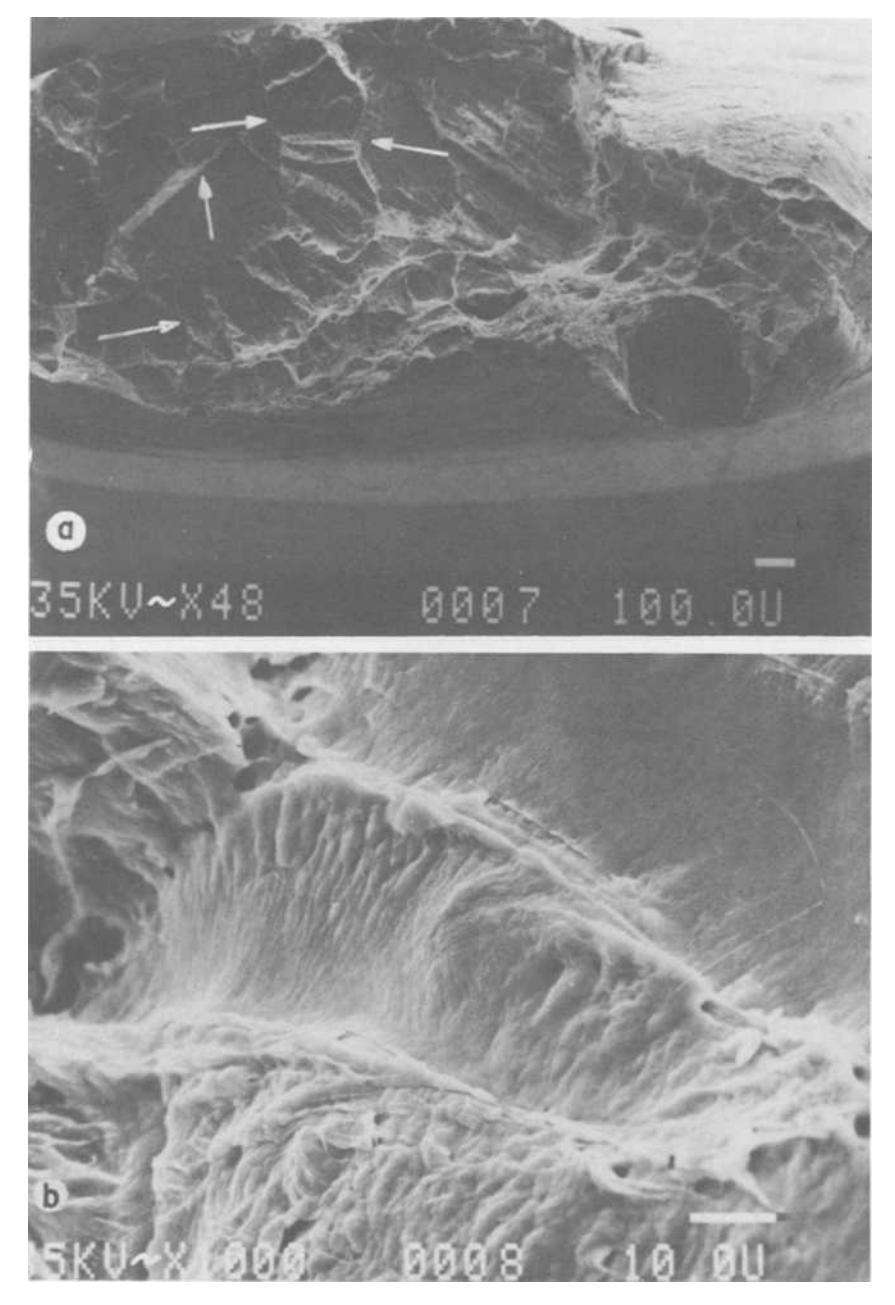
FIG. 5—The SEM fractographs of grain-coarsened and prestreined E-brite failed in situ during stress hydrogen charging.

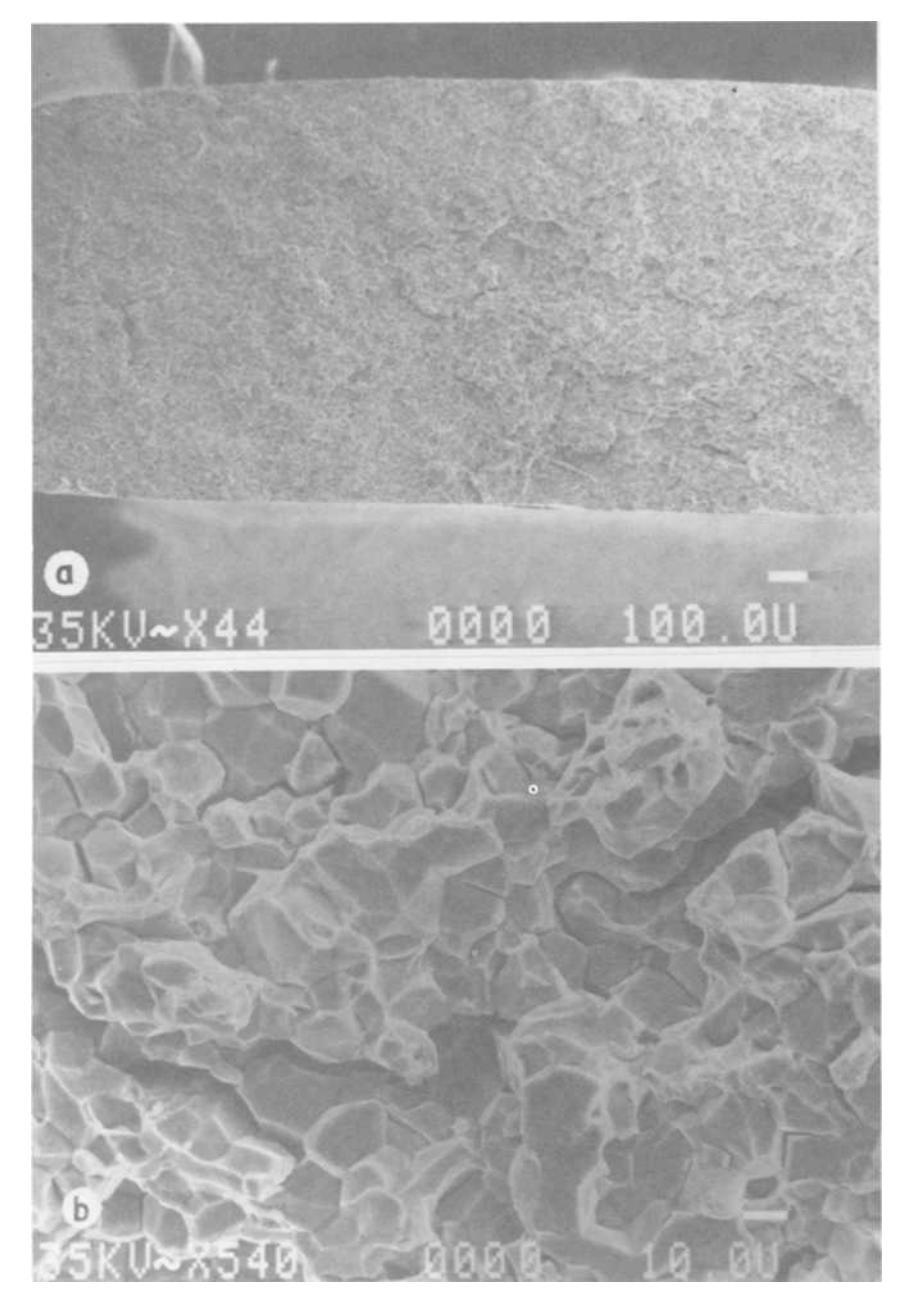
FIG. 7—The SEM fractographs of prestrained 26-1S failed by stress hydrogen charging.

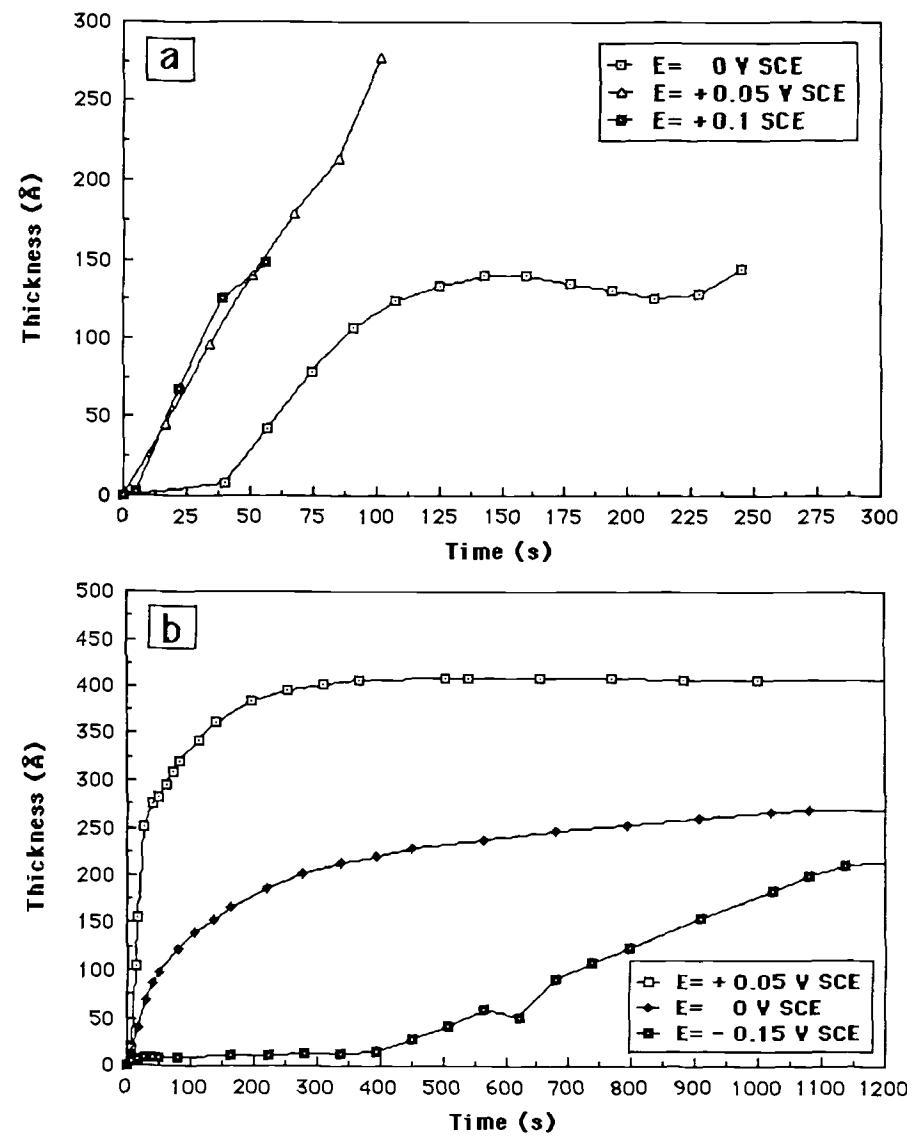
FIG. 7—Time variation of the thicknesses of the oxides grown on $\{110\}$ copper surfaces in (a) 0.1 M sodium acetate, pH 5.5, and (b) 1 M sodium nitrite, pH 9.

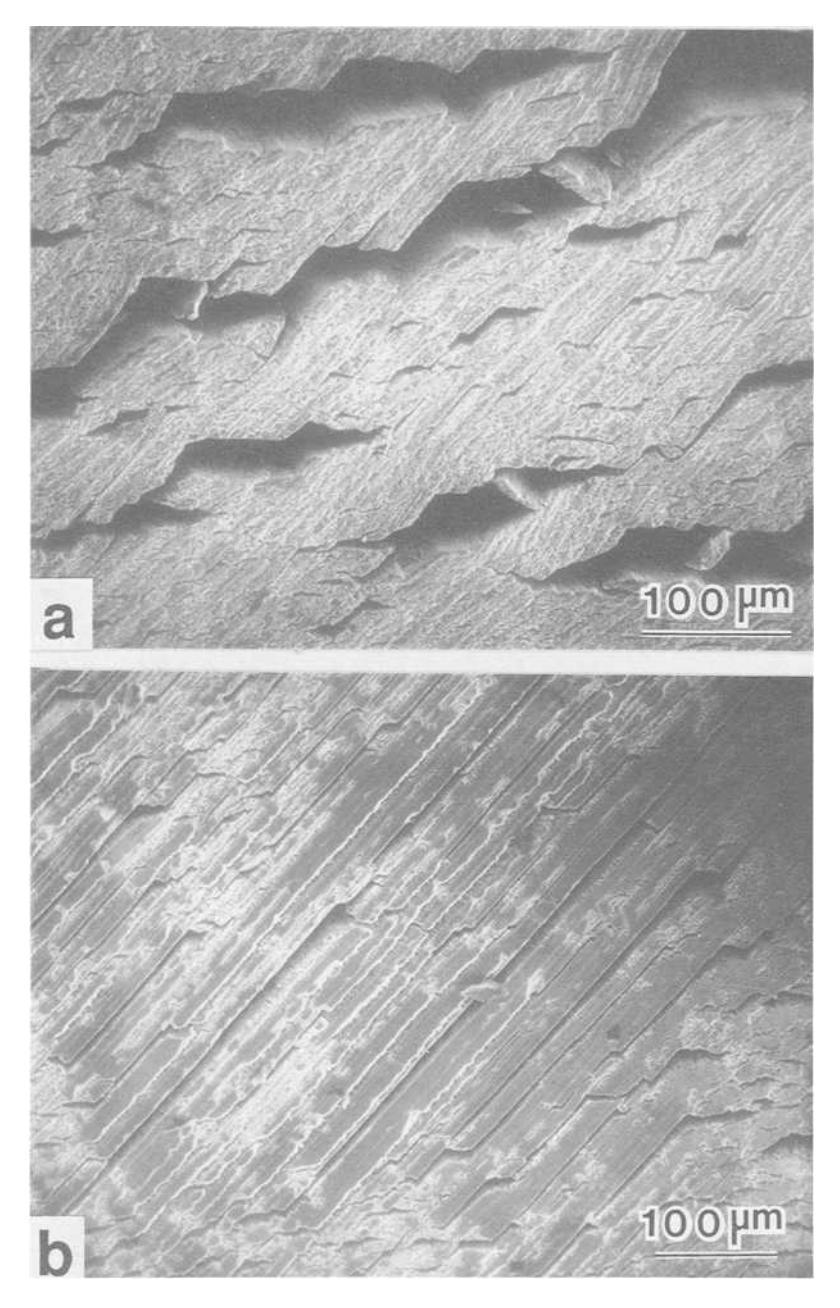
FIG. 8—Scanning electron micrographs of the free surface of a randomly oriented copper monocrystal tested in 0.1 M sodium acetate, pH 5.5, at an applied potential of +0.04 V SCE and a strain rate of 10^{-6} s⁻¹, (a) adjacent to the primary fracture (high strain), (b) further from the primary fracture. The tensile axis is vertical.

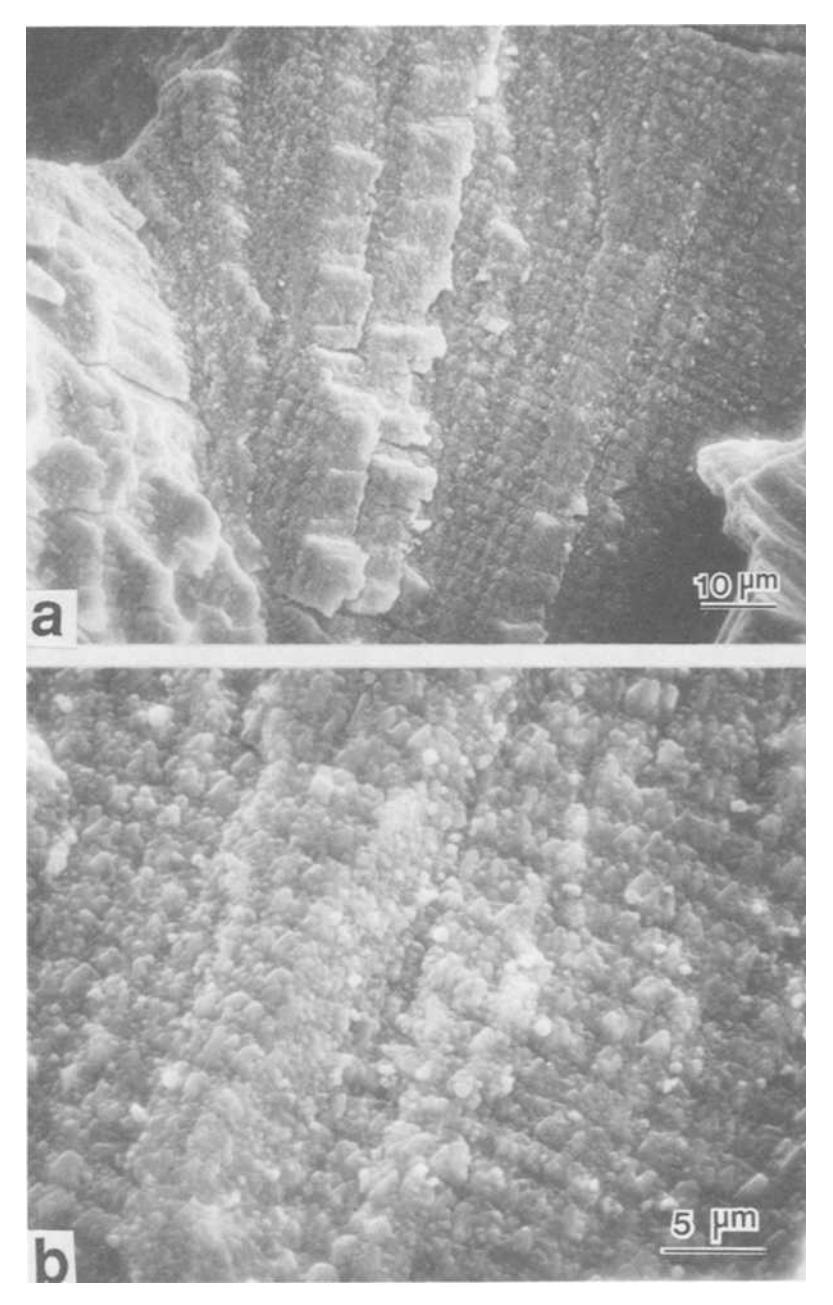
FIG. 12—Scanning electron micrographs showing crack arrest markings observed on the fracture surface of an oriented copper monocrystal tested in 1 M sodium nitrite, pH 9, at an applied potential of +0.05 V and a strain rate of 10^{-6} s⁻¹. The direction of crack propagation is from lower left to upper right; (b) shows a magnified area of (a).

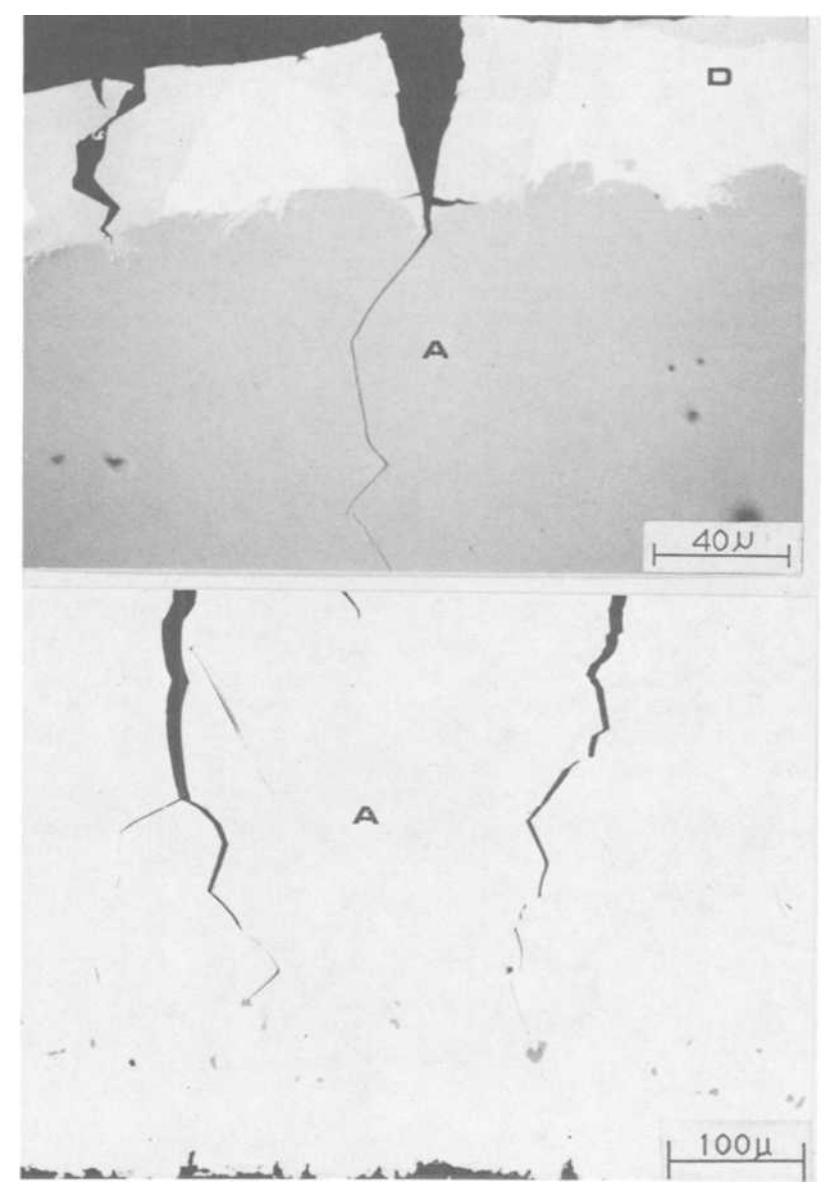
FIG. 4—SEM micrographs (secondary electron detector) of the cross section in Fig. 3 showing mixed intergranular and transgranular crack propagation through the dealloyed layer (D) and into the alloy substrate (A). The sample was dealloyed at E = 942 (SHE) for 102 coul cm⁻² of charge, and then stressed for 10 min while maintaining E = 942 mV.

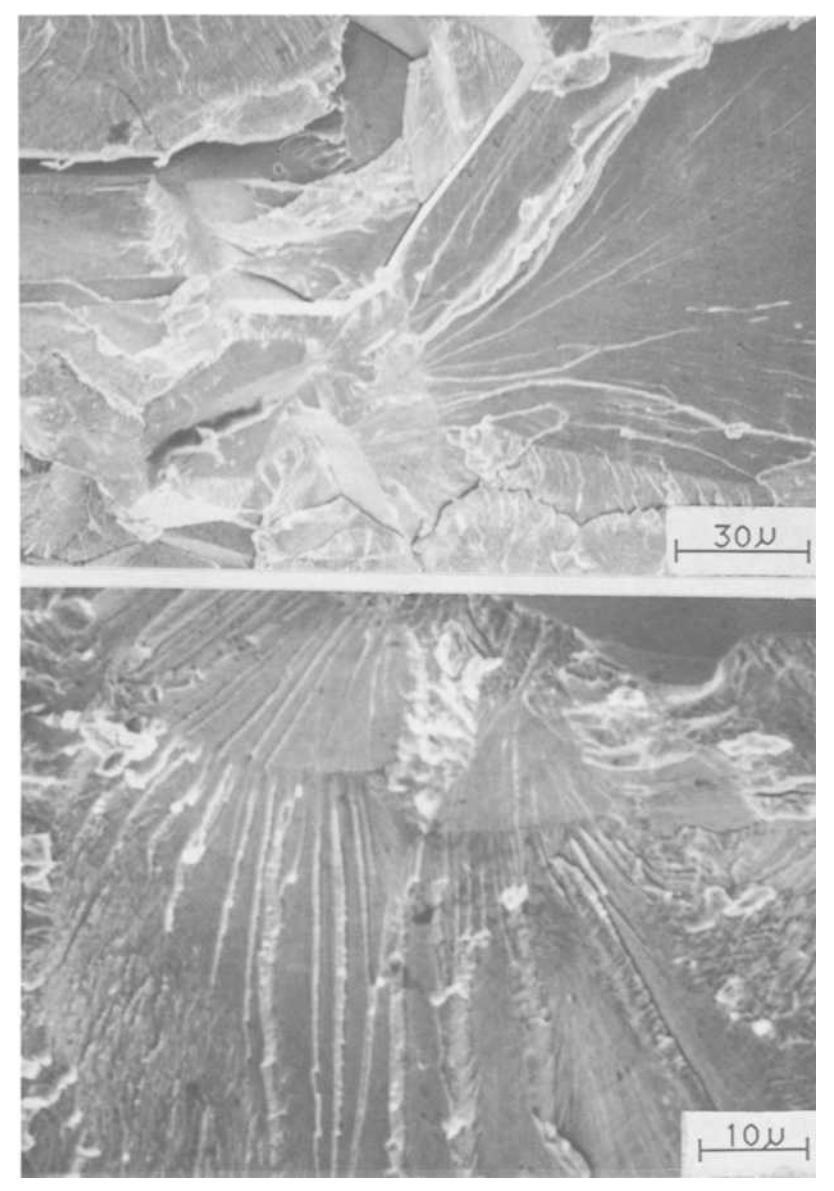
FIG. 5—Typical SEM micrographs of the fracture surface of cracks in the substrate alloy, showing "river" patterns and parallel ledge morphology typical of a transgranular cleavage fracture.

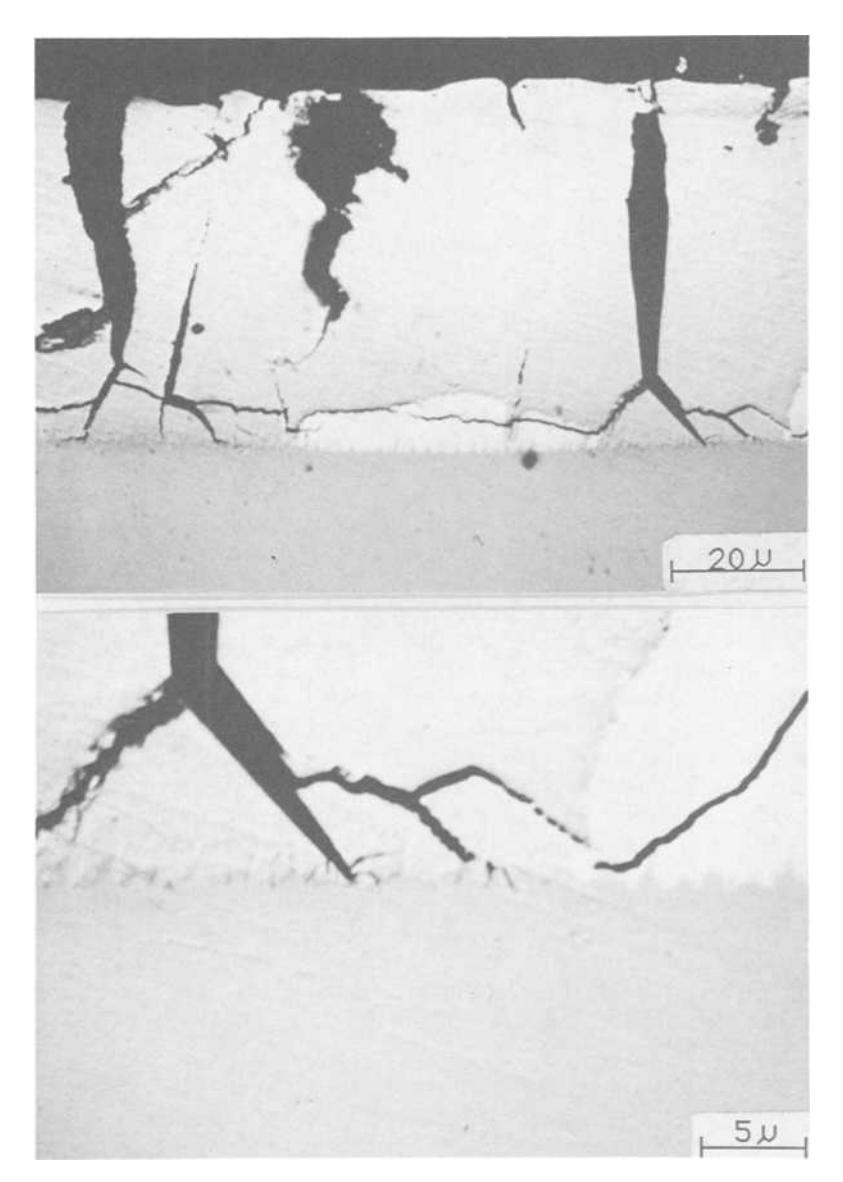
FIG. 6—Same as Fig. 4, except the sample shows no crack propagation beyond the dealloyed layer/ alloy interface when stressed for 10 min while maintaining E = 142 mV (SHE) instead of 942 mV; b is an enlargement of a.

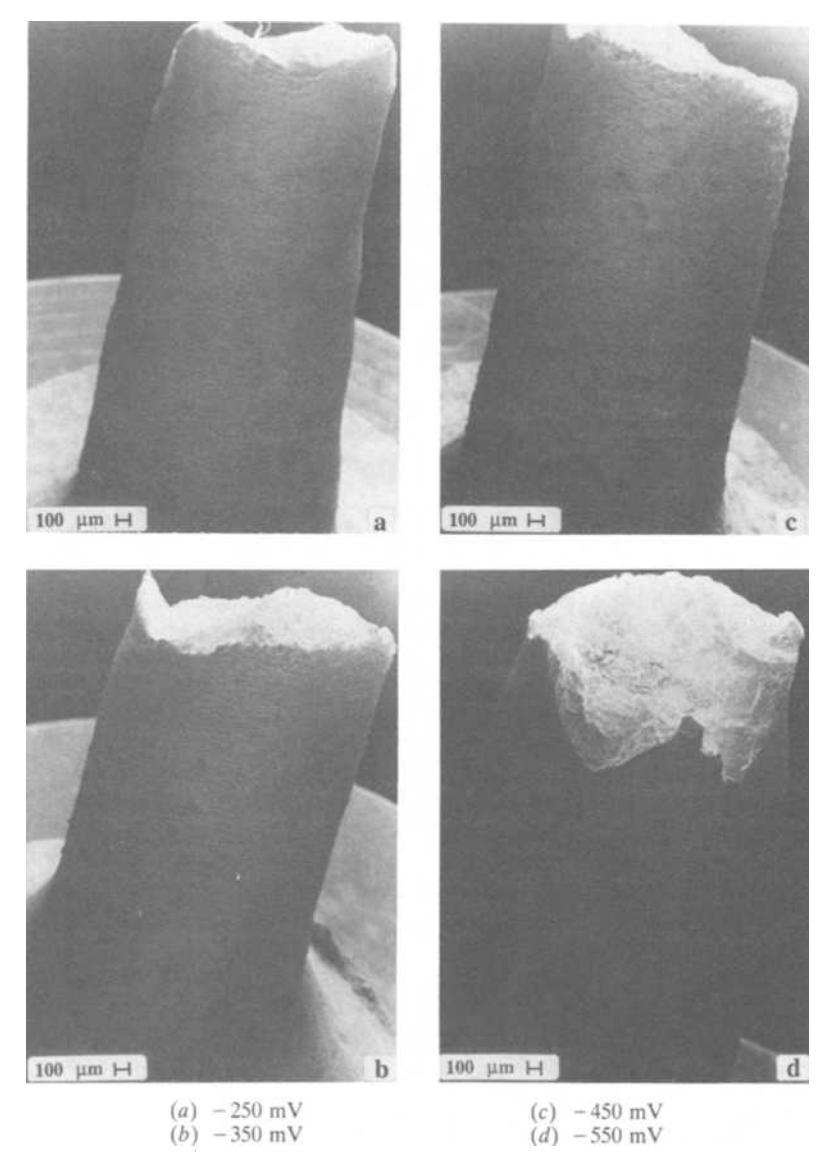
FIG. 7—Side views of fractured tension specimens tested at a strain rate of $8 \times 10^{-7}/s$ in the breech chamber residue. Specimens tested at various electrode potentials and in oil (SEM photographs).

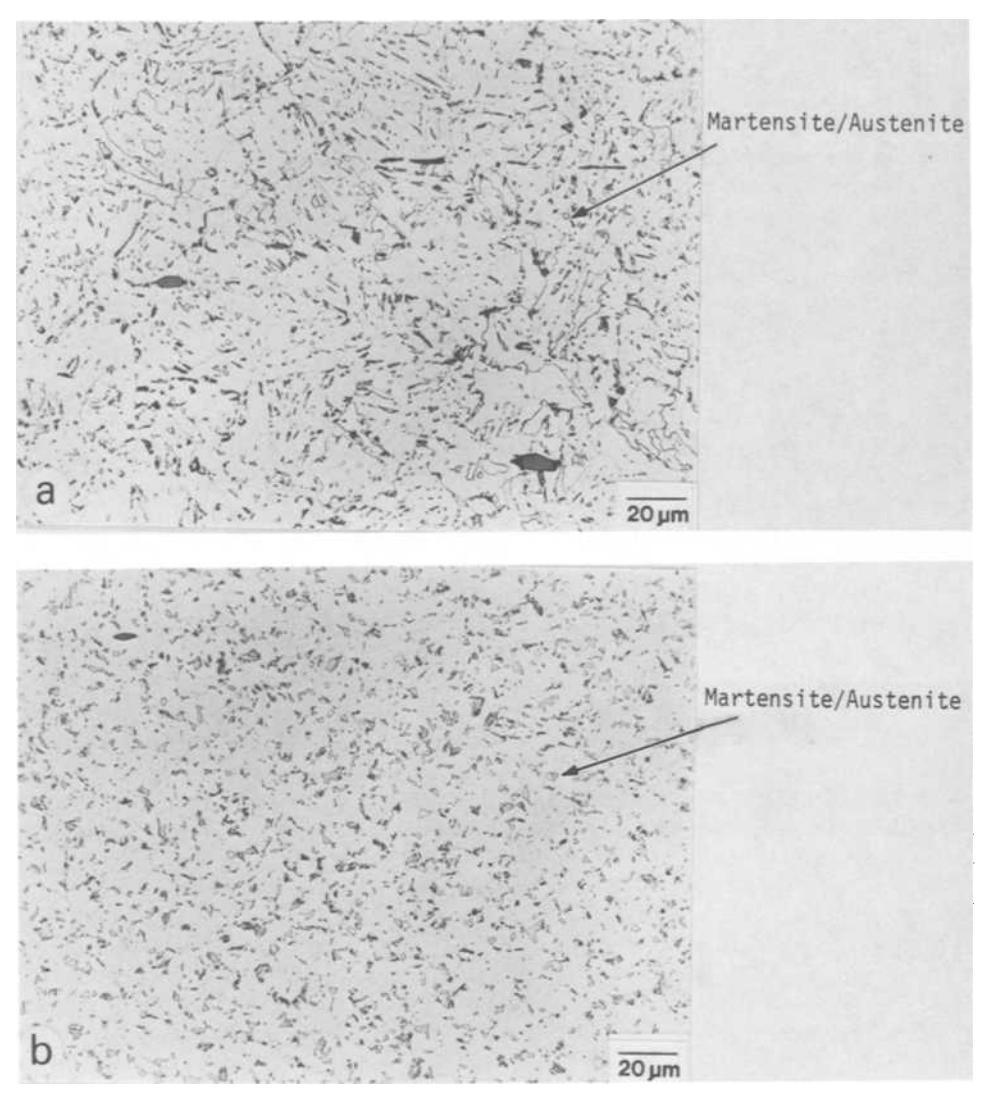
FIG. 2-Microstructures of HAZ Subzones 1 (a) and Subžone 2 (b) in Pipe 1664.

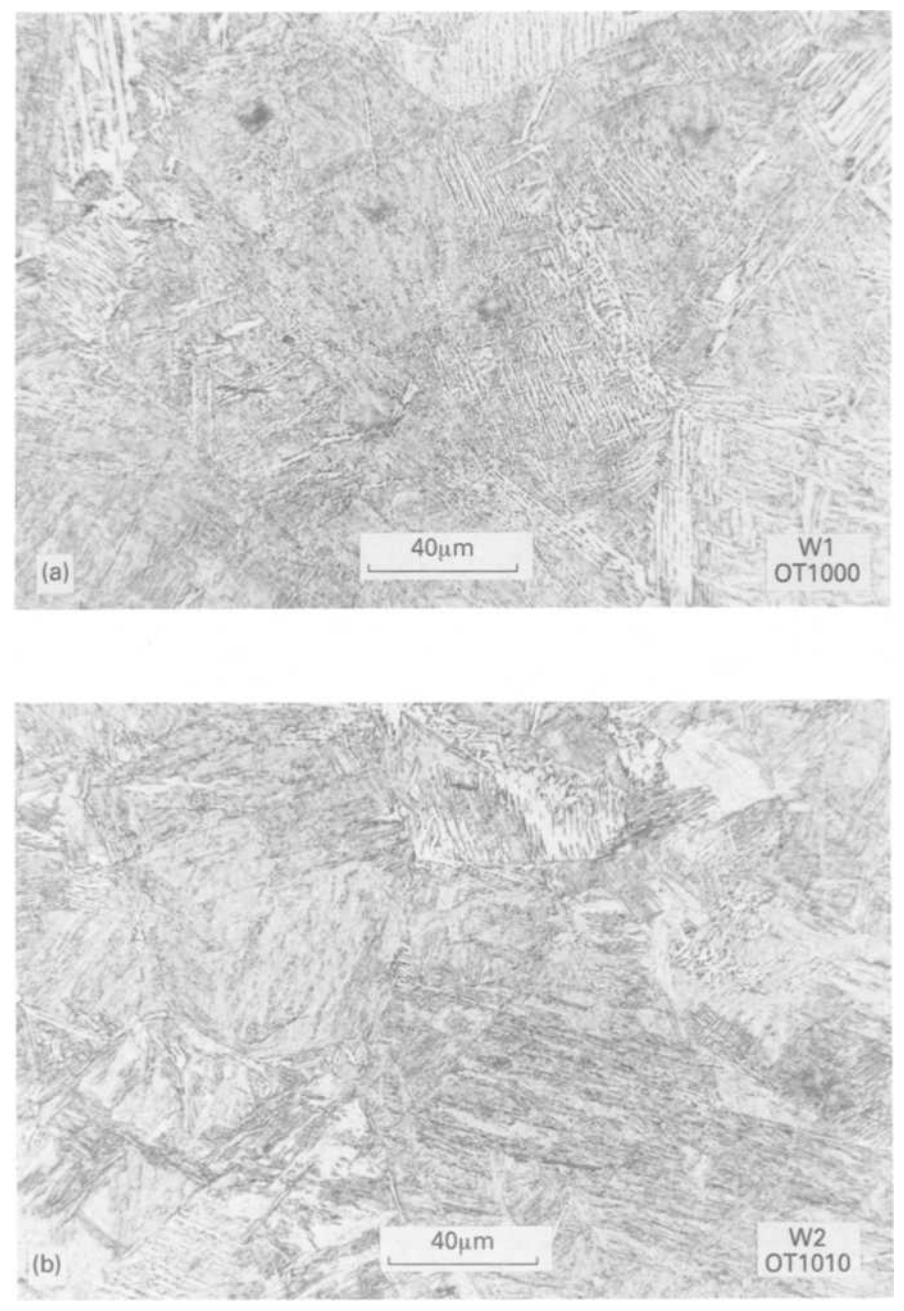
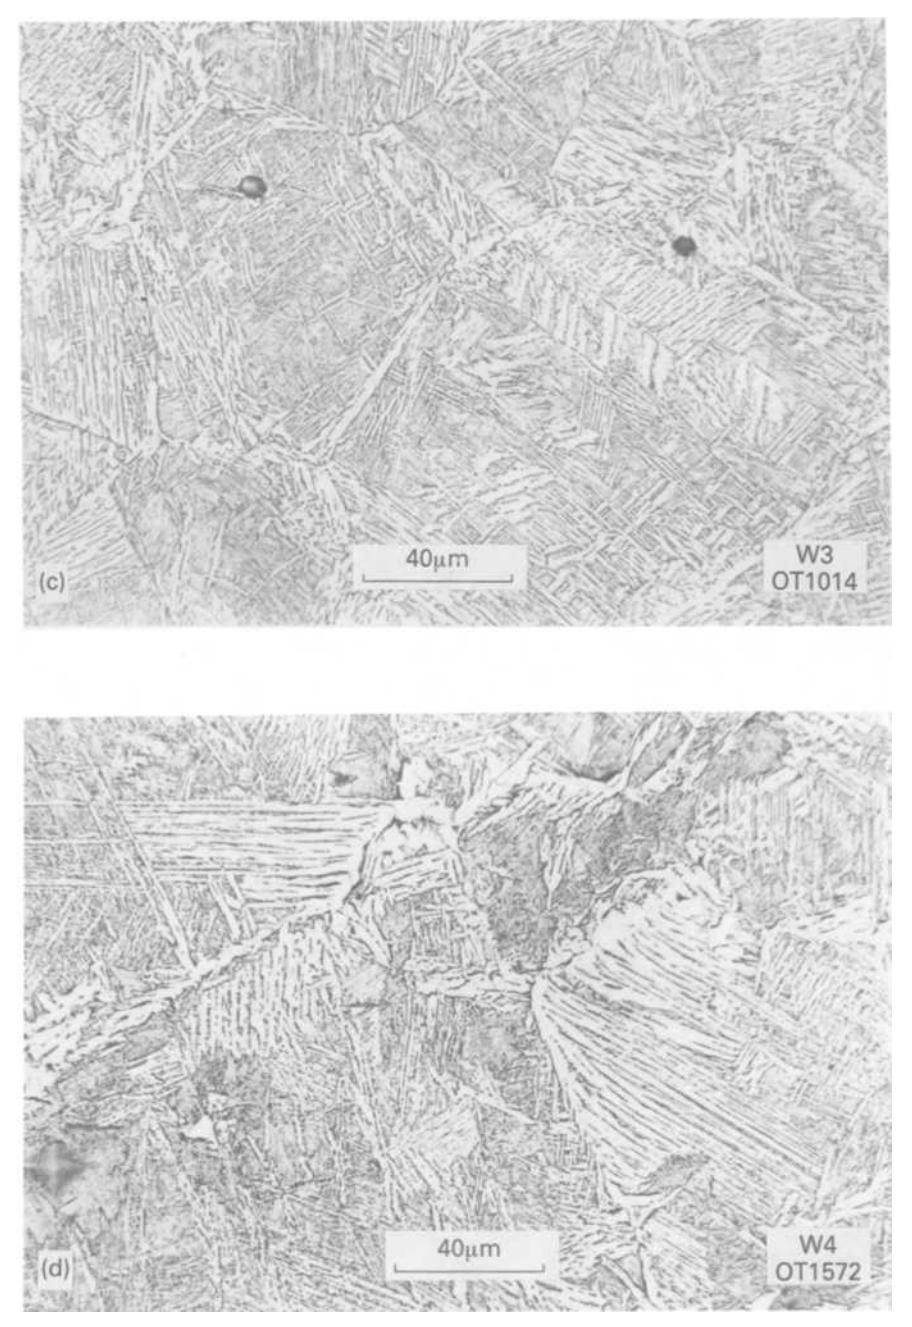
FIG. 4—Microstructures of grain coarsened HAZs.

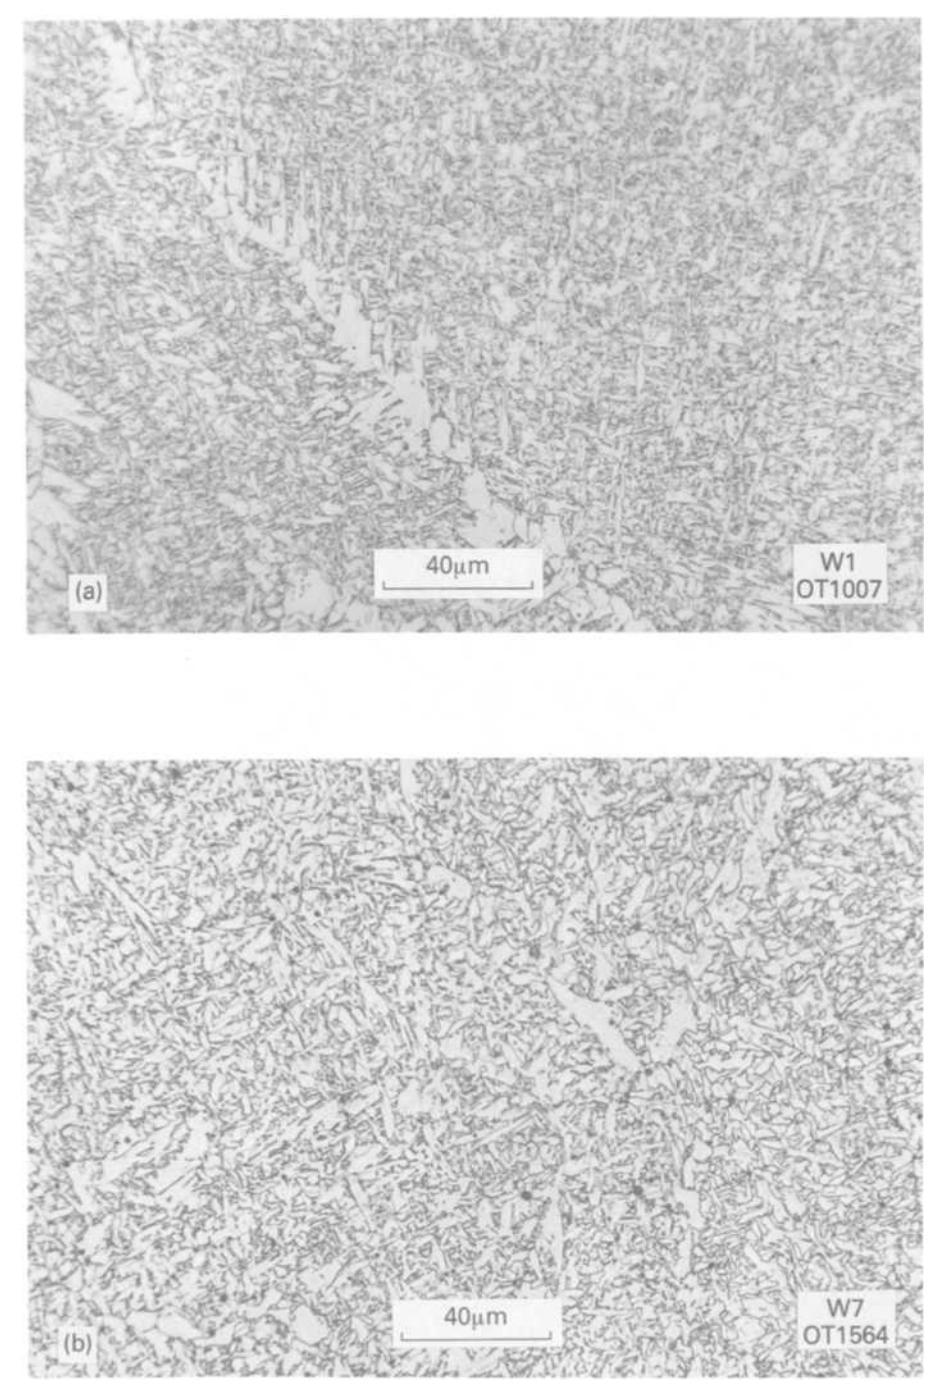
FIG. 7—Weld metal microstructures.

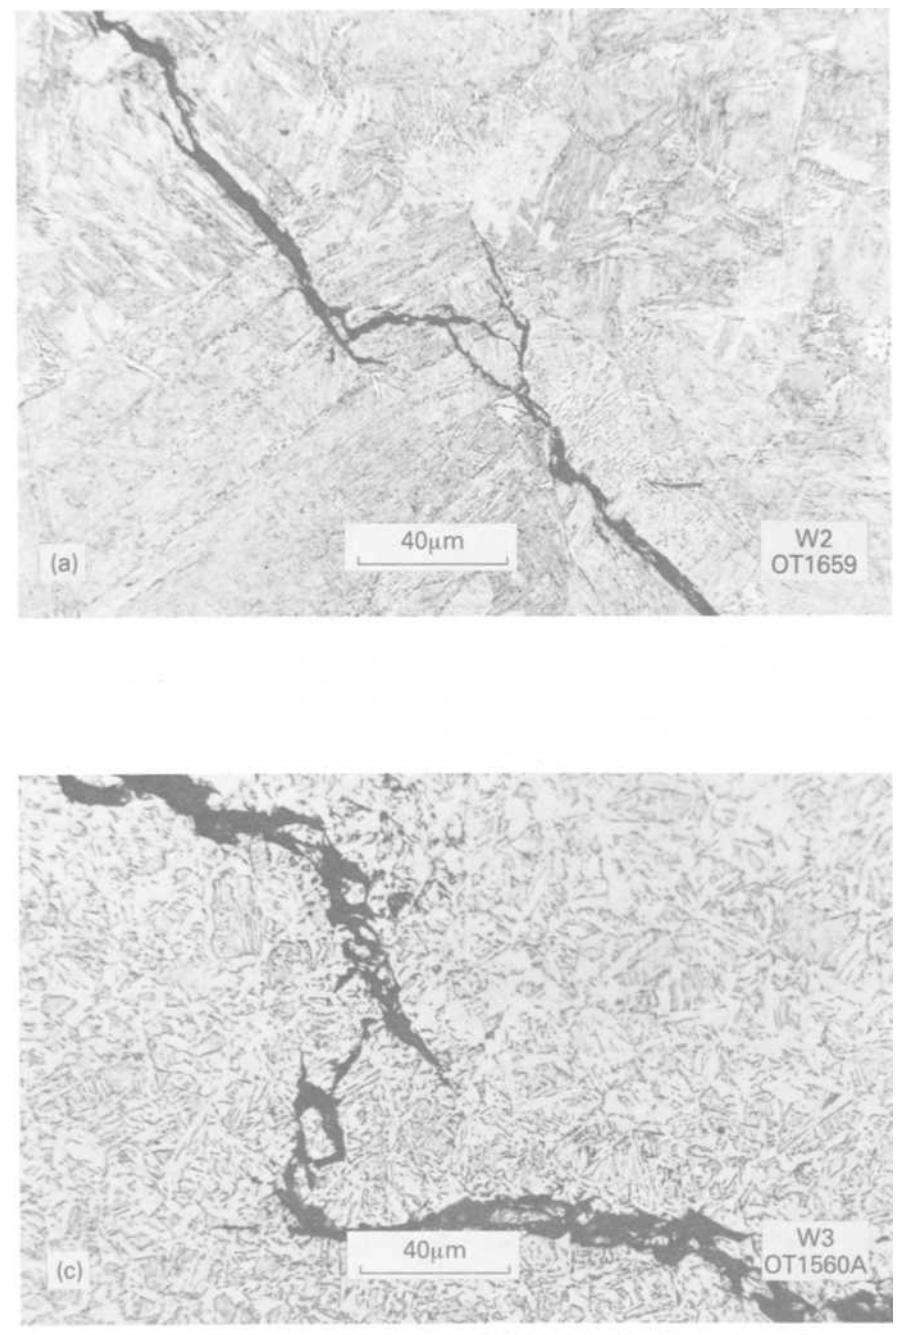
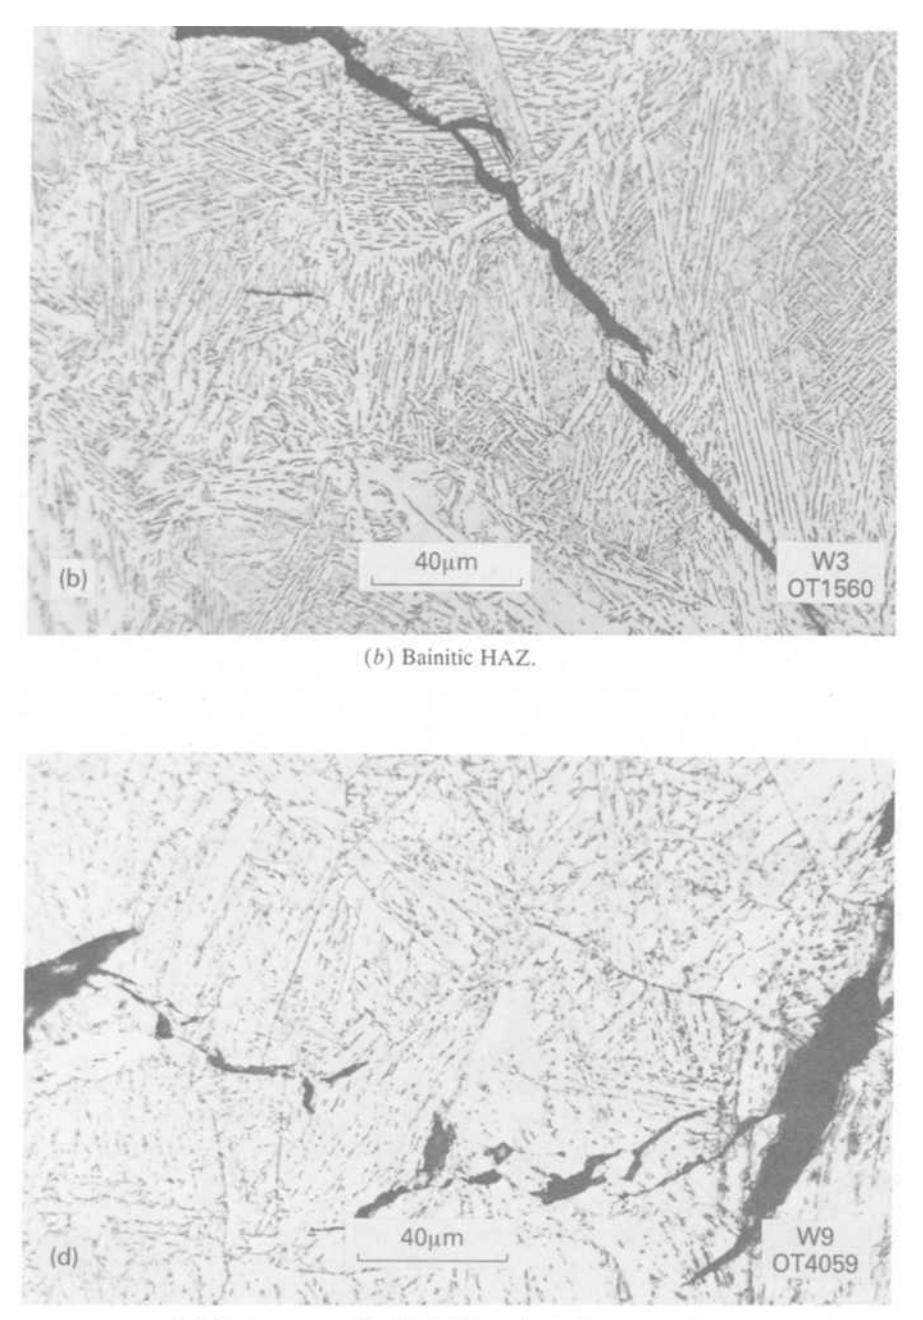
(c) Outer regions of HAZ shown in (b).

FIG. 12-Micrographs of cracking in HAZ.

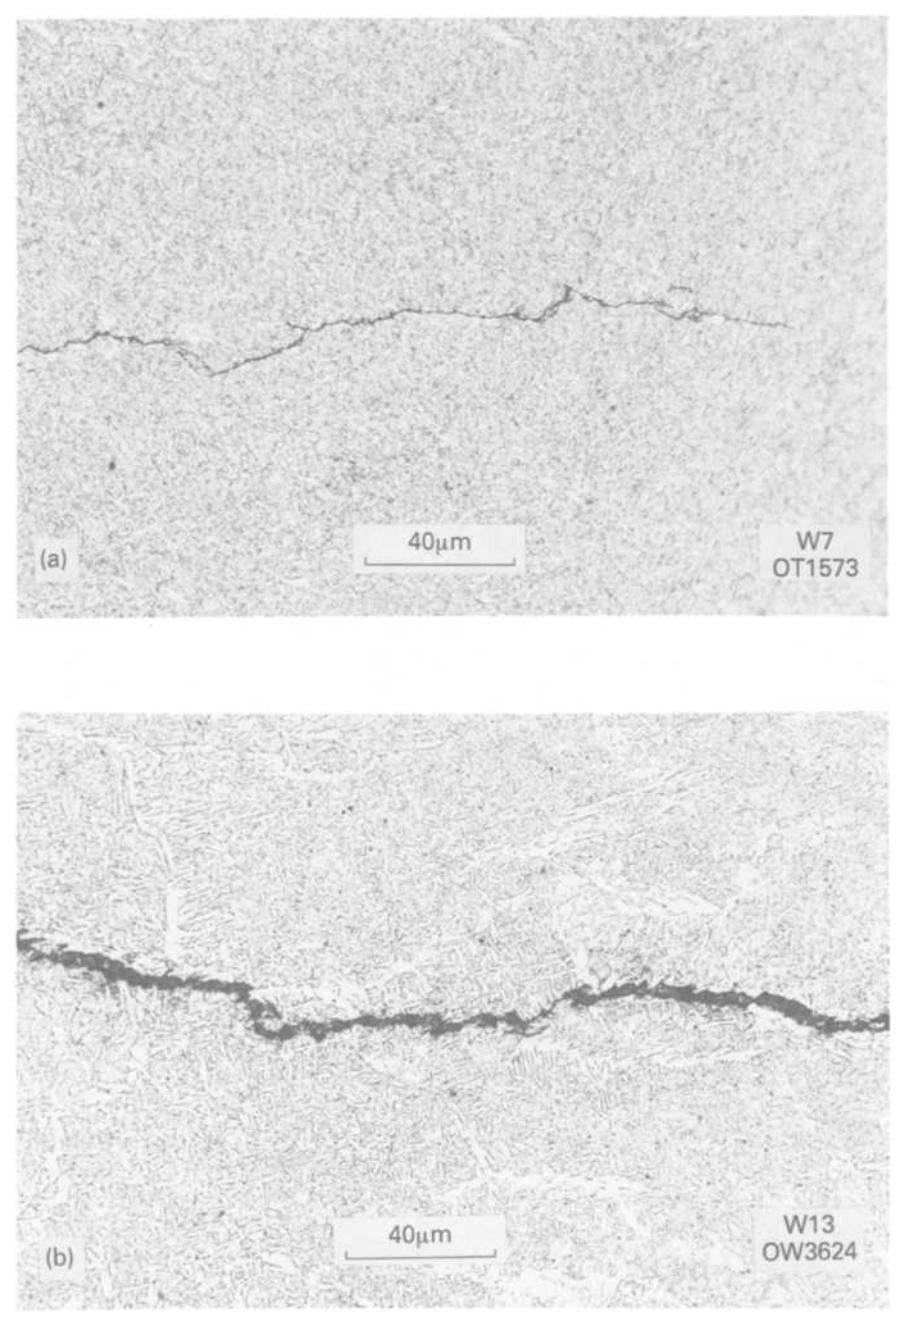
FIG. 13—Micrographs of cracking in weld metal.

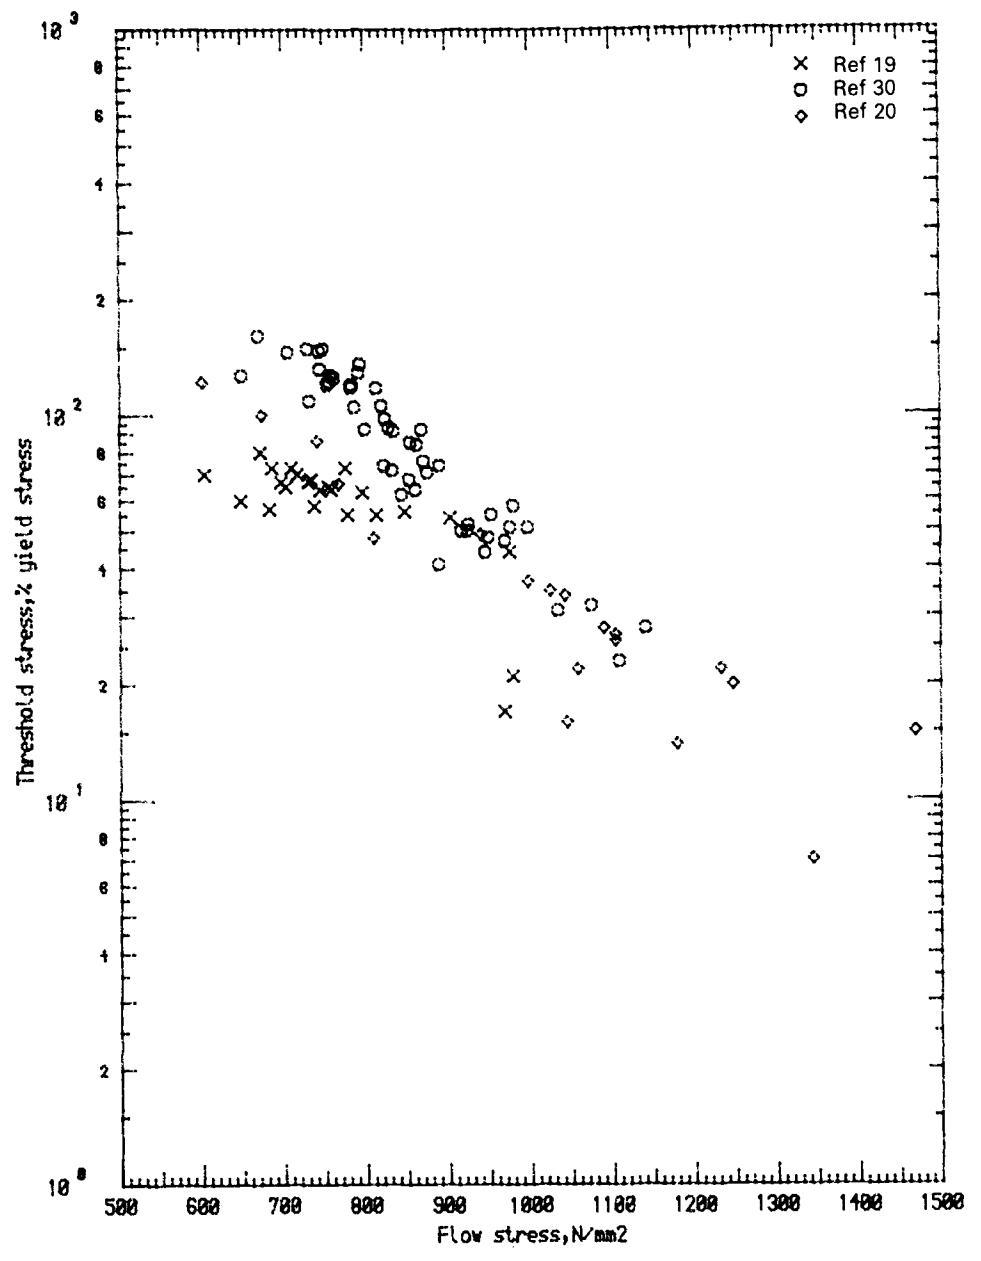
FIG. 27—Relationship between strength and threshold stress for cracking in saturated H_2S environments taken from the literature.

The factor most commonly reported as influencing the susceptibility of steels to hydrogenassisted stress corrosion is material strength level. Figure 27 shows data for smooth bend specimens taken from three separate references [19-21]. Despite different experimental techniques, there is close agreement between the three sets of data, showing a decrease in threshold stress with increasing strength. Similar good agreement between different sets of

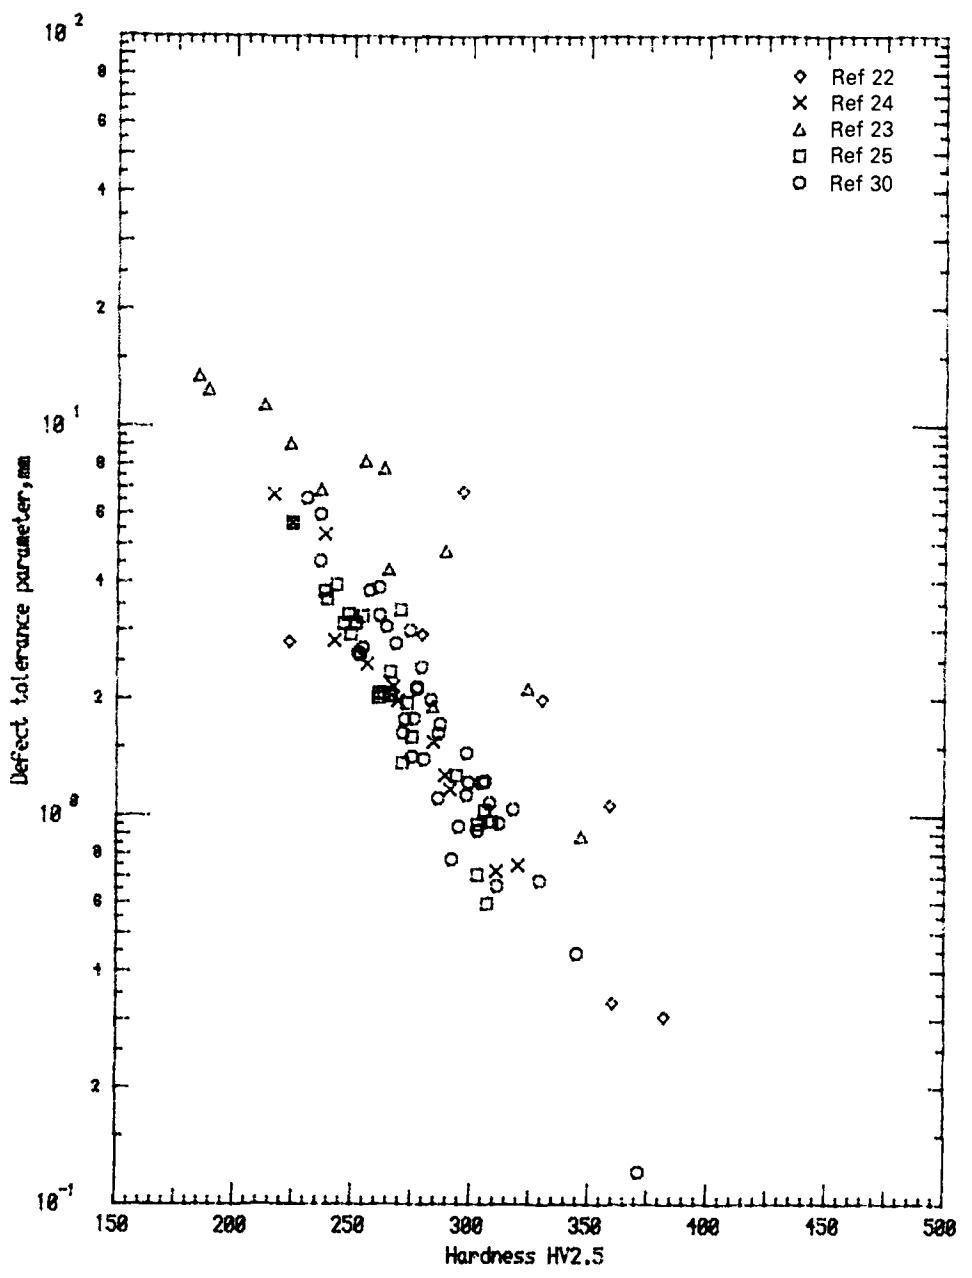
FIG. 28—Data from K_{ISCC} testing carried out in NACE solution reported in the literature.

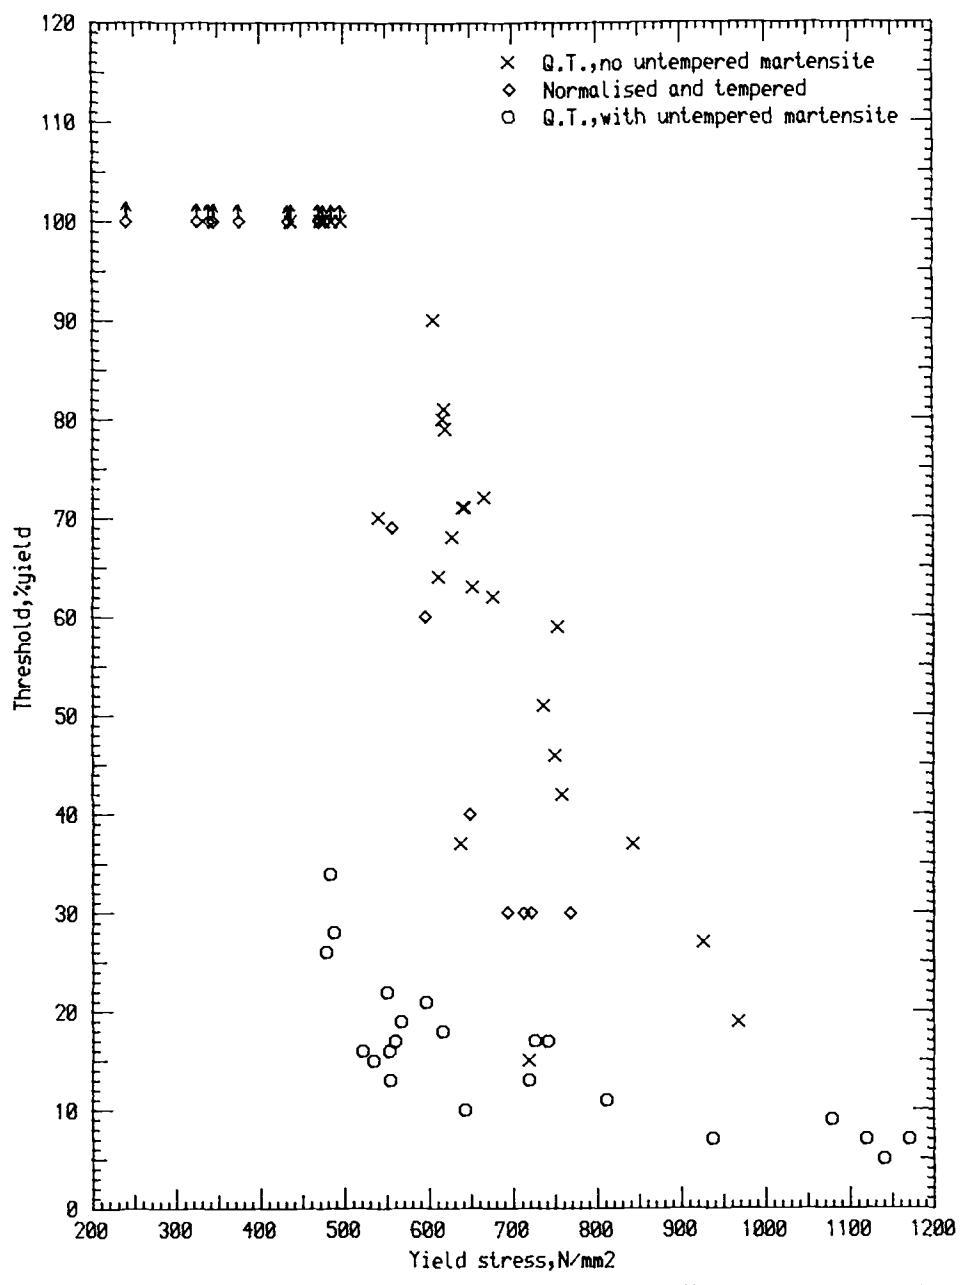
FIG. 29—Data from Ref 6 showing the effects of microstructure on sulfide stress corrosion cracking.
