Environmentally Assisted Cracking: Science and Engineering

STP 1049

W. Barry Lisagor, Thomas W. Crooker, and Brian N. Leis, editors

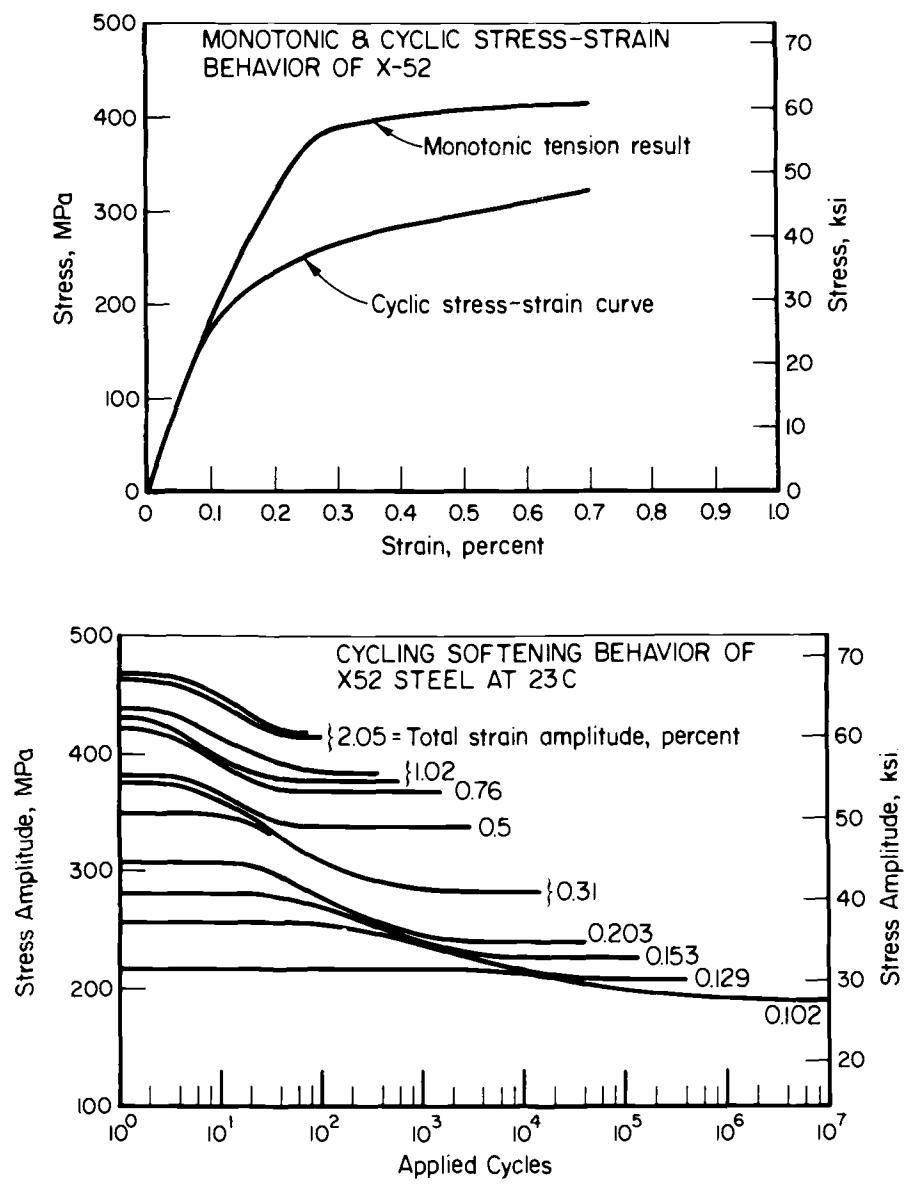
FIG. 4—Cyclic deformation behavior of X52 steel at $23^{\circ}C$; (a) monotonic and cyclic stress-strain behavior and (b) stress response as a function of applied cycles.

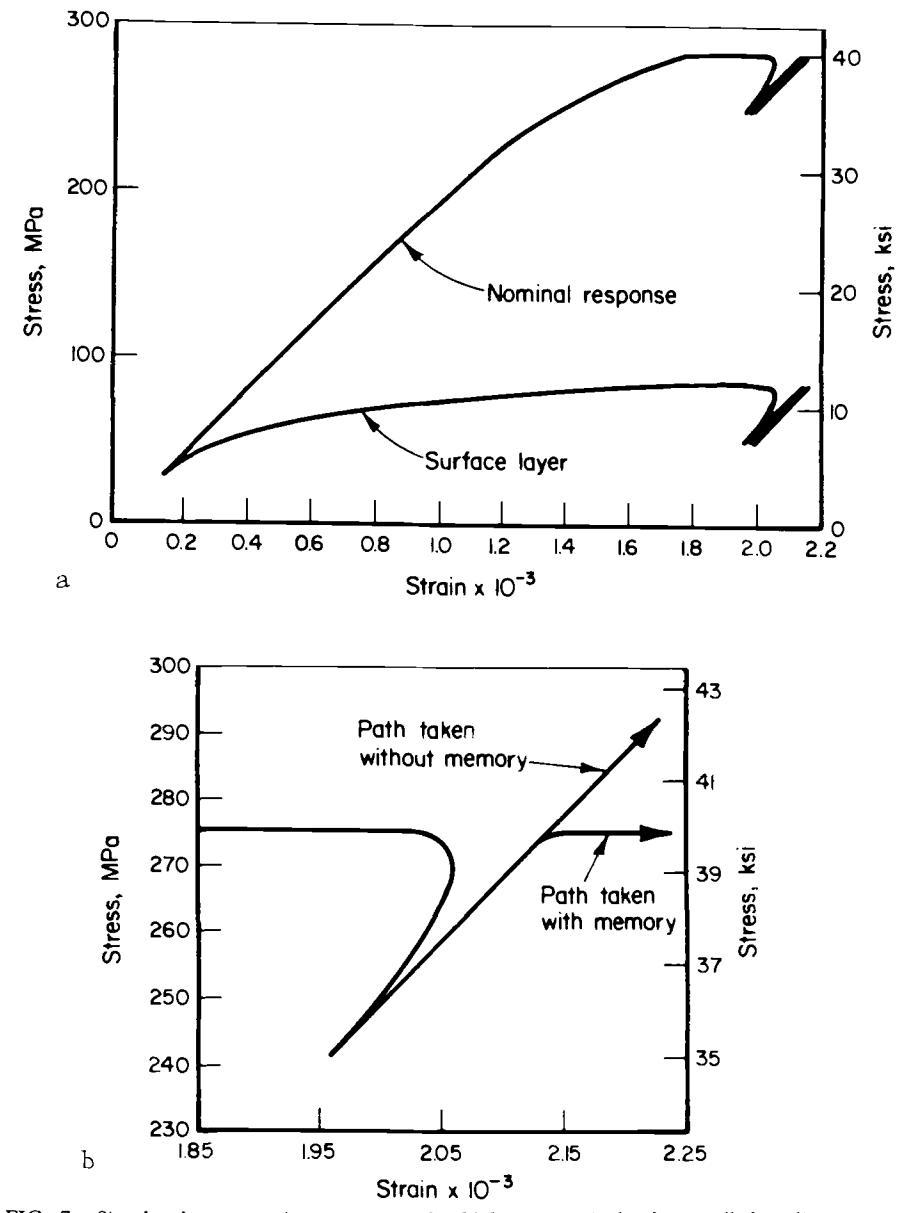
FIG. 7—Simulated stress-strain response under high stress-ratio load-controlled cycling at a crosssection in a tapered-tension-test specimen; (a) nominal and surface layer response simulating loading conditions in a seven-day test and (b) detail from Part a indicating predicted paths with and without memory for prior plastic flow.

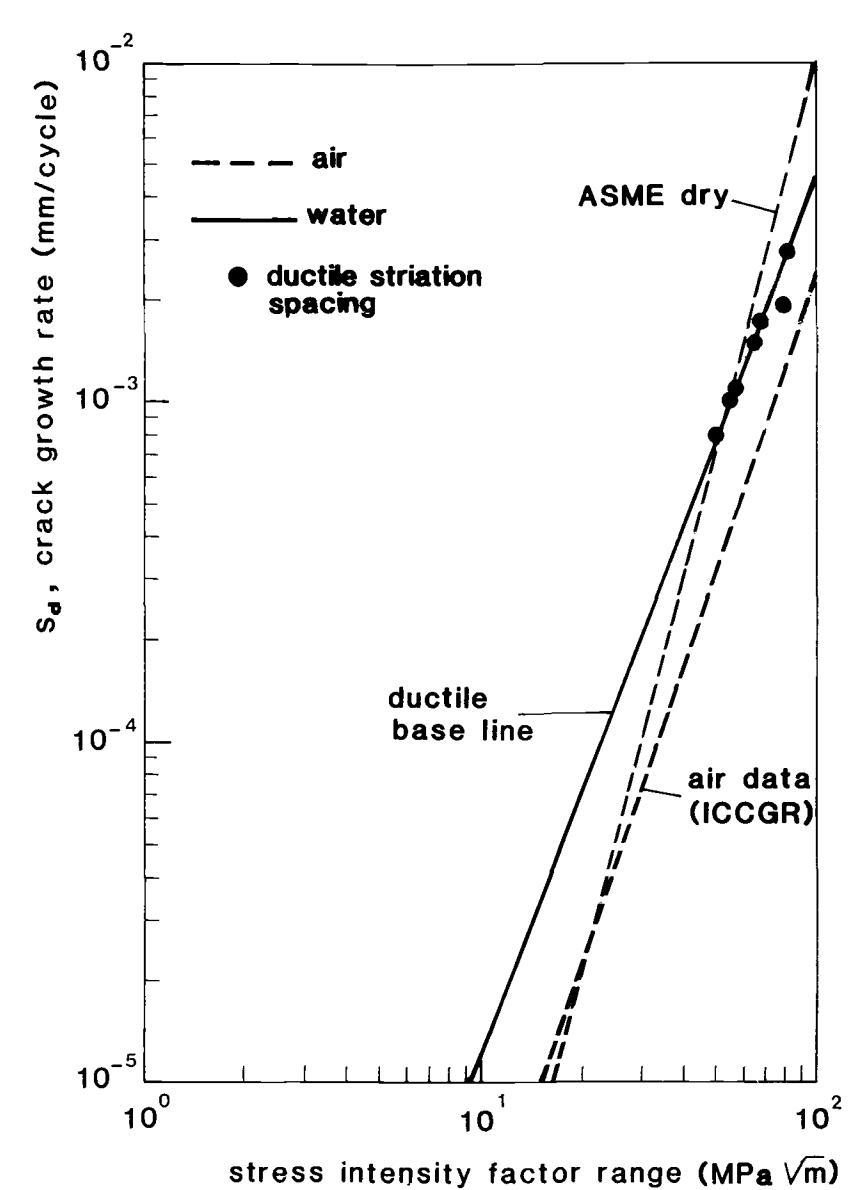
FIG. 5—"Ductile base line" obtained for A533B steel and measured values of ductile striation spacing (dots).

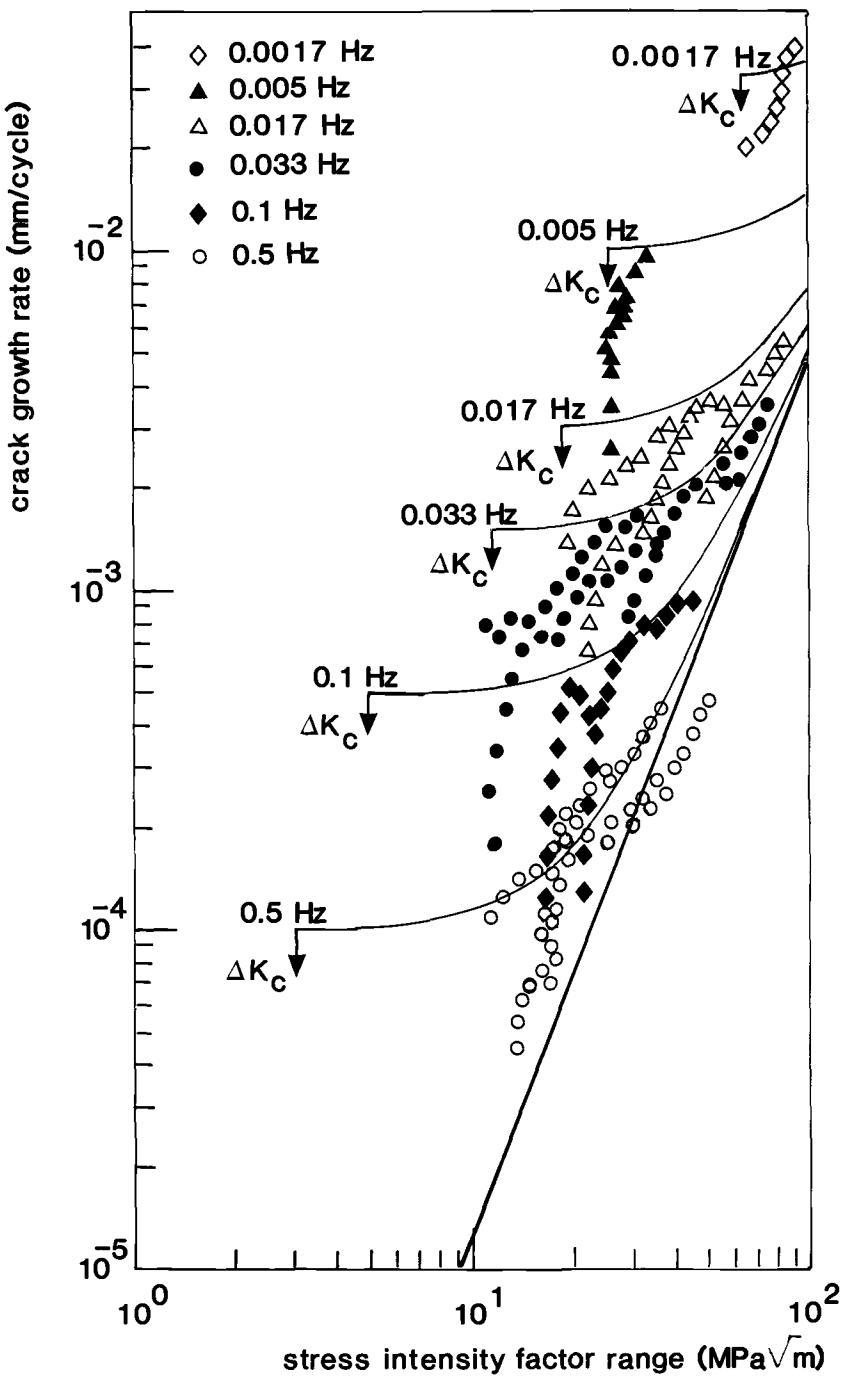
FIG. 10—Comparison between the limit curves of the model and CISE results for A533B steel at different frequencies.

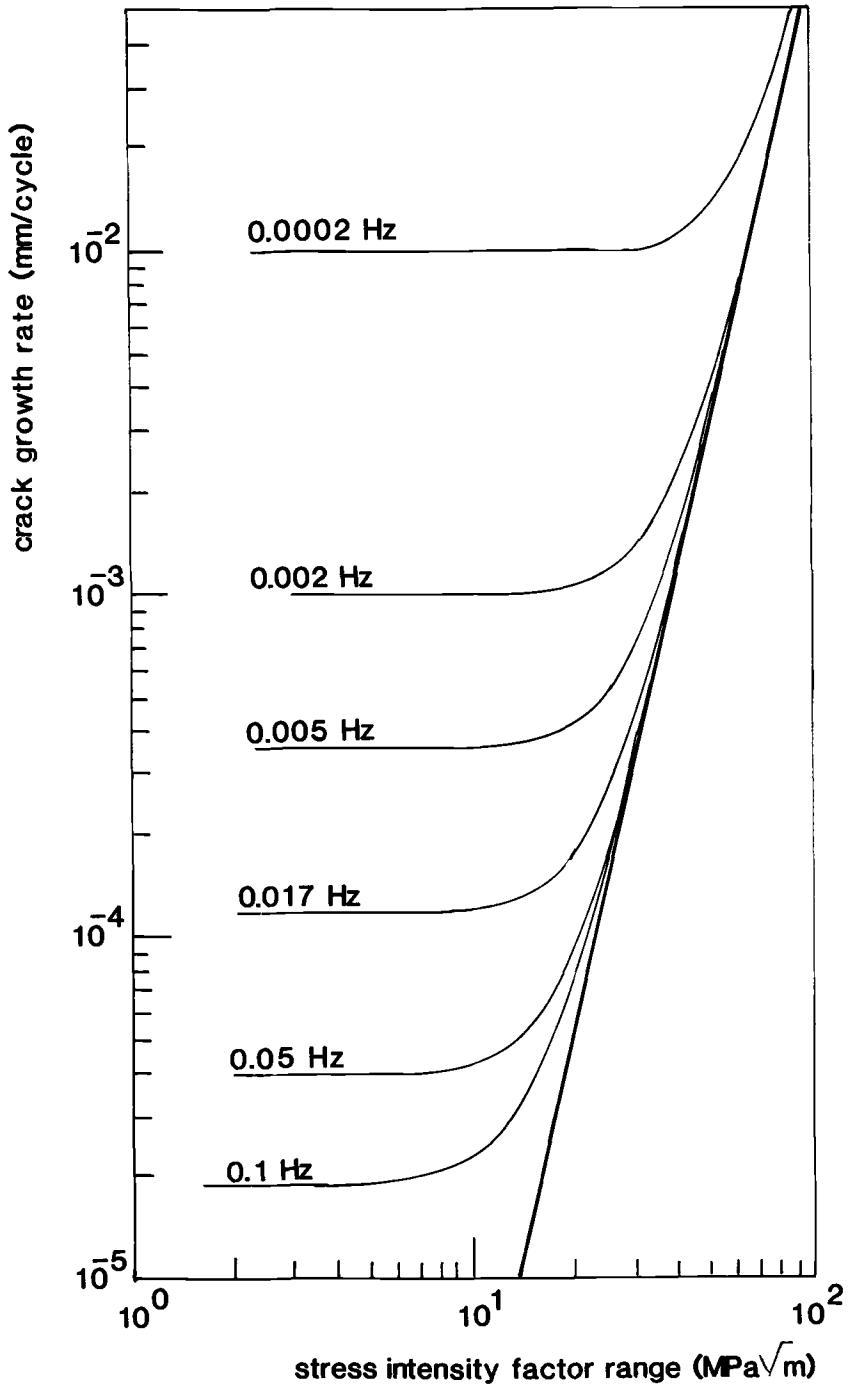
FIG. 13—Limit curves for stainless steel obtained from the ductile base line of Fig. 11 and the $(da/dt)_{sc}$ value corresponding to oxygenated water (T = loading part of the cycle period).

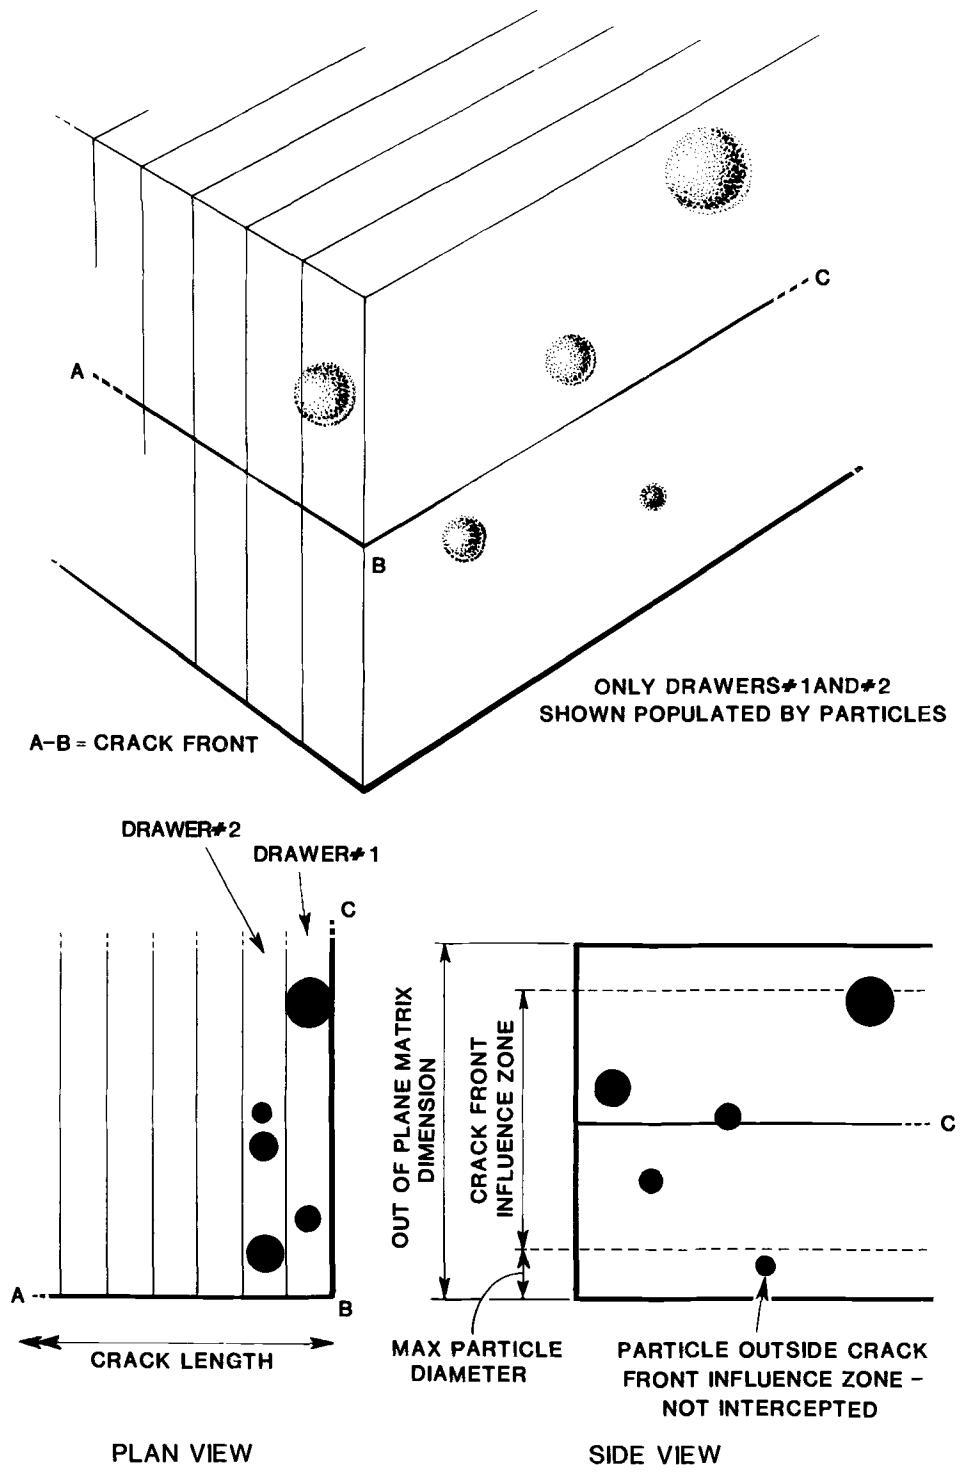
FIG. 2-Seeding of matrix by second-phase particles.

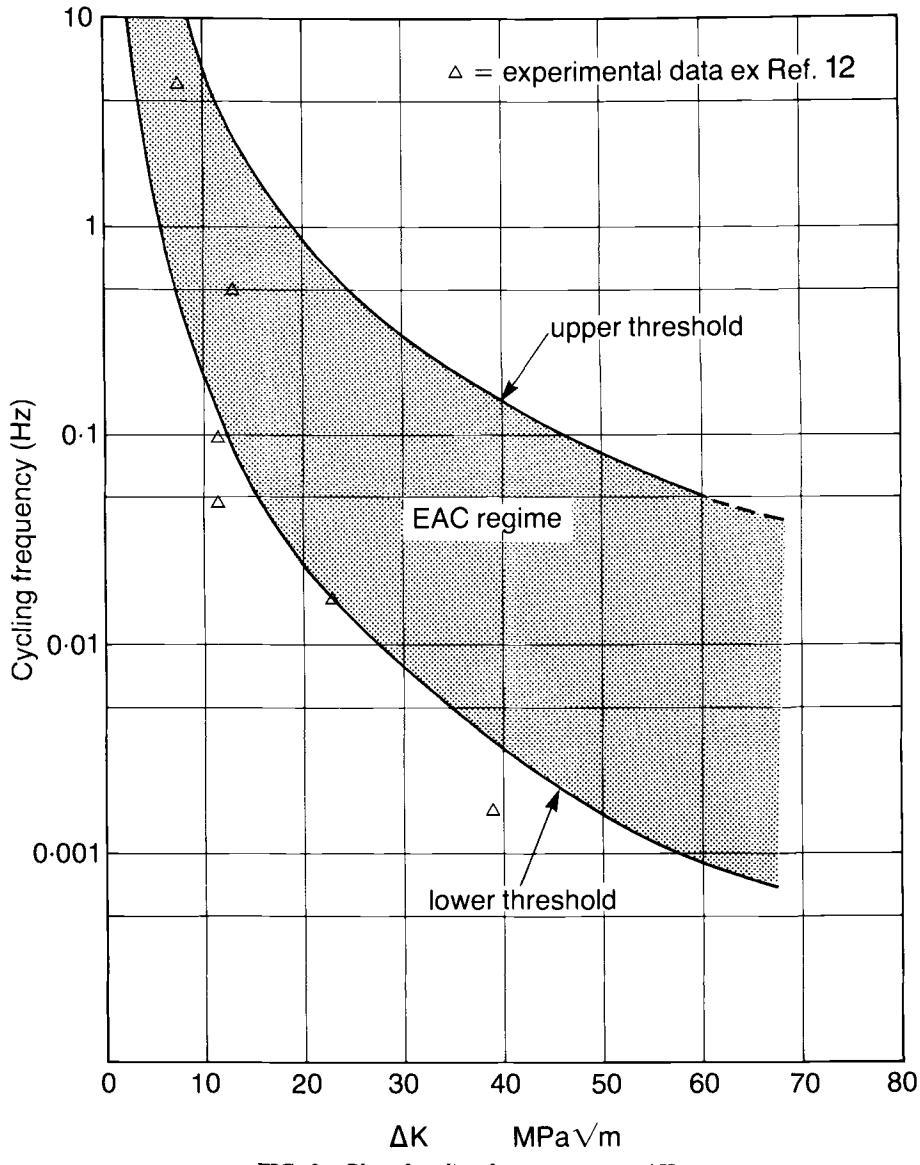
FIG. 9—Plot of cycling frequency versus ΔK .

on cycling frequency, increasing as cycling frequency increases due to, possibly, stirring effects within the crack. Figure 9 indicates that the upper and lower threshold boundaries for EAC meet in the high frequency, low ΔK region, but do not at the low frequency, high ΔK end. The actual value of frequency and ΔK where the upper and lower boundaries meet is, for this set of conditions, of no practical significance. Thus, we would have to conclude that, with the inherent uncertainties associated with in-service conditions, there would be

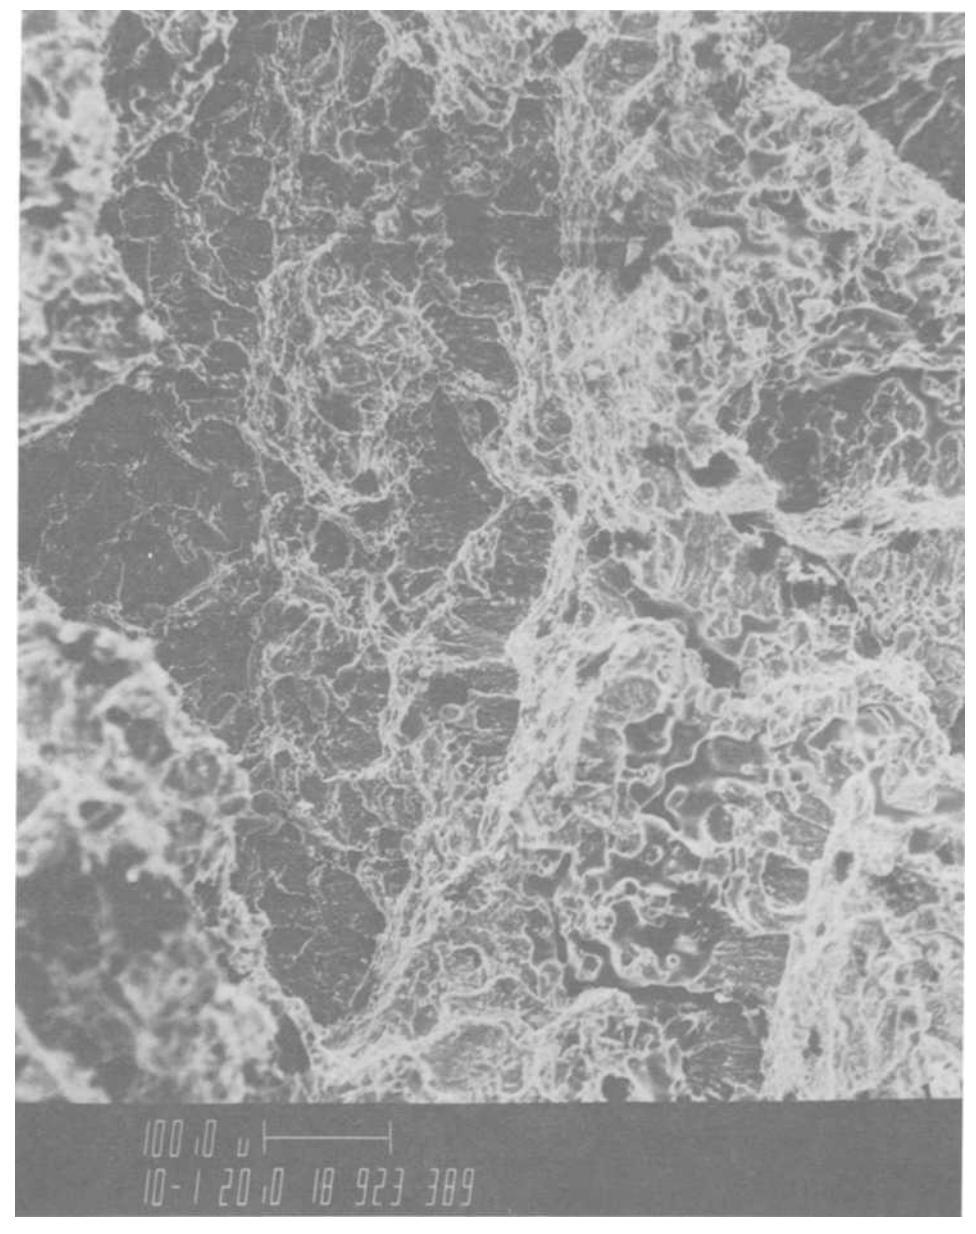
FIG. 3—Surface features of sustained load specimen tested at 925°C.

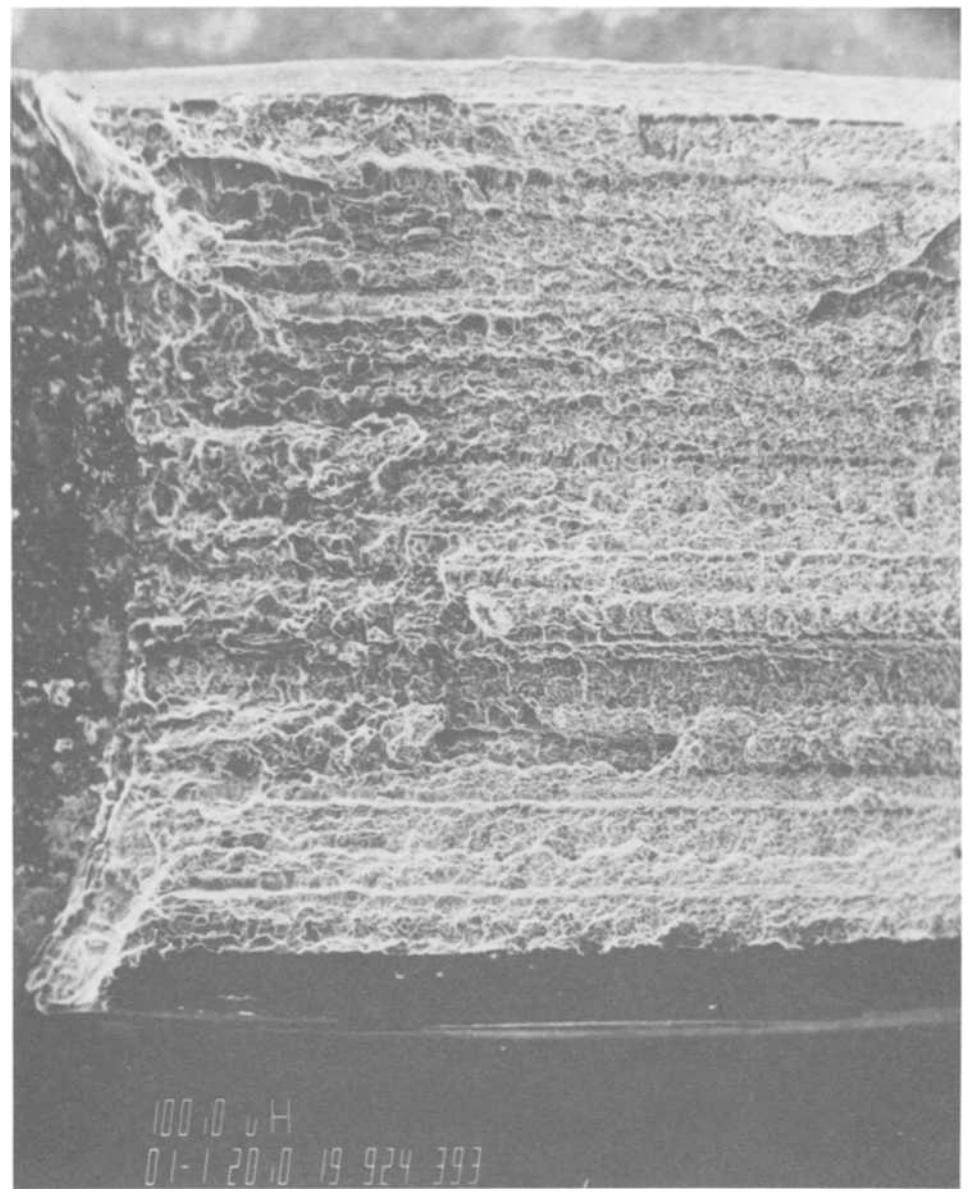
FIG. 6—Surface feature of specimen tested under sustained load at 870°C in laboratory air.

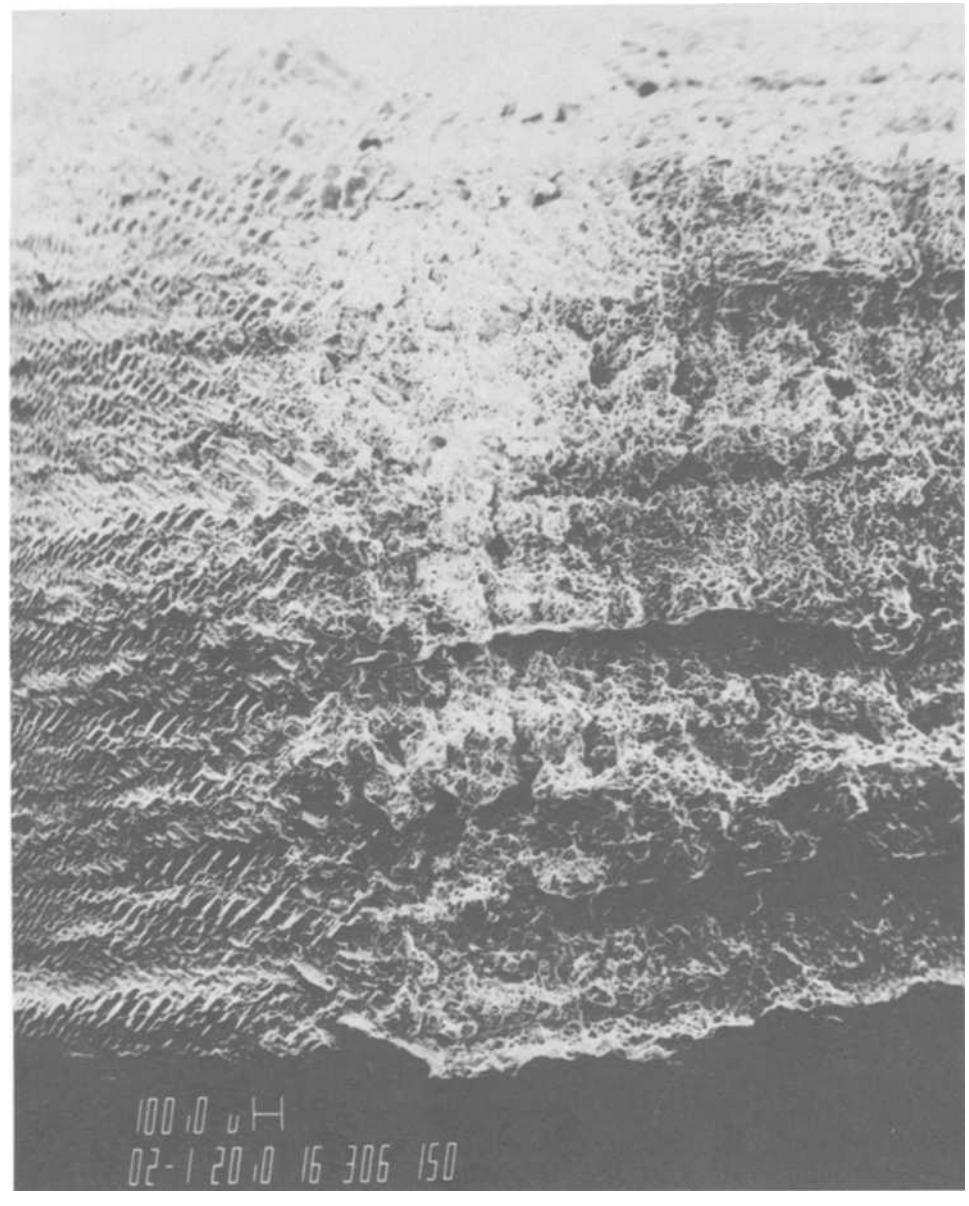
FIG. 7—Surface features showing the transition from interdendritic to crystallographic fracture.

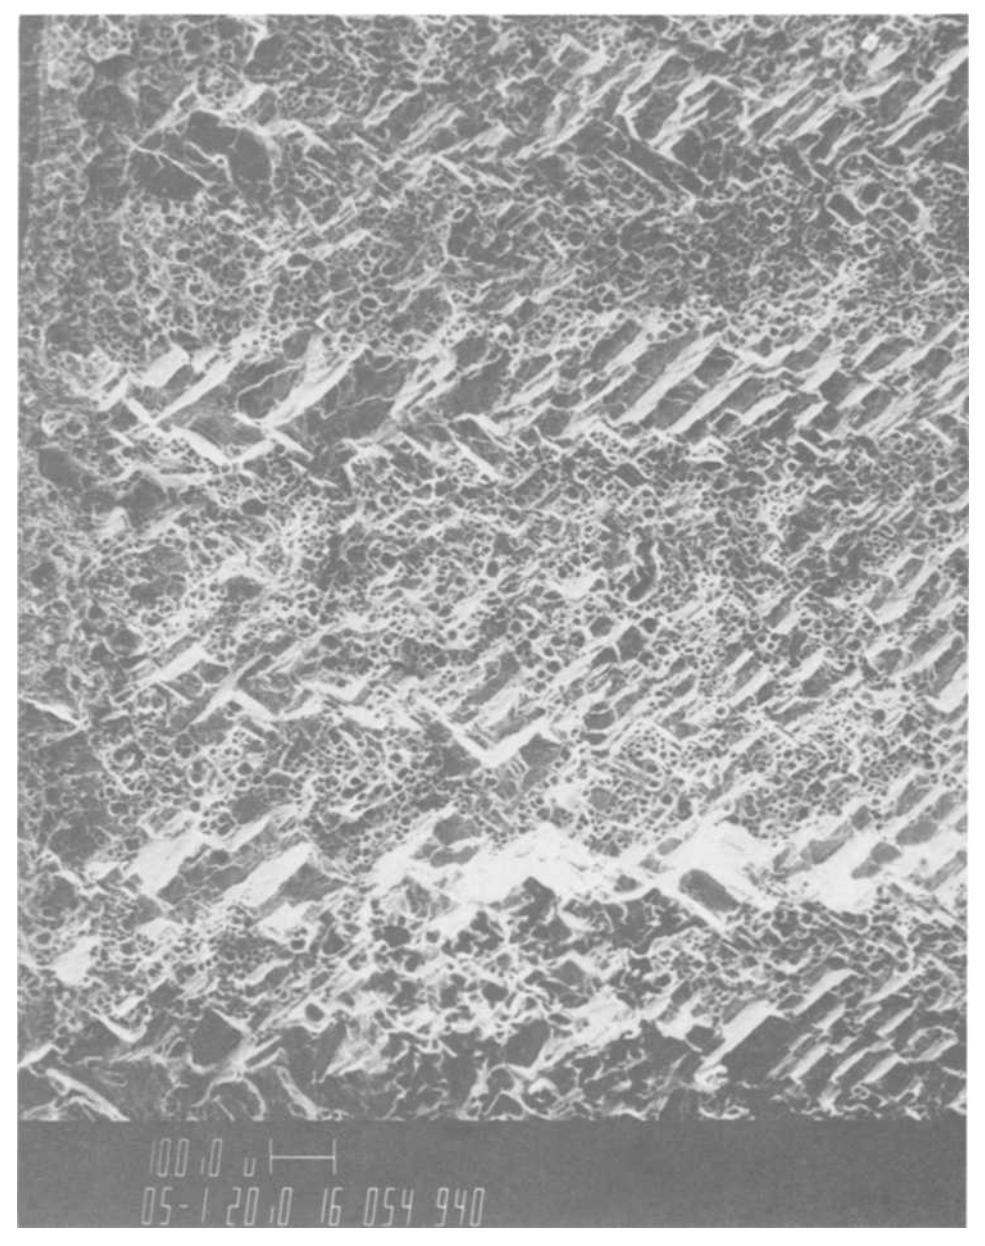
FIG. 8—Surface feature of specimen tested under sustained load at 870°C in vacuum.

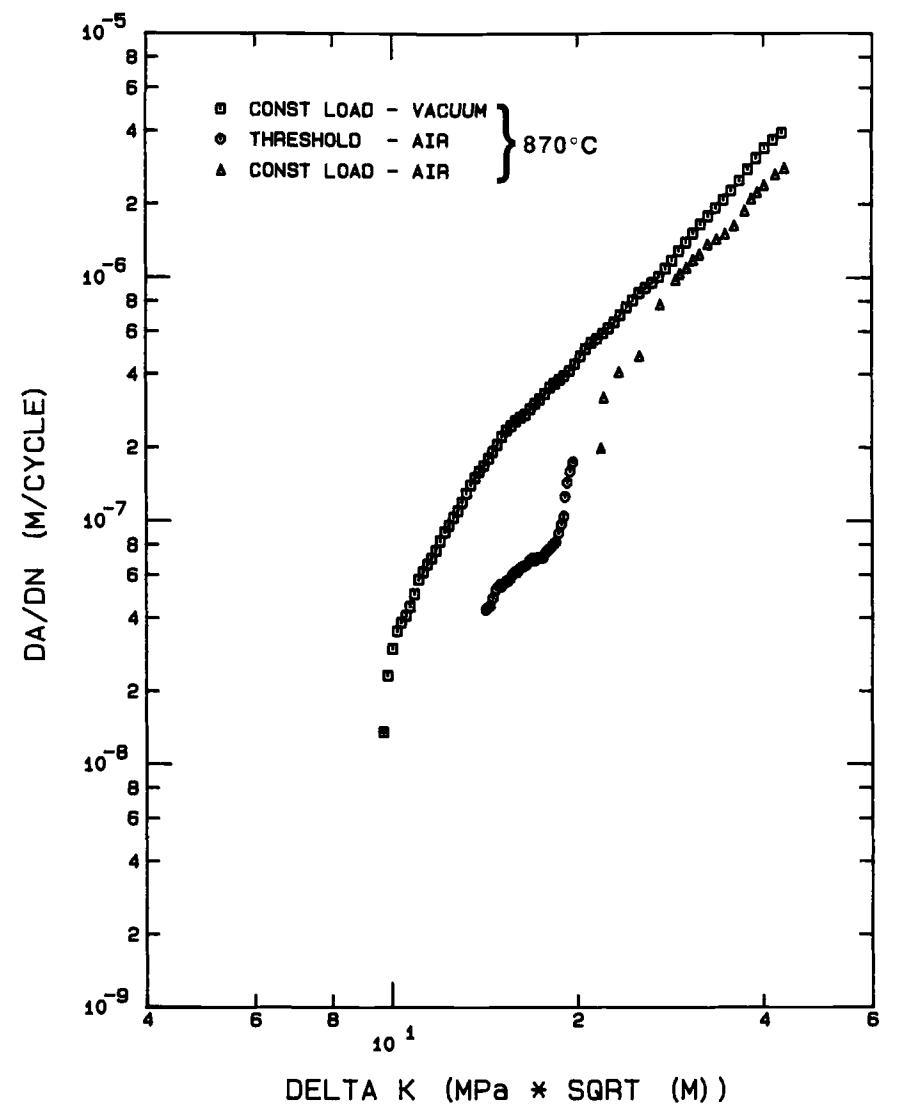
FIG. 9—Fatigue crack growth behavior of Renè N4 single crystal at 870°C in laboratory air and vacuum.

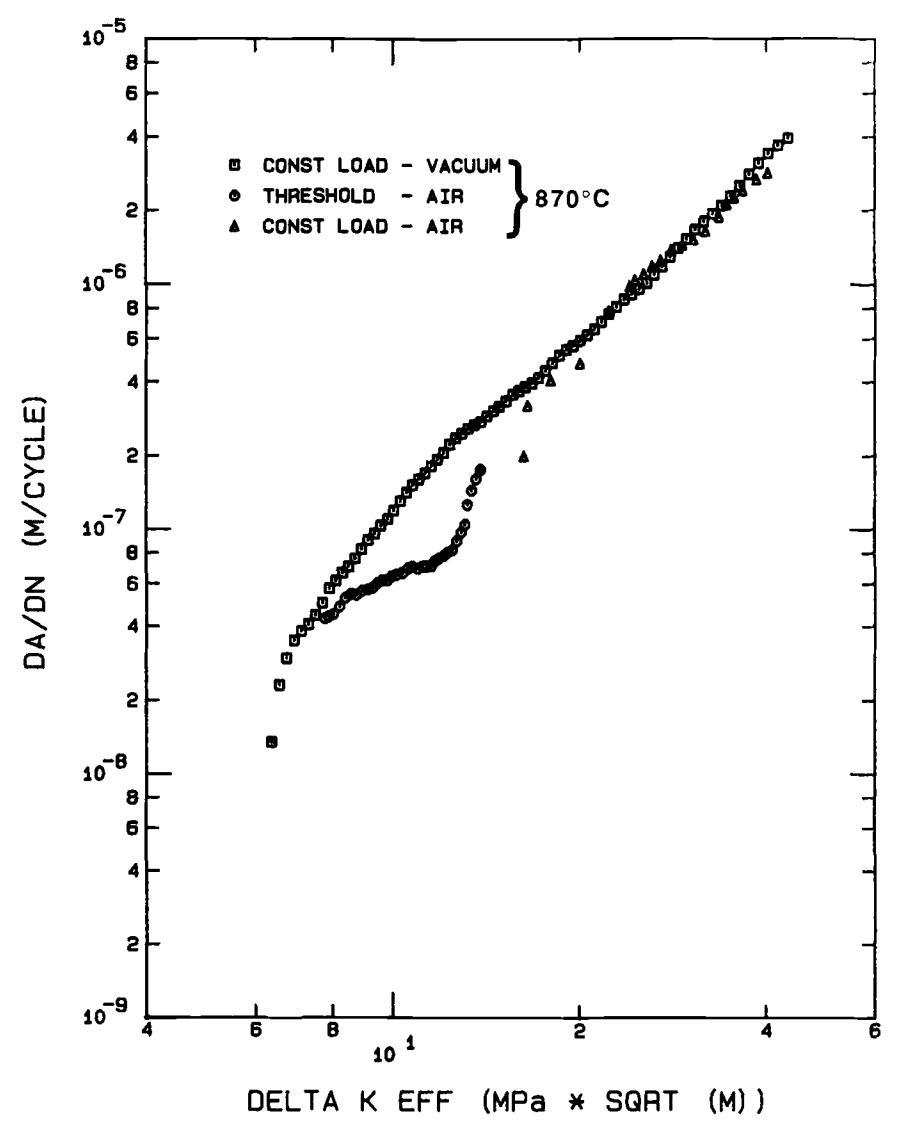
FIG. 10—The da/dN versus ΔK_{eff} plots of Renè N4 single crystal tested at 870°C in laboratory air and vacuum.

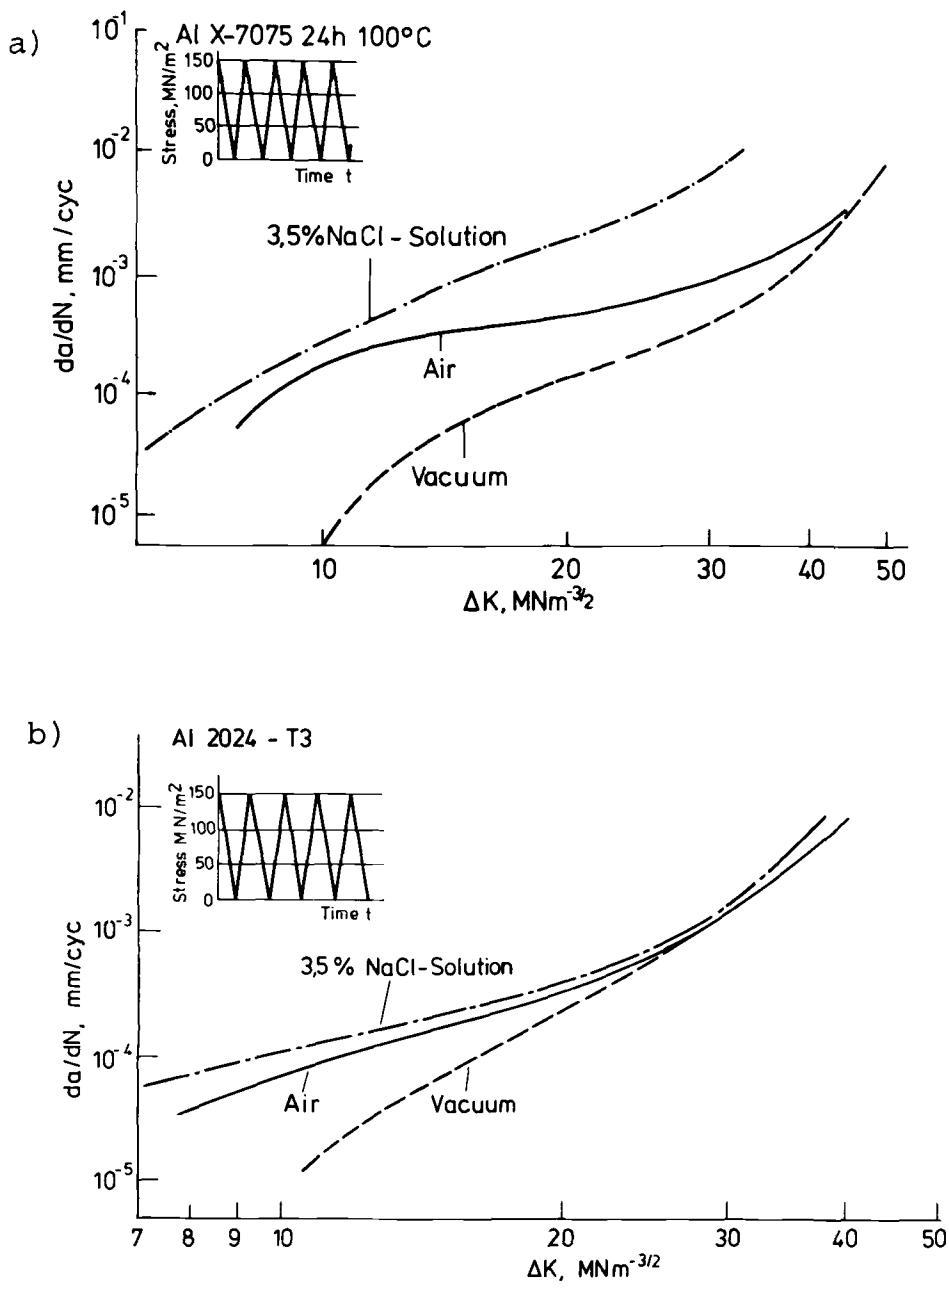
FIG. 1—(a) Crack propagation behavior of Al X-7075, 24 h at 100° C, (underaged) in vacuum, air and in the 3.5% NaCl solution. (b) Crack propagation behavior of Al 2024-T3 in vacuum, air, and in the 3.5% NaCl solution.

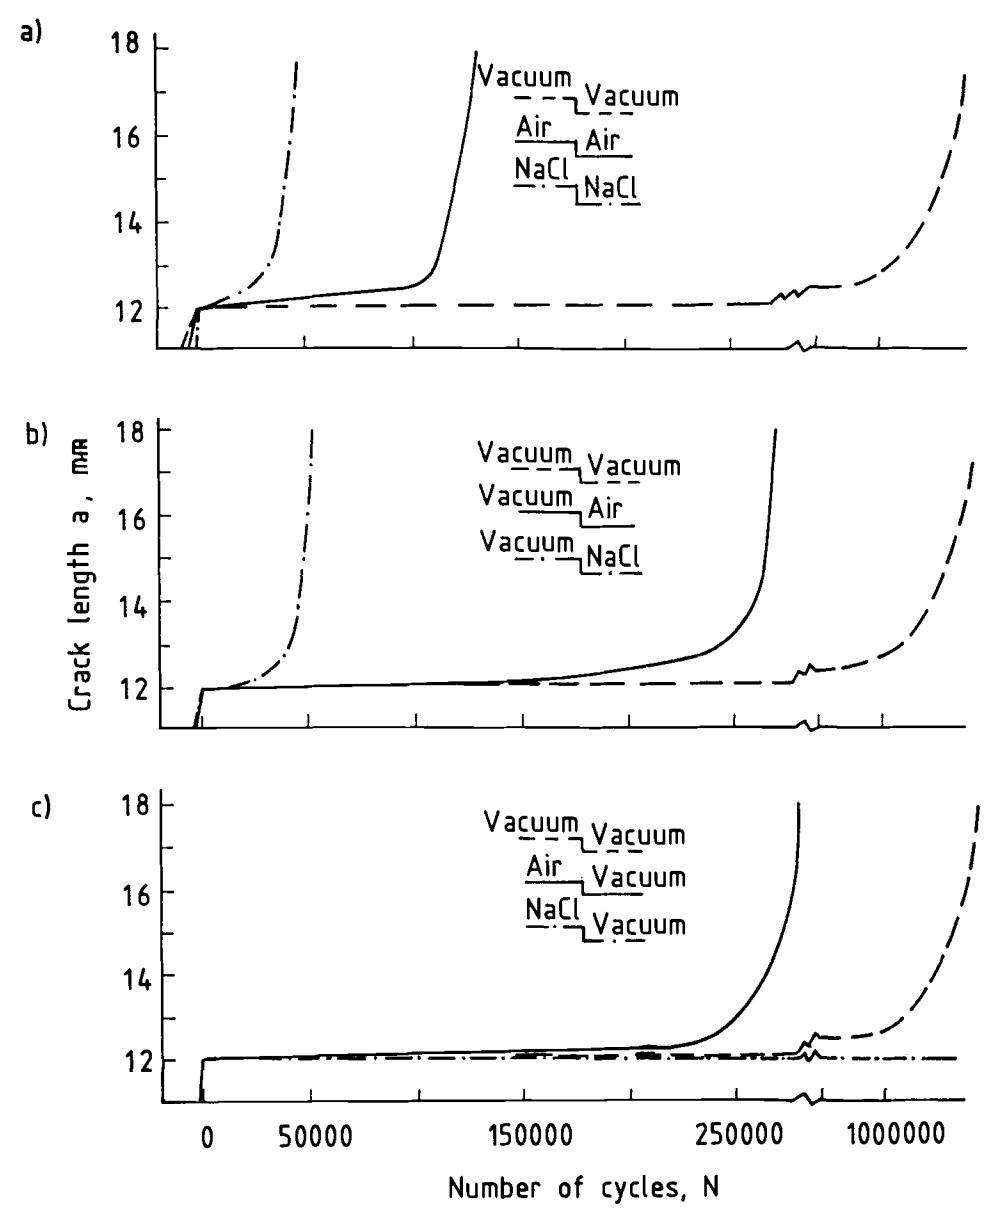
- (a) Crack retardation behavior in vacuum, air, and 3.5% NaCl solution (constant environment in the tests).
- (b) Crack retardation behavior in vacuum, air, and 3.5% NaCl-solution. Change of the environment from vacuum in the high loading level to vacuum, air, and 3.5% NaCl solution in the low loading period.
- (c) Crack retardation behavior in vacuum after a parallel change in the loading level (high-low sequence) and in the environment from vacuum, air, and 3.5% NaCl solution (at the high loading level) to vacuum

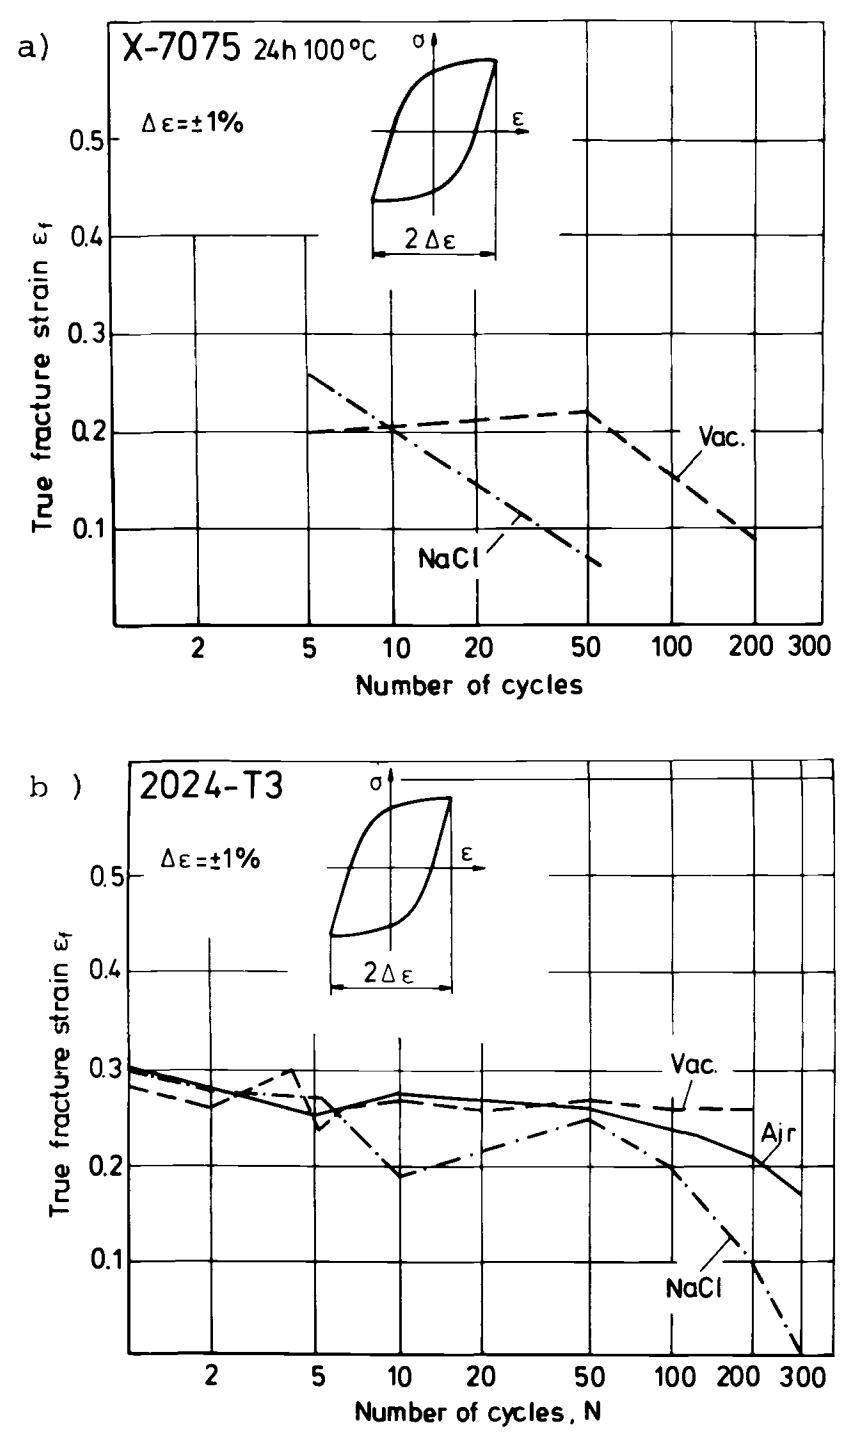
FIG. 13—True fracture strain in a tension test after N strain cycles in vacuum, air and in a 3.5% NaCl solution for (a) Al X-7075, 24 h at 100°C and (b) Al 2024-T3.

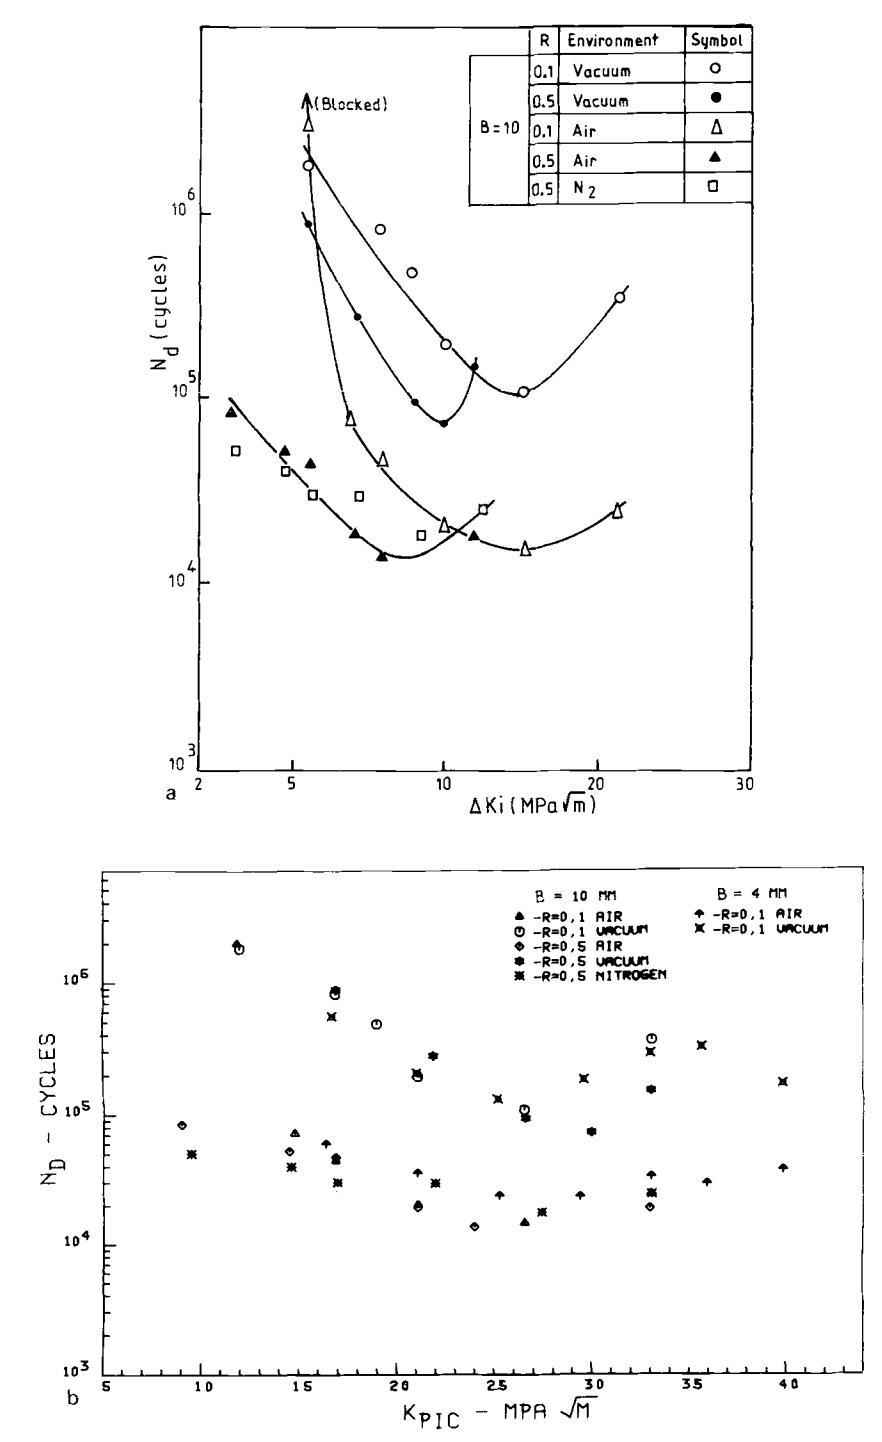
FIG. 3—(a) Evolution of the number of delay cycles with respect to ΔK_i for 10-mm thick specimens, and (b) normalization of delay behavior with respect to K_{pic} .

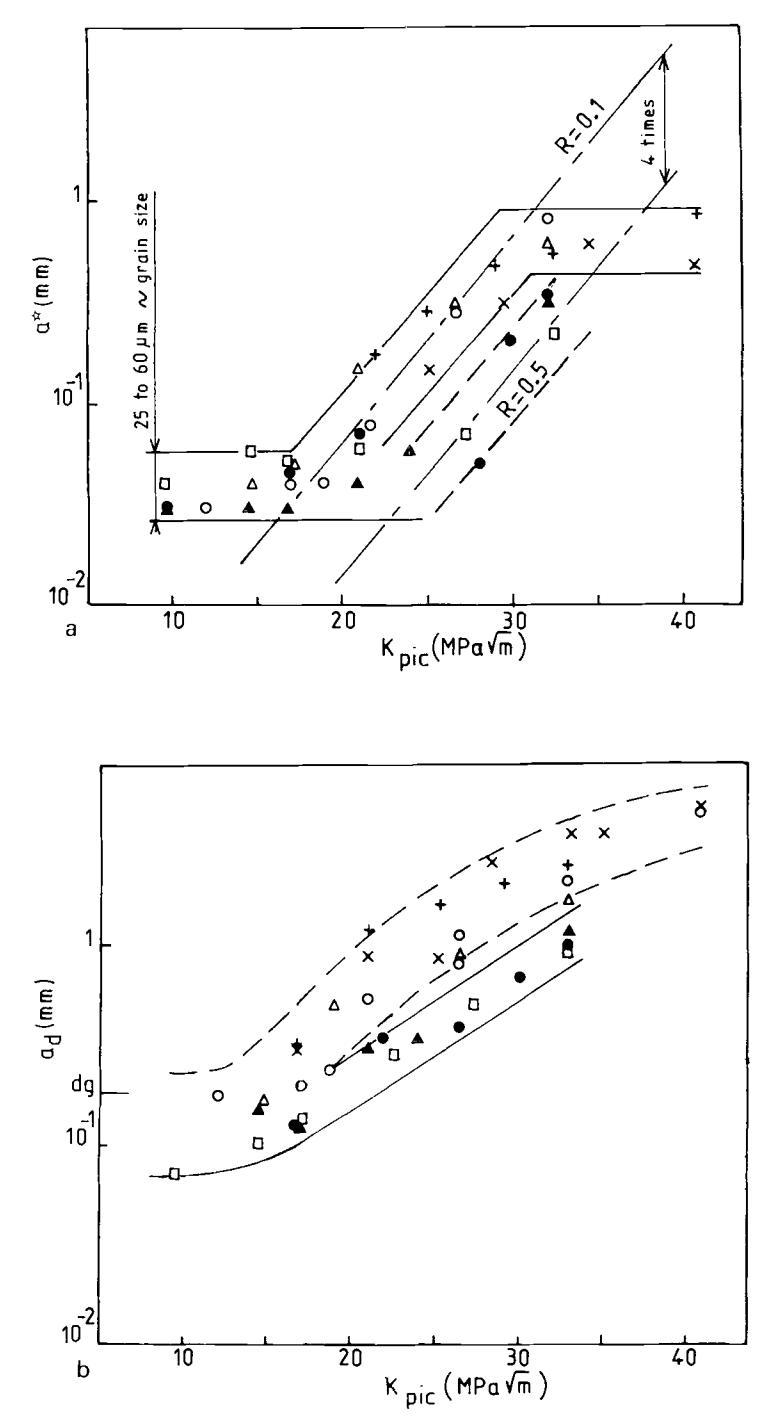
FIG. 7—(a) Crack length required to reach the minimum growth rate, a^* , as a function of K_{pic} : same symbols as in Fig. 5; and (b) total crack length affected by the overload, a_{d} , with respect to K_{pic} : same symbols as in Fig. 5.

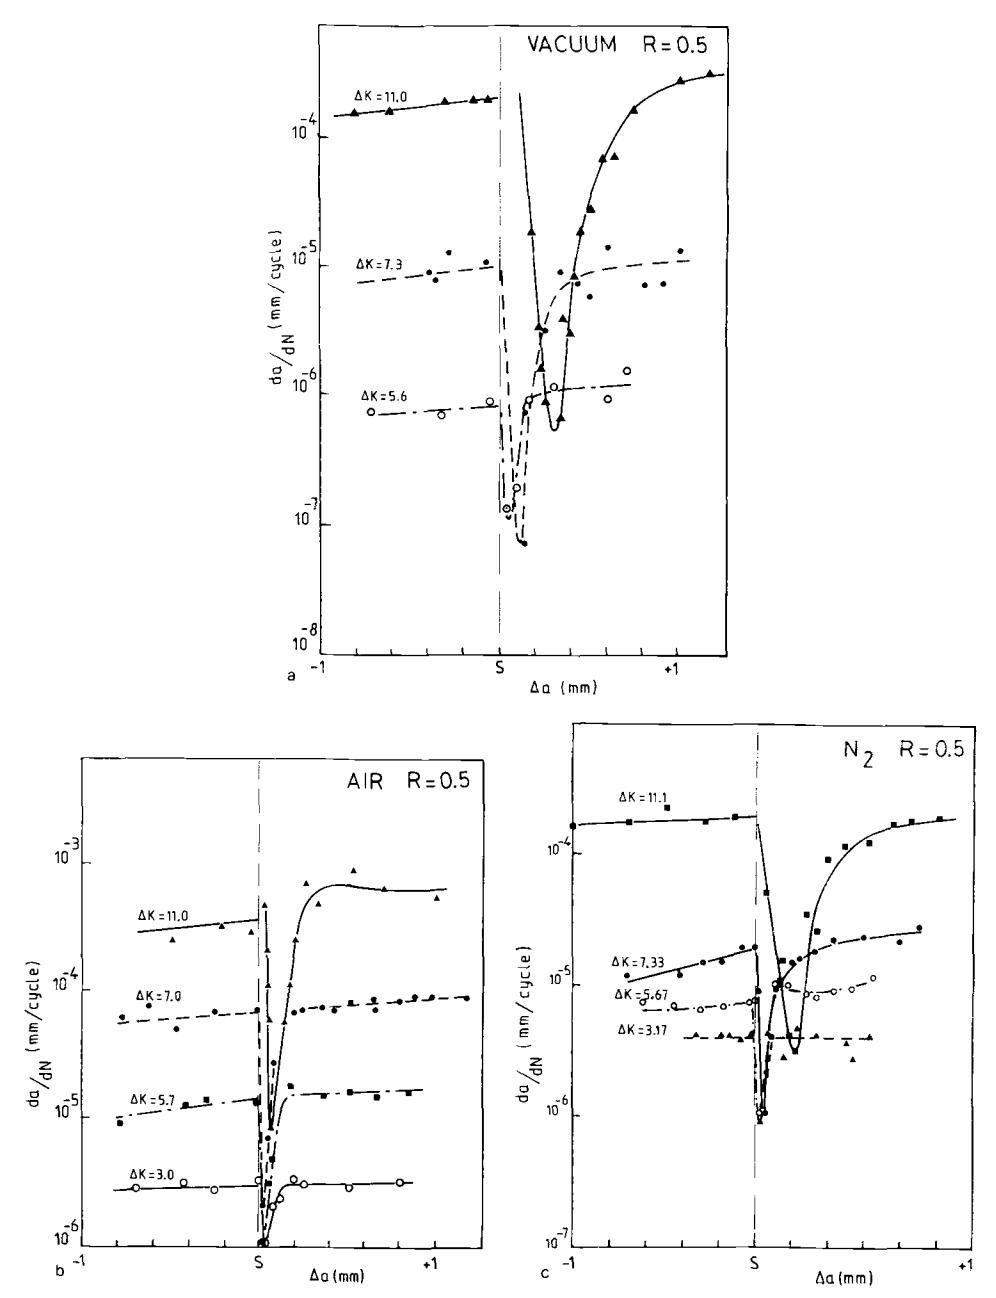
FIG. 9—(a) Delay curves obtained at $R_i = 0.5$ in vacuum, (b) delay curves obtained at $R_i = 0.5$ in air, and (c) delay curves obtained at $R_i = 0.5$ in N_2 .
