Environmentally Assisted Cracking: Science and Engineering

STP 1049

W. Barry Lisagor, Thomas W. Crooker, and Brian N. Leis, editors

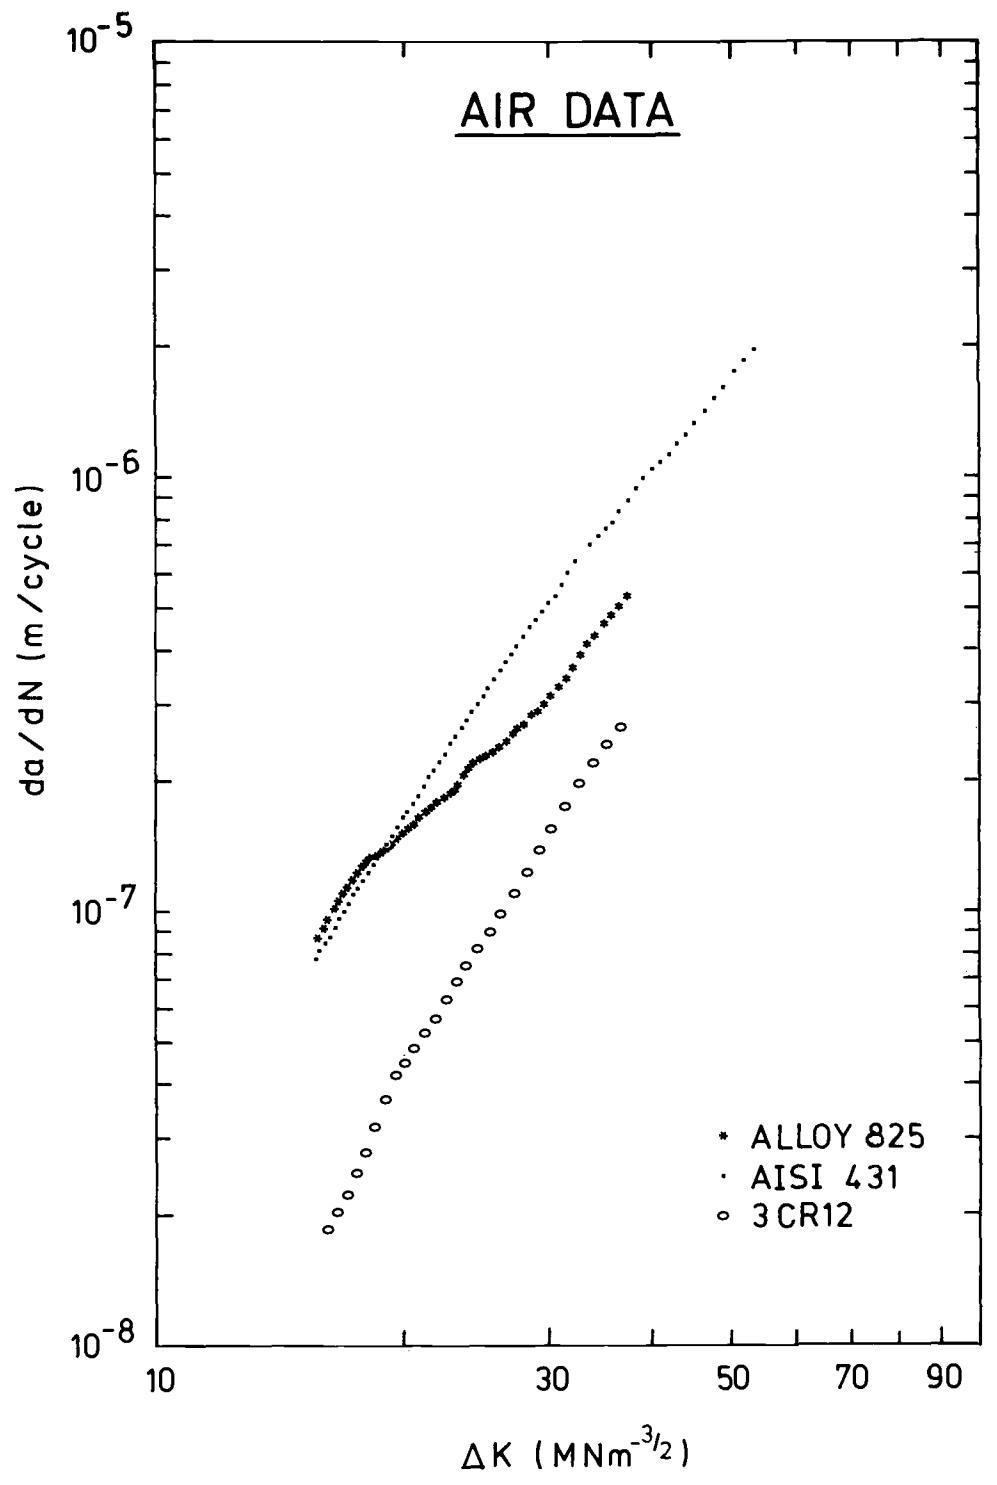
FIG. 1—The FCGR behavior of the materials tested in air at a frequency of 3 Hz.

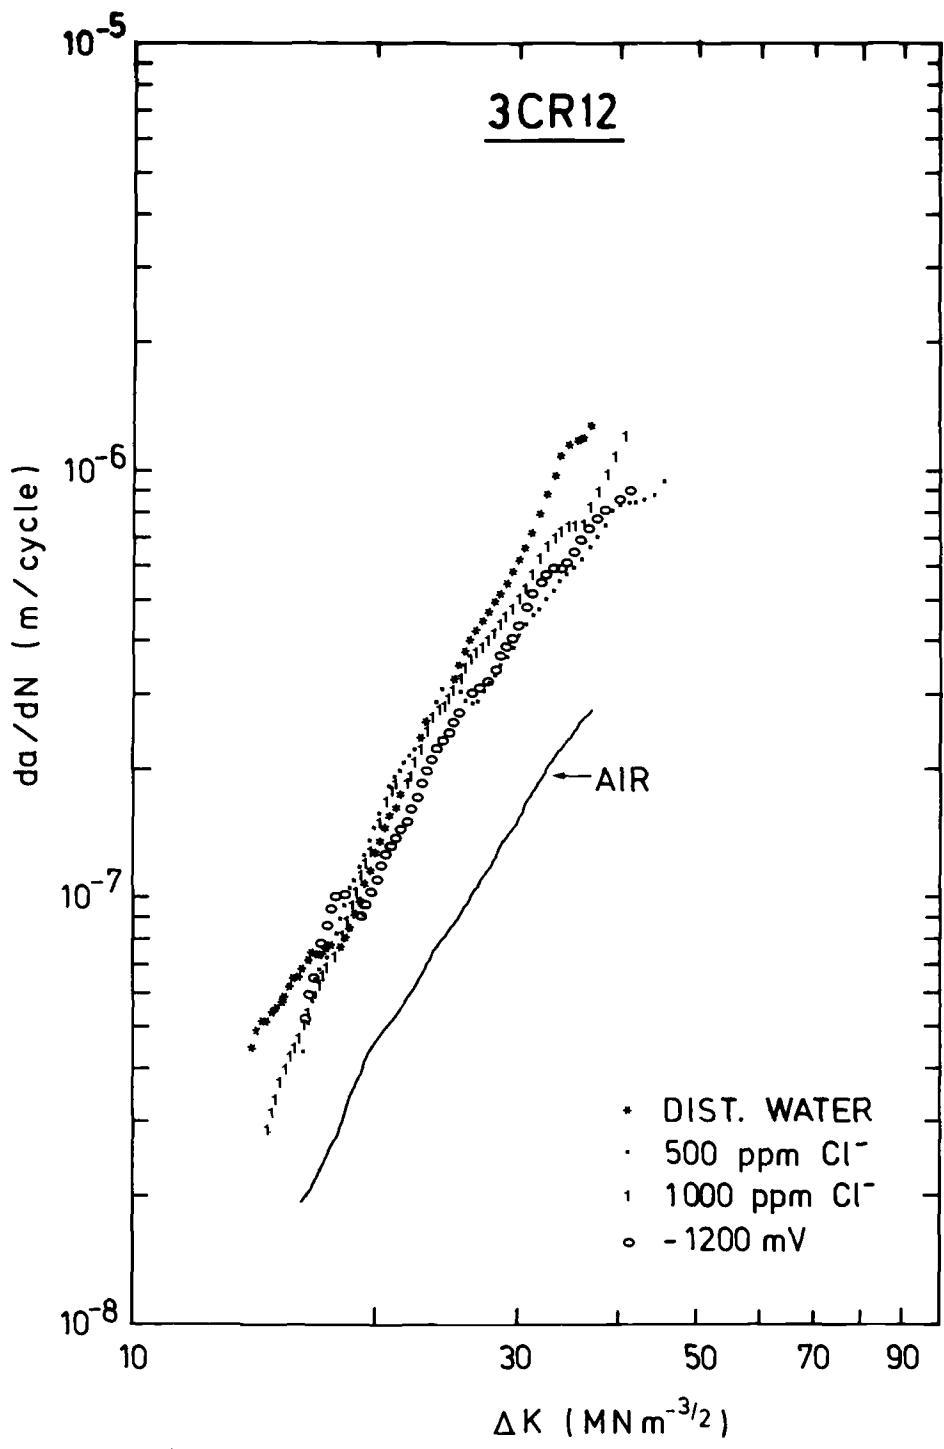
FIG. 6—Influence of environment on the rate of crack growth of 3CR12.

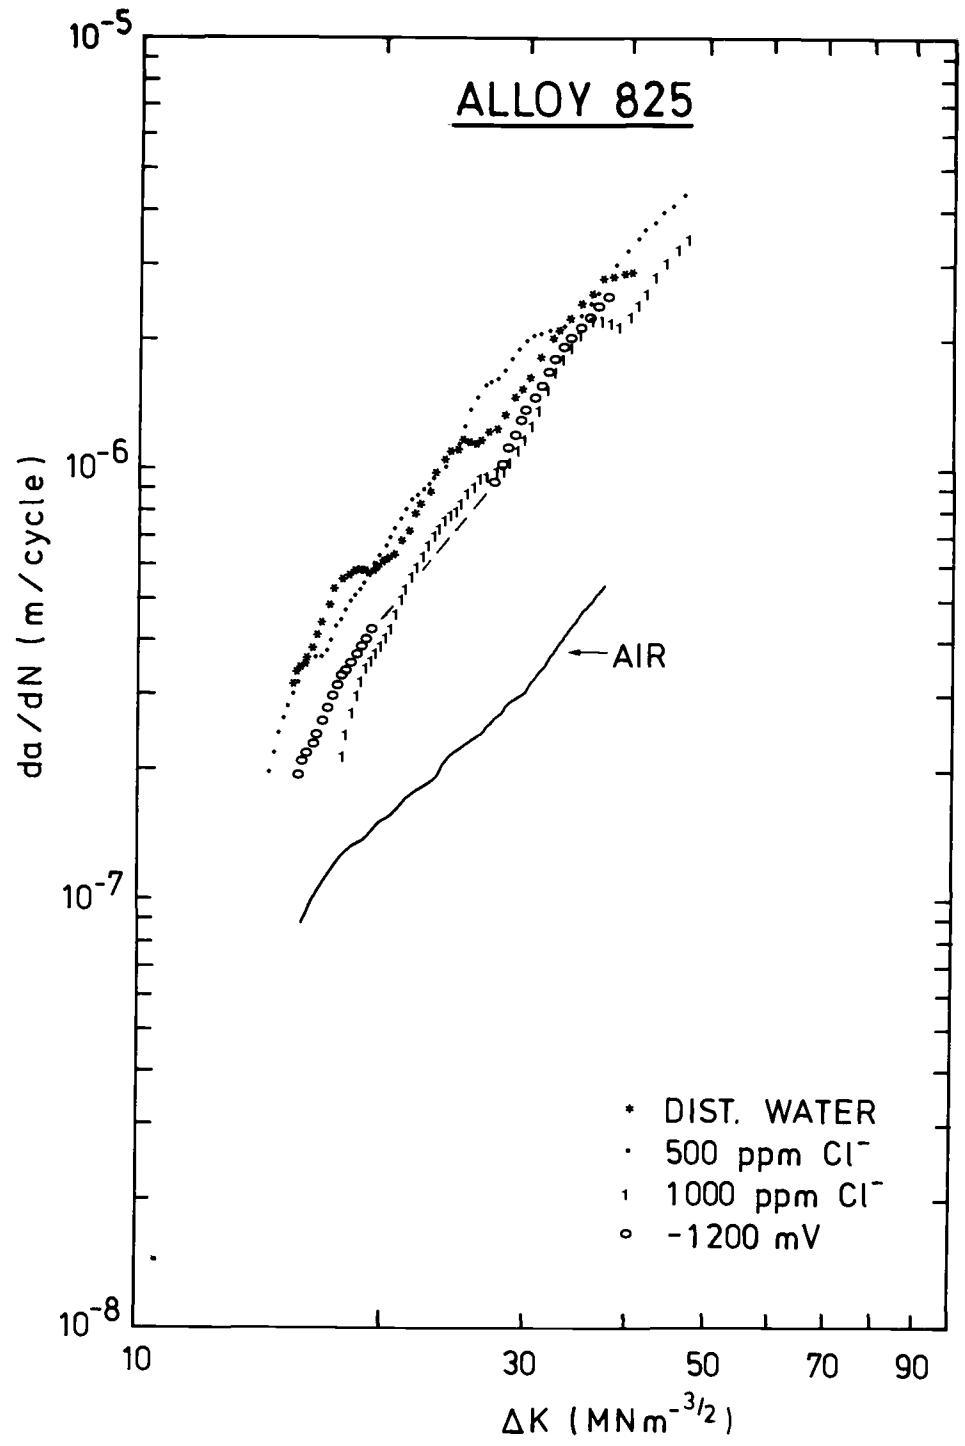
FIG. 9—Influence of environment on the rate of crack growth of Alloy 825. (Note: the broken line indicates a disruption during testing.)

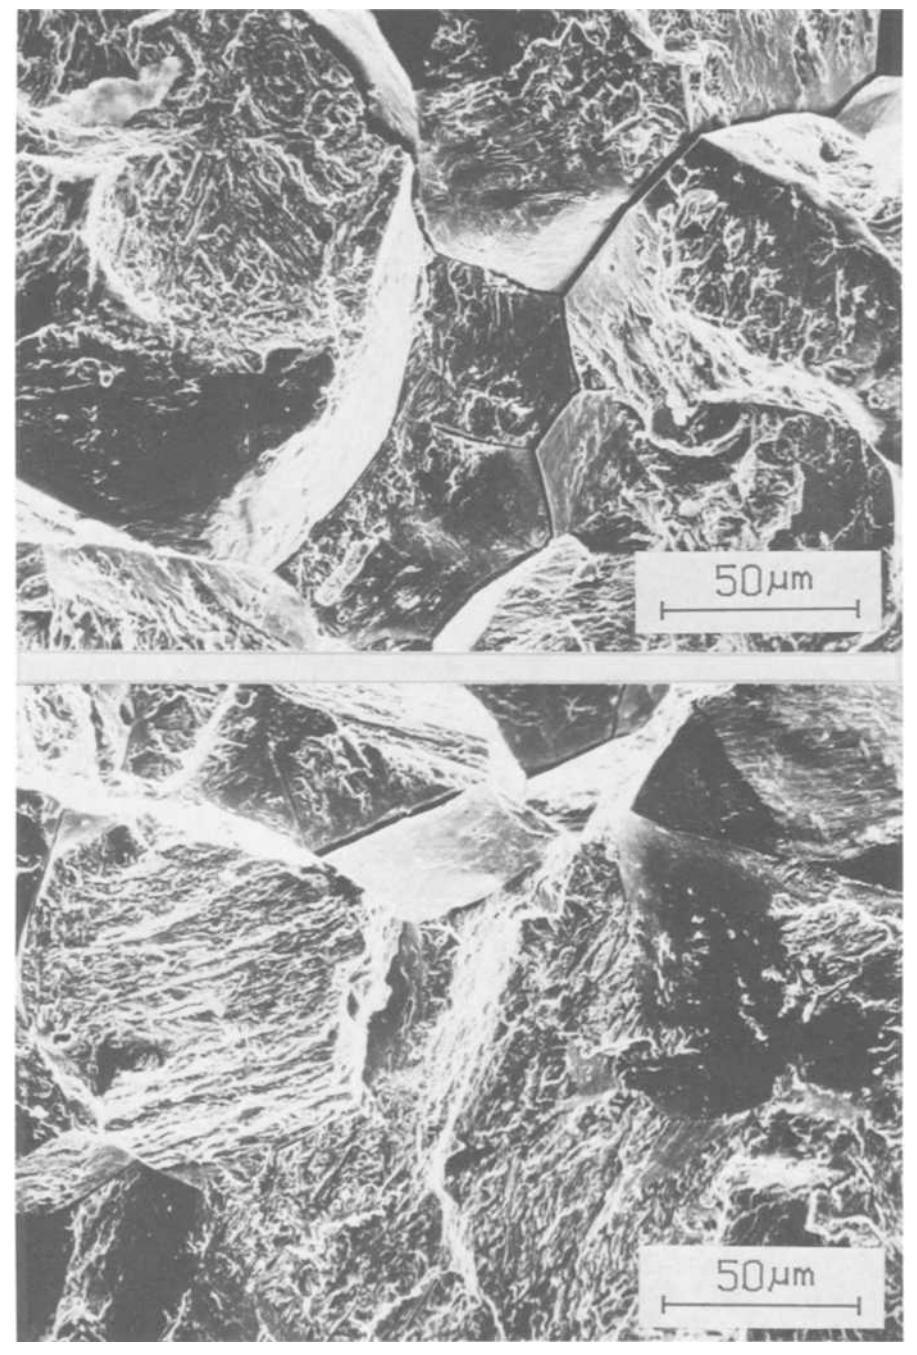
FIG. 10—Mixed-mode cracking on Alloy 825 surface tested in 500 ppm Cl⁻ solution: (a) $\Delta K = 30$, and (b) $\Delta K = 35$ MN m^{-3/2}.

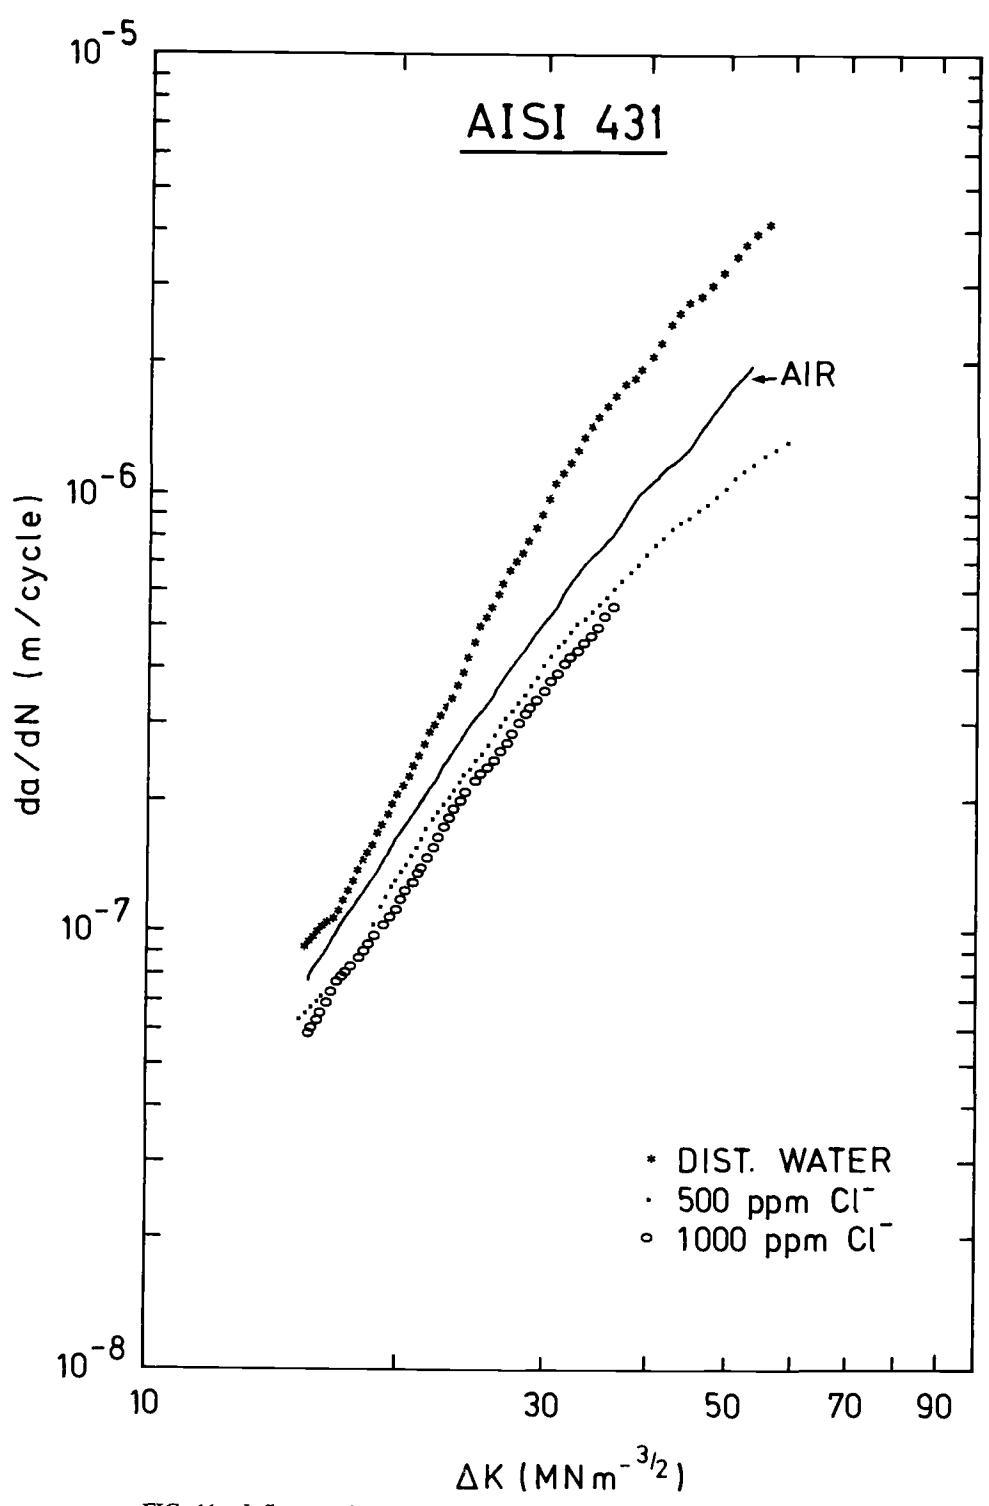
FIG. 11—Influence of environment on the rate of crack growth of AISI 431.

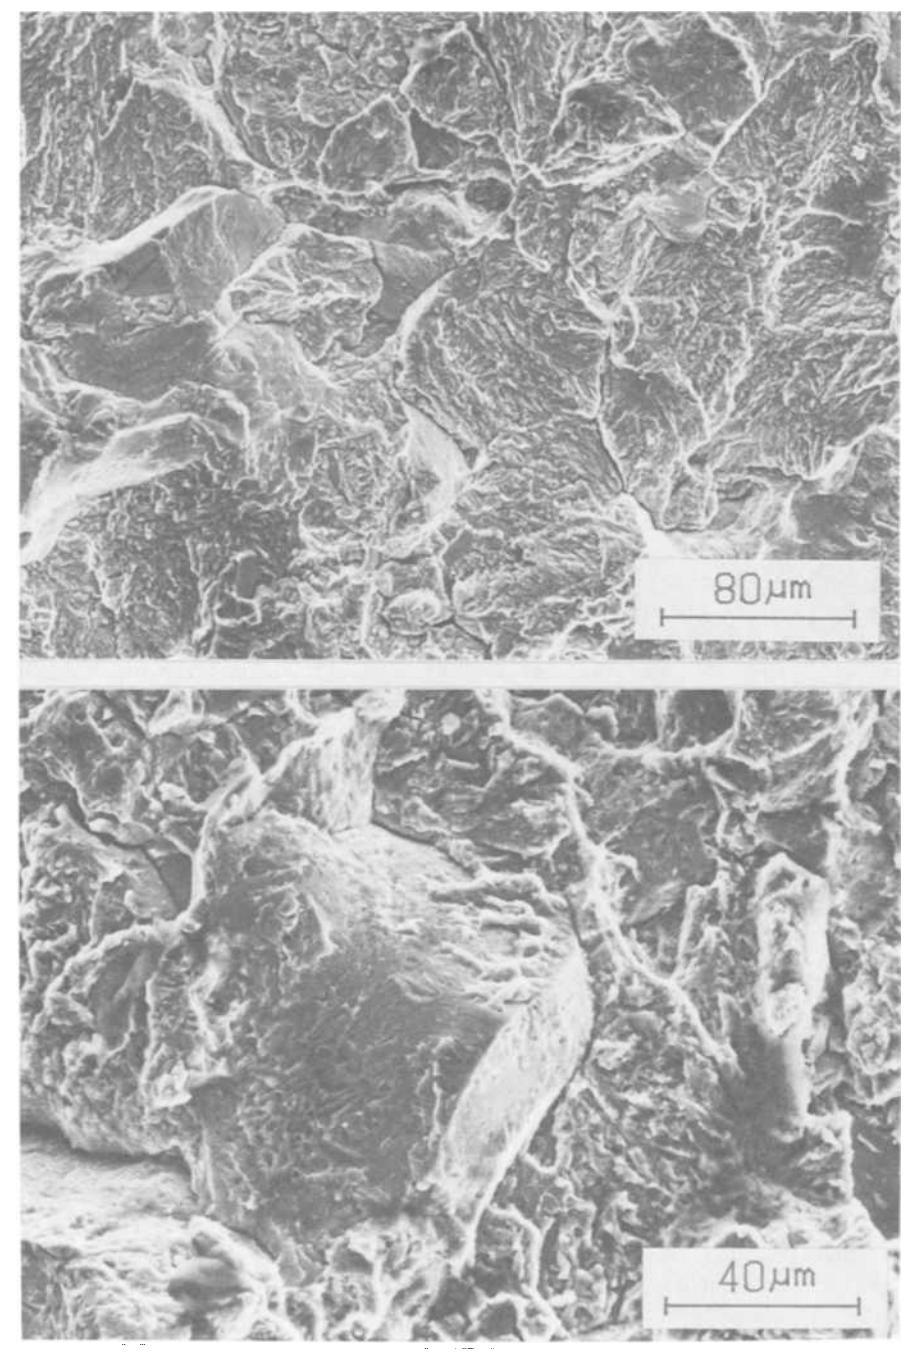
FIG. 12—Interganular features on AISI 431 surface tested in distilled water: (a) $\Delta K = 19$, and (b) $\Delta K = 35 \text{ MN m}^{-3/2}$.
