CORROSION OF REINFORCING STEEL IN CONCRETE

A symposium sponsored by ASTM Committee G-1 on Corrosion of Metals AMERICAN SOCIETY FOR TESTING AND MATERIALS Bal Harbour, Fla., 4-5 Dec. 1978

ASTM SPECIAL TECHNICAL PUBLICATIONS 713 D. E. Tonini, American Hot Dip Galvanizers Association, Inc., and J. M. Gaidis, W. R. Grace & Co., editors

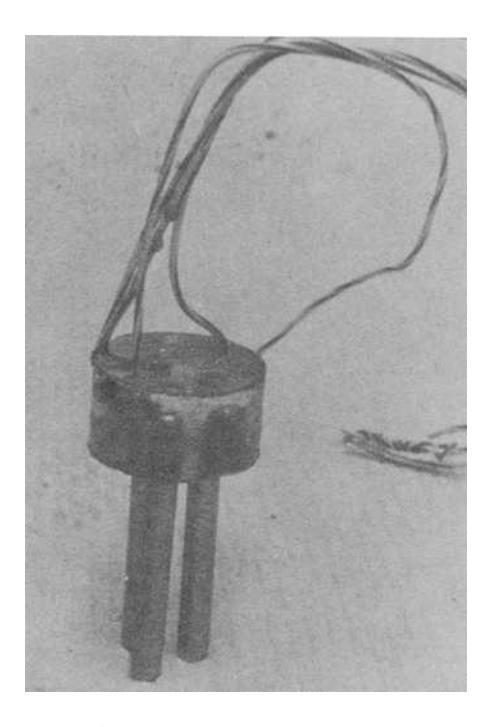
FIG. 1-Three-electrode probe.

The corrosion rate of reinforcing steel at two different surface conditions has been studied. In the first set, three-electrode polarization probes were made from reinforcing steel. One-half-inch (12.7 mm) reinforcing steel bars were machined to 0.63 cm ($^{1}/_{4}$ in.) and three pieces were mounted symmetrically 1.35 cm (0.53 in.) apart in an epoxy resin as shown in Fig. 1. The exposed surface area of each electrode was 9 cm² (1.39 in.²). Each probe was then washed with acetone and cast in 15.2 by 30.5 cm (6 by 12 in.) concrete cylinders. These probes are referred to as "machined probes." Seven different batches of concrete were made, each containing a different sodium chloride concentration ranging from 0 to 1 percent (weight percent of total

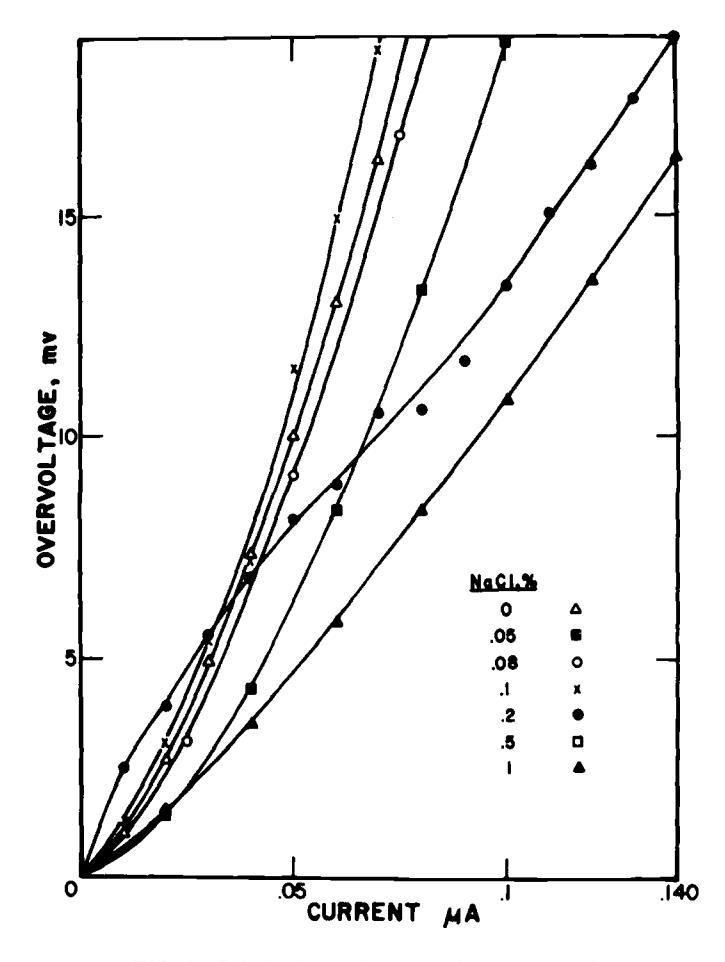
FIG. 2-Polarization resistance of 3-electrode probe.

Figure 2 shows the results of polarization resistance tests for machined probes which were conducted for a 20-mV shift from the free corrosion potentials. The results of anodic and cathodic polarization tests for these specimens are shown in Figs. 3 and 4, respectively.

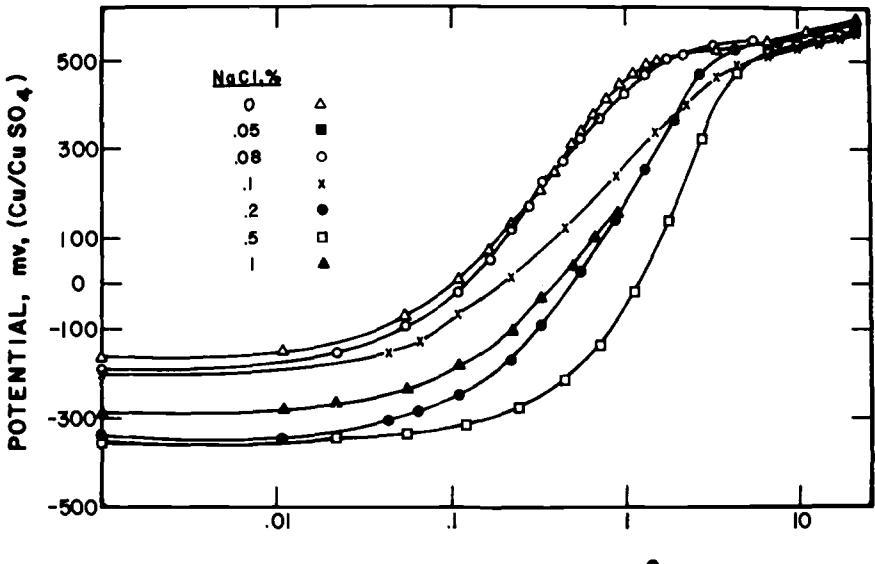
FIG. 3-Anodic polarization of 3-electrode probe.

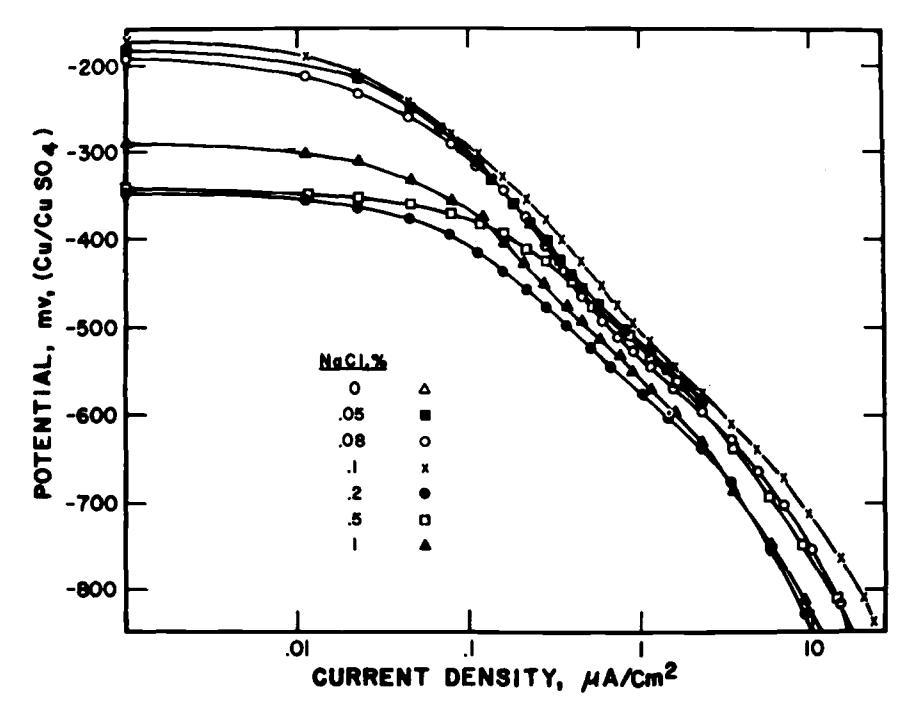
FIG. 4-Cathodic polarization of 3-electrode probe.

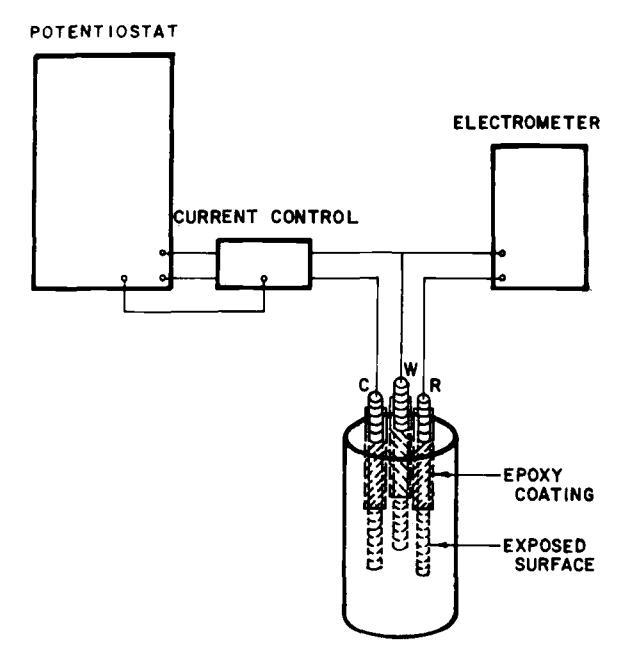
FIG. 5-Galvanostatic polarization setup for reinforcing steel.

Polarization resistance and anodic and cathodic polarization experiments have also been conducted for the specimens with steel rebars. Figure 5 shows the galvanostatic setup for these tests. The results of the polarization resistance tests are shown in Figs. 6 and 7. Two different types of polariza-

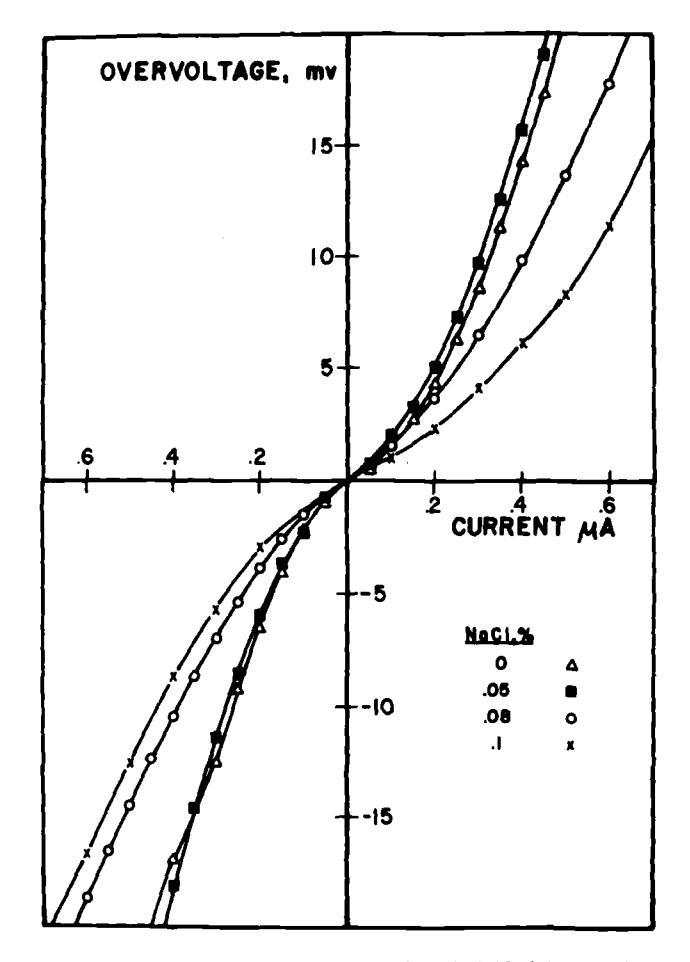
FIG. 6-Polarization resistance of reinforcing steel for 0, 0.05, 0.08, and 0.1 percent salt.

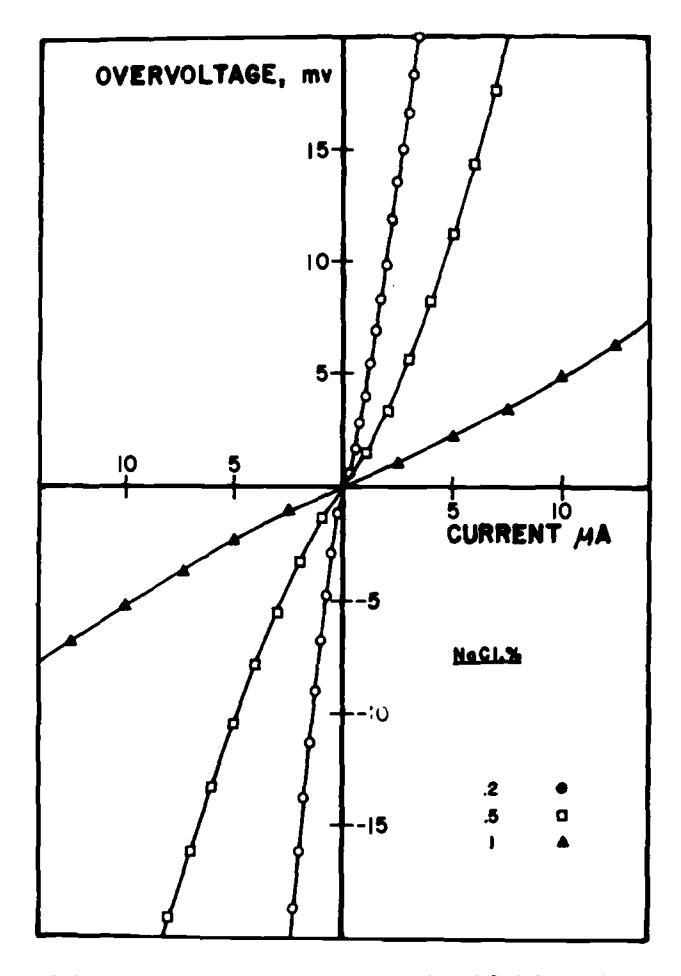
FIG. 7-Polarization resistance of reinforcing steel for 0.2, 0.5. and 1 percent salt.

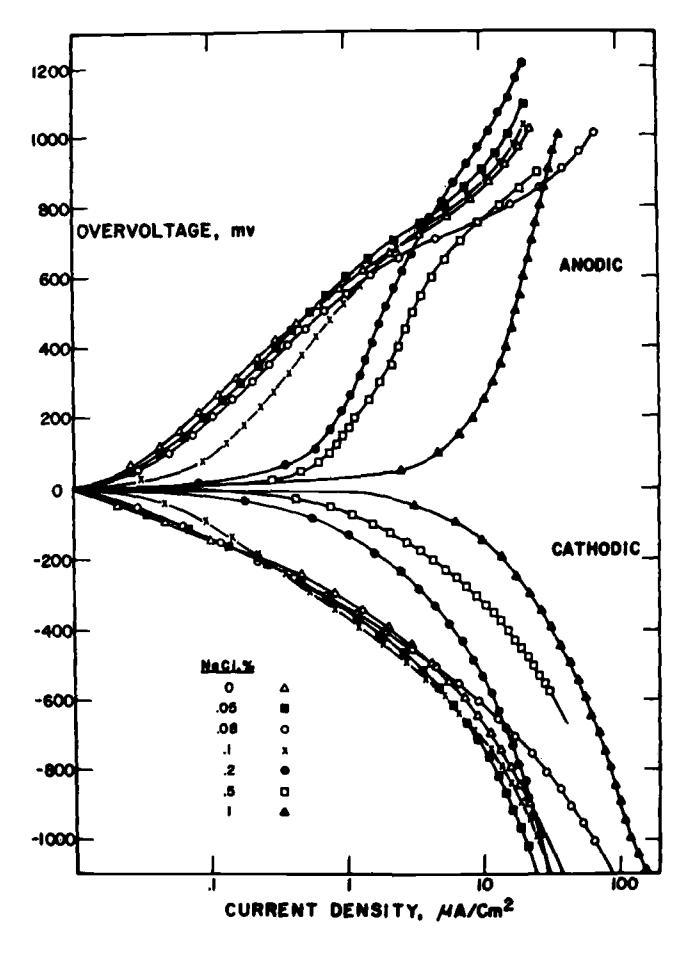
FIG. 8—Anodic and cathodic polarization of reinforcing steel.

The high values of Tafel slopes calculated in this investigation can be attributed to IR drop due to the high resistivity of concrete. It is generally ac-

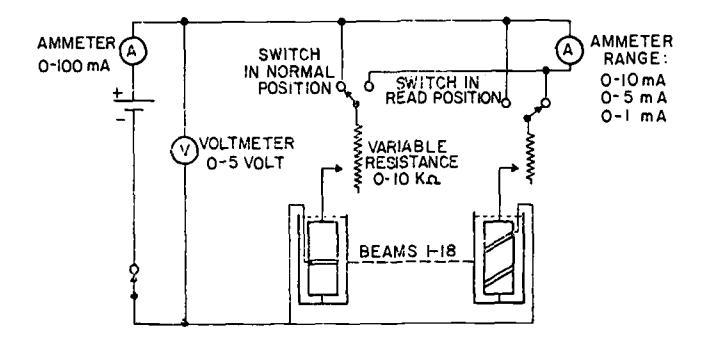
FIG. 2-Electric circuit.

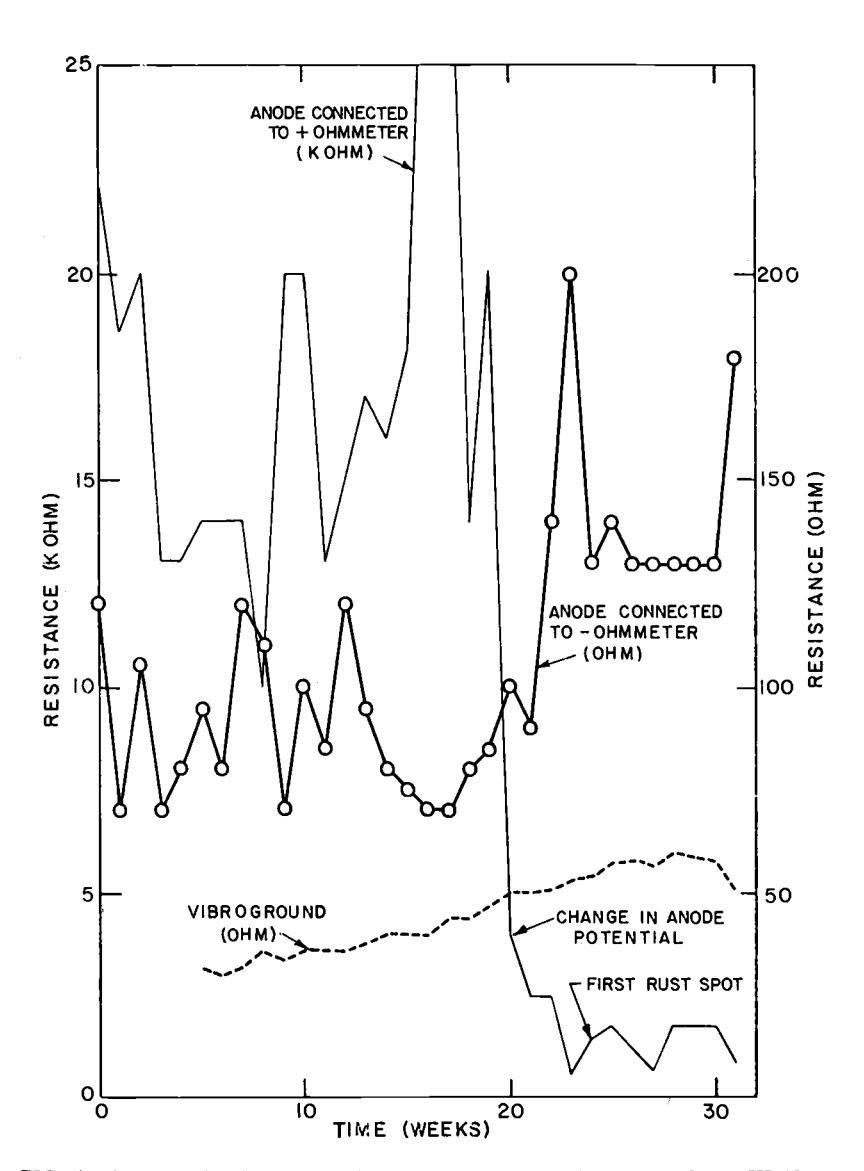
FIG. 4—An example of variation of resistance with time of exposure: beam III 13, concentrated cathode, $54 \text{ mA/m}^2 (5 \text{ mA/ft}^2)$.

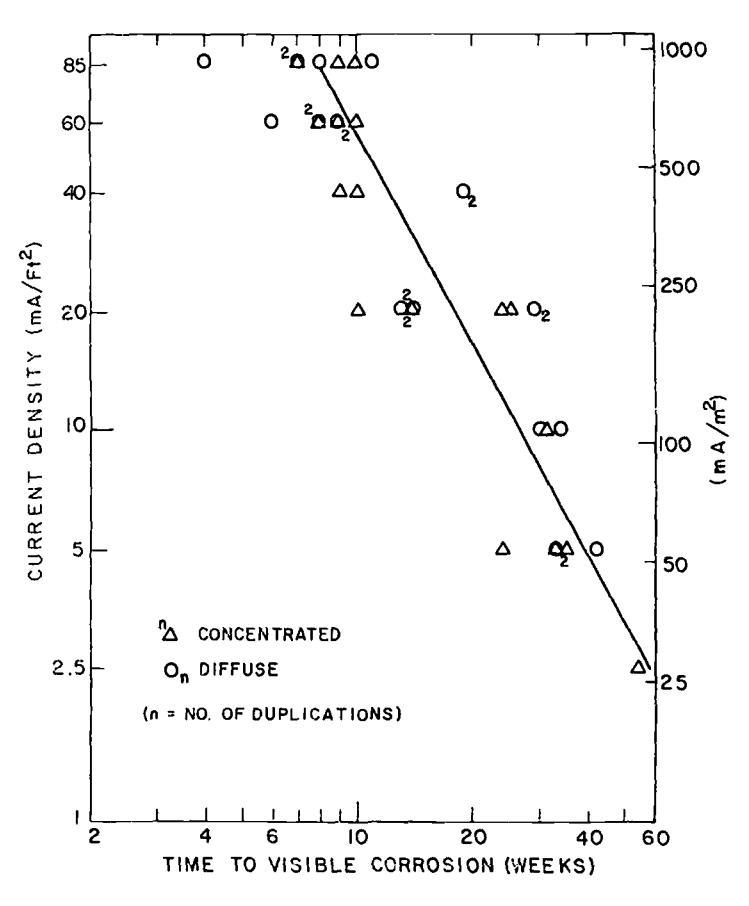
FIG. 7-Influence of current density on time to visible corrosion.

Beams that have passed the time to corrosion will show visible signs of corrosion a few weeks later; the lower the current, the longer the time between the change in potential on and the appearance of a crack or rust spot or both (Fig. 7). For both Figs. 6 and 7, a straight-line fit is drawn between the current densities 915 and 27 mA/m² (85 and 2.5 mA/ft²). Beyond these two limits, a straight-line fit may not be correct. The latest data for two beams without impressed current show that a change in steel potential has occurred after 53 weeks of exposure in seawater.

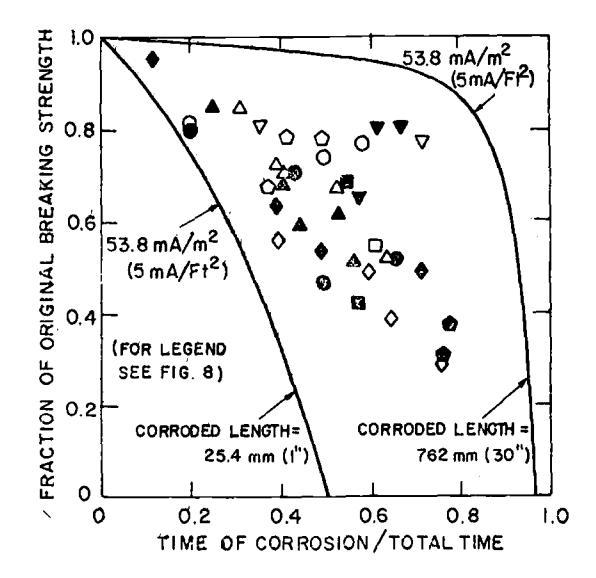
FIG. 9-Fraction of original breaking strength versus time of corrosion/total time.

Figure 8 may be replotted as fraction of the original breaking strength versus time of corrosion divided by total time. This plot is suggested by the fact that the longer the time of exposure, the longer the corroded length, and the less is the reduction in breaking strength for the same amperehours of corrosion (Fig. 9). Two curves are drawn for cases where beams are subjected to a current density of 54 mA/m² (5 mA/ft²) with a corroded length of 25.4 mm (1 in.) and 762 mm (30 in.).

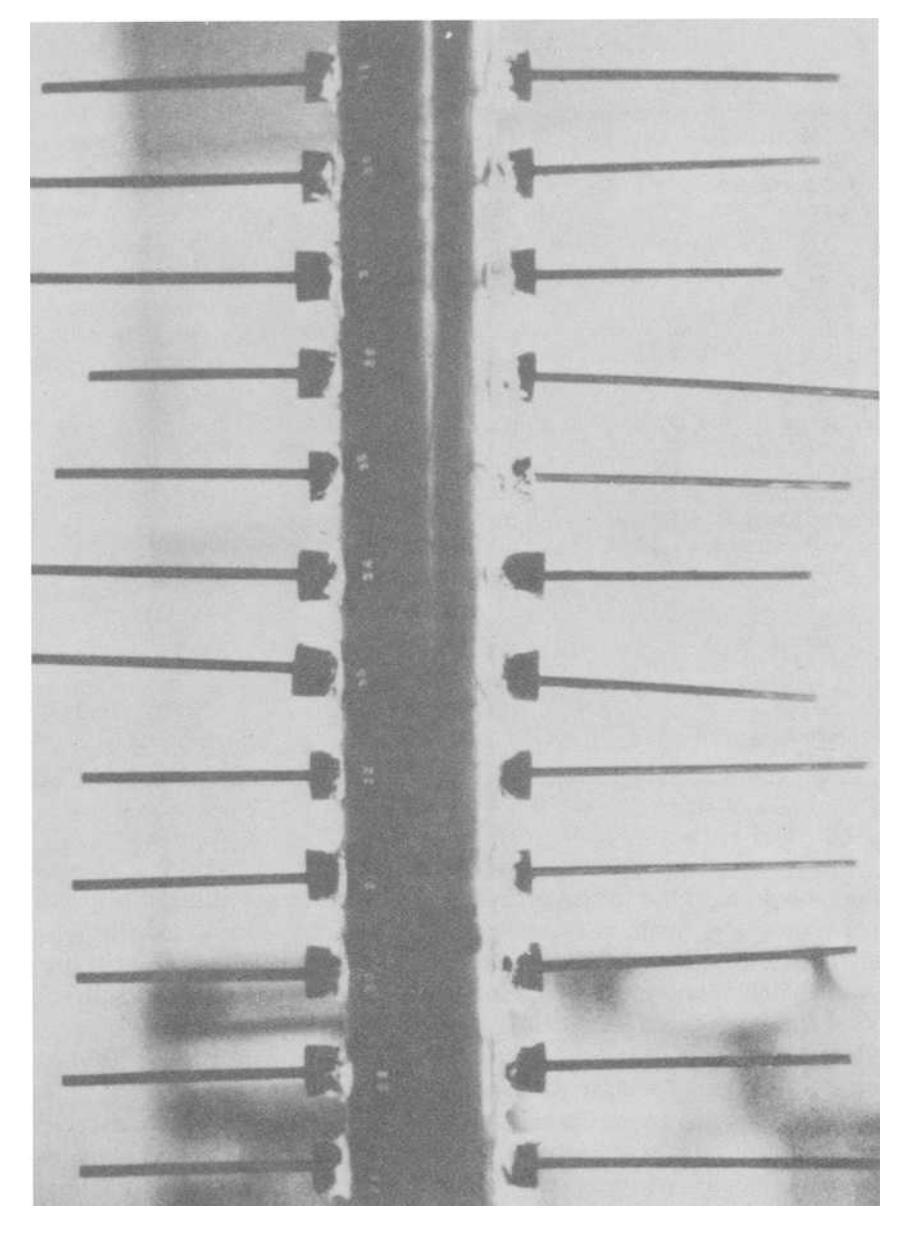
FIG. 1—Photograph of test specimens mounted in polyvinyl chloride pipe.

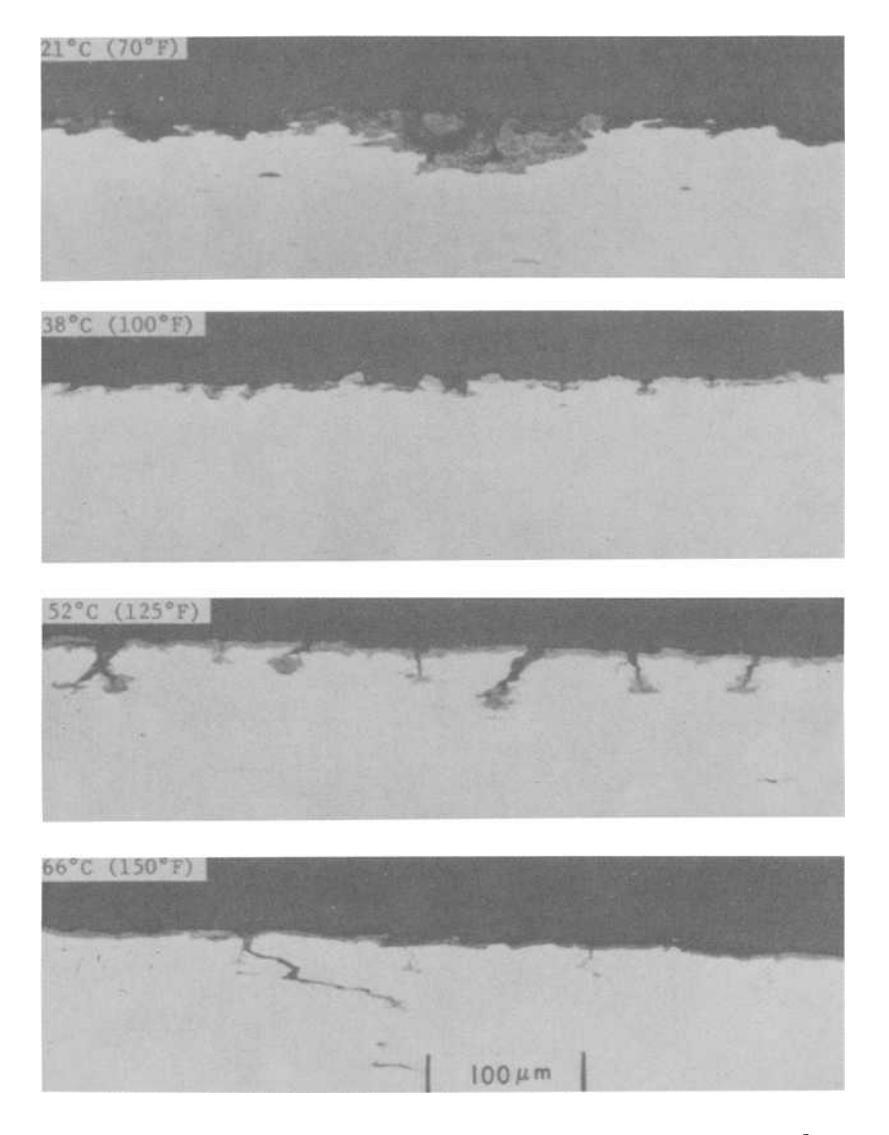
FIG. 2—Attack on steel tendons wires in 0.2-M NH₄ NO₃. Strain rate, 4.2×10^{-7} /s.

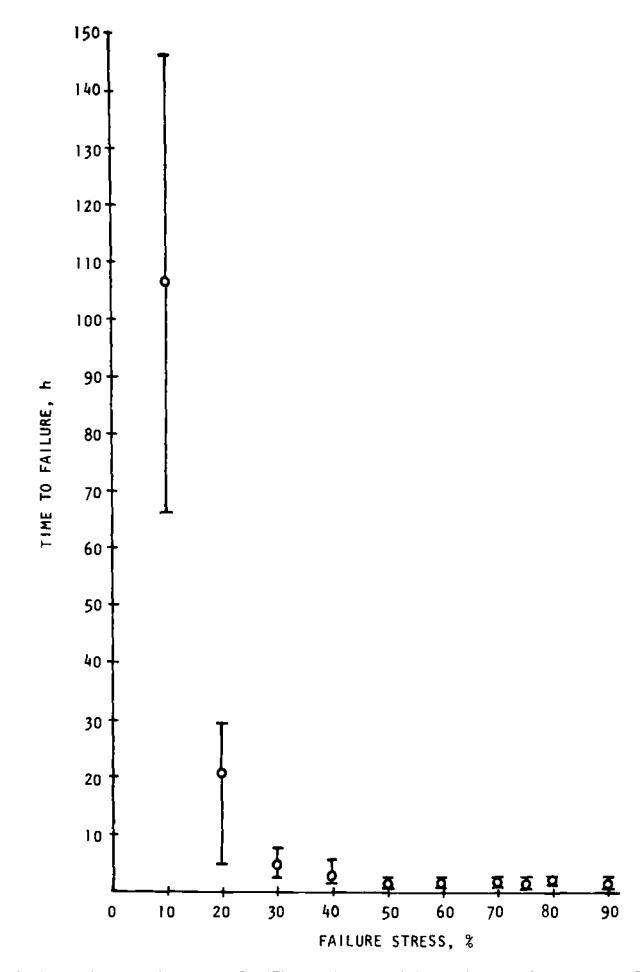
FIG. 4-Effect of stress (percent UTS) on time to failure for tendon wire in 0.1-M H₂S.

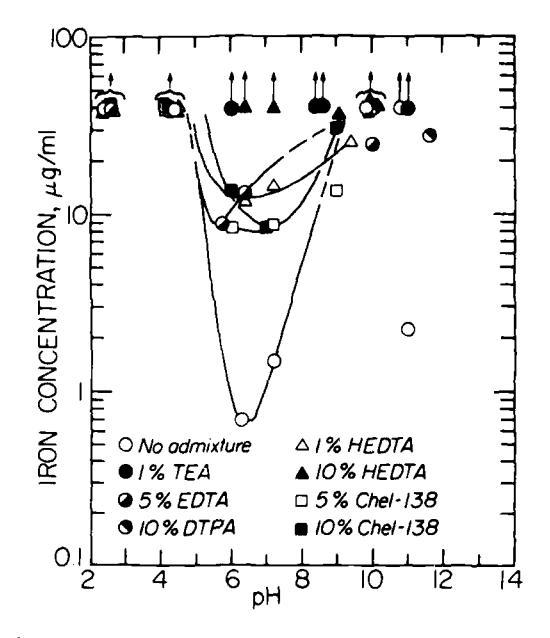
FIG. 1-Iron solubility limit as a function of pH and type of chelating agent.

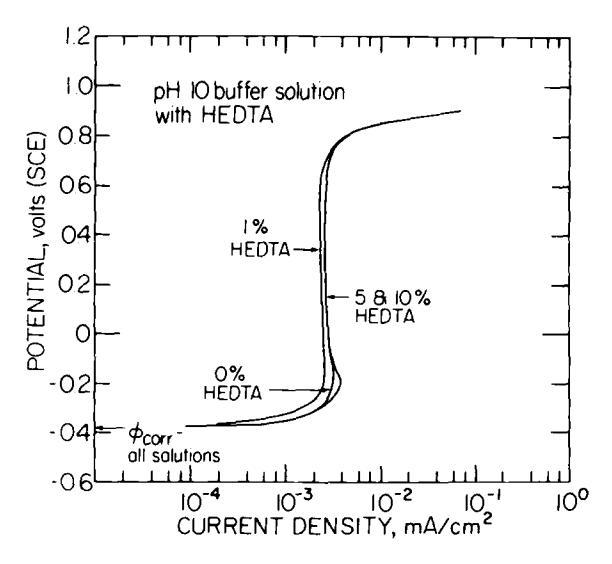
FIG. 2—Anodic polarization curve for steel in pH 10 buffer solution as a function of volume percent HEDTA.

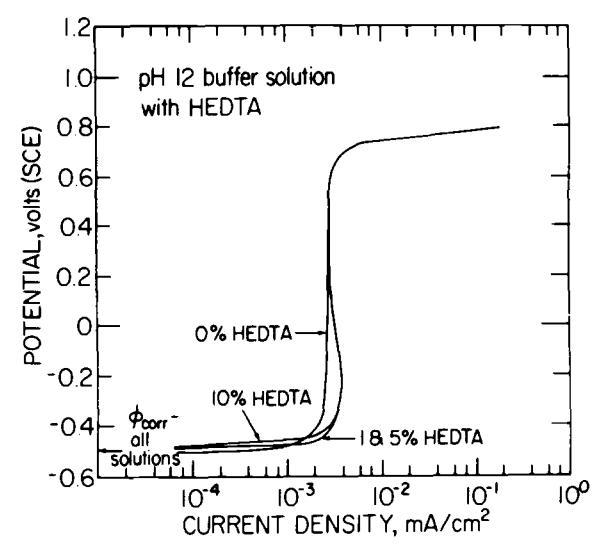
FIG. 3—Anodic polarization curve for steel in pH 12 buffer solution as a function of volume percent HEDTA.

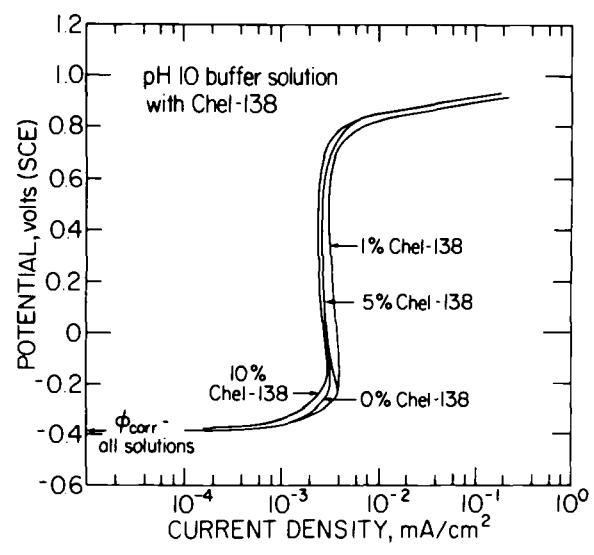
FIG. 4—Anodic polarization curve for steel in pH 10 buffer solution as a function of volume percent Chel-138.

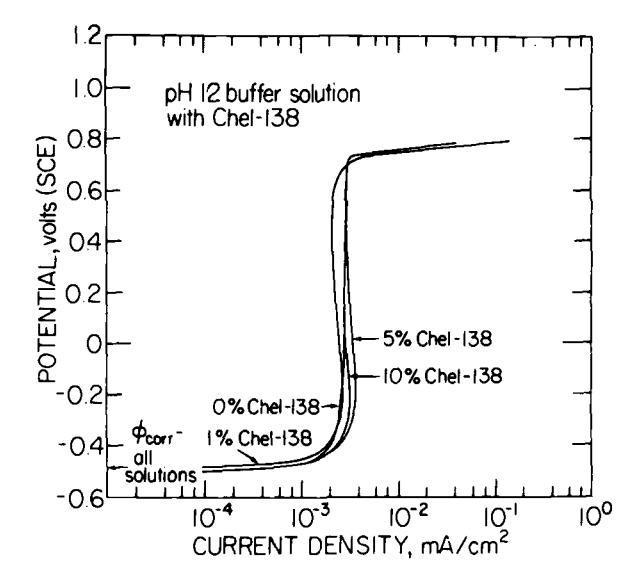
FIG. 5—Anodic polarization curve for steel in pH 12 buffer solution as a function of volume percent Chel-138.

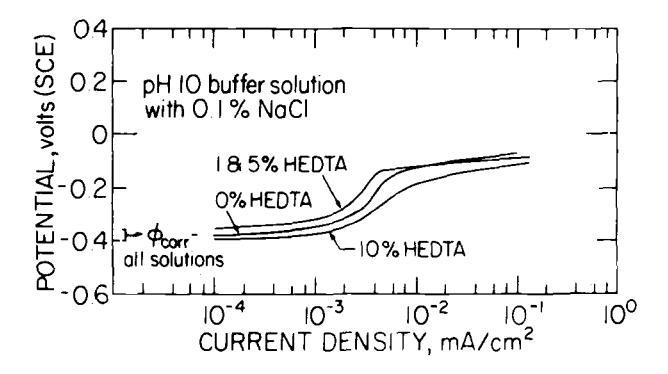
FIG. 6—Anodic polarization curve for steel in pH 10 buffer solution with 0.1NaCl as a function of volume percent HEDTA.

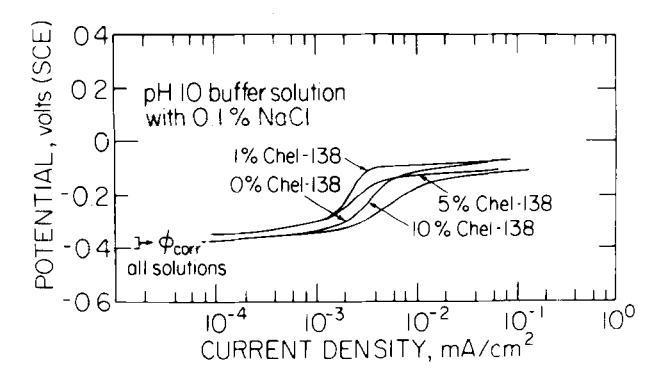
FIG. 7—Anodic polarization curve for steel in pH 10 buffer solution with 0.1NaCl as a function of volume percent Chel-138.

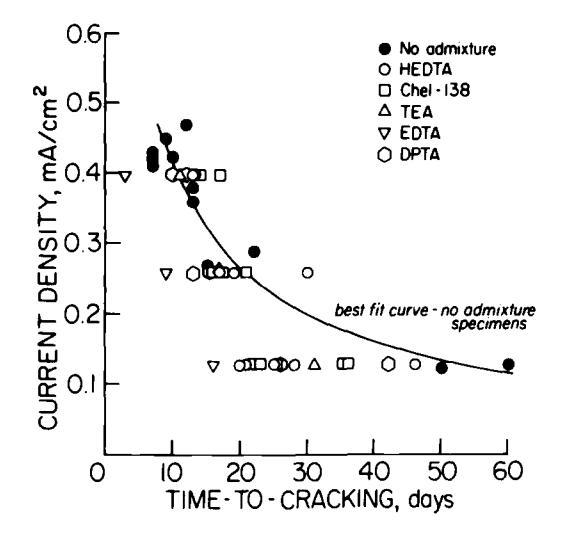
FIG. 10—Time-to-cracking of reinforced concrete specimens as a function of impressed current density and type of chelating admixture.

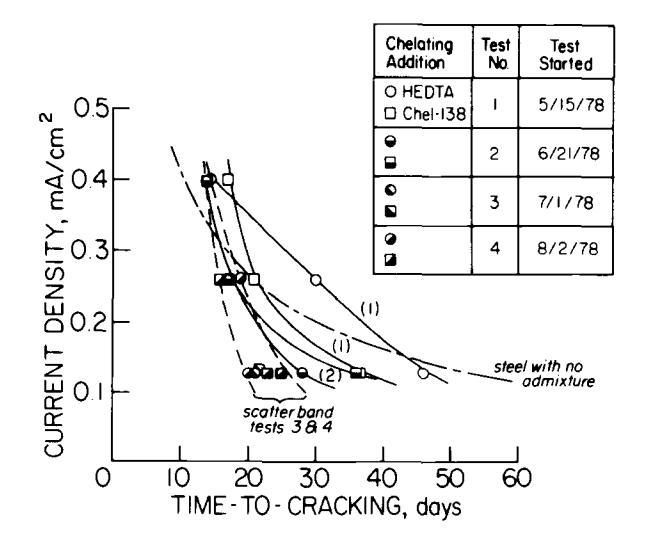
FIG. 11—Time-to-cracking for the data in Fig. 10, taking into account time the test commenced.

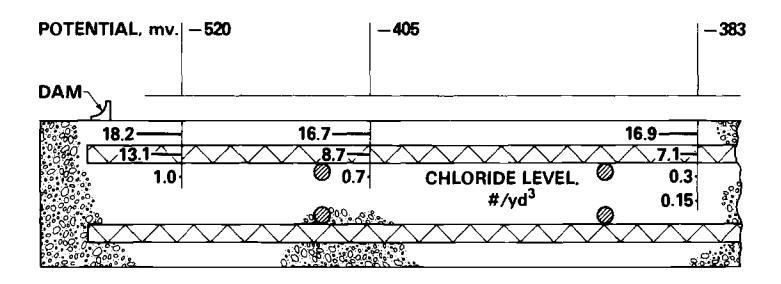
FIG. 1-Chloride levels and potentials for Slab No. 8.

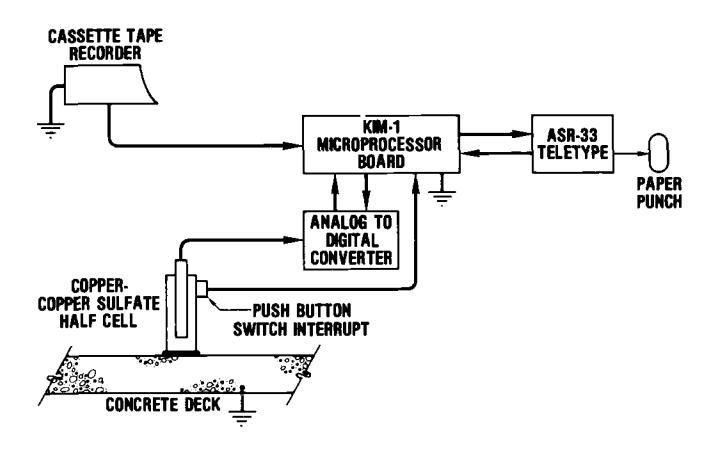
FIG. 2-Schematic of data recording with microprocessor.

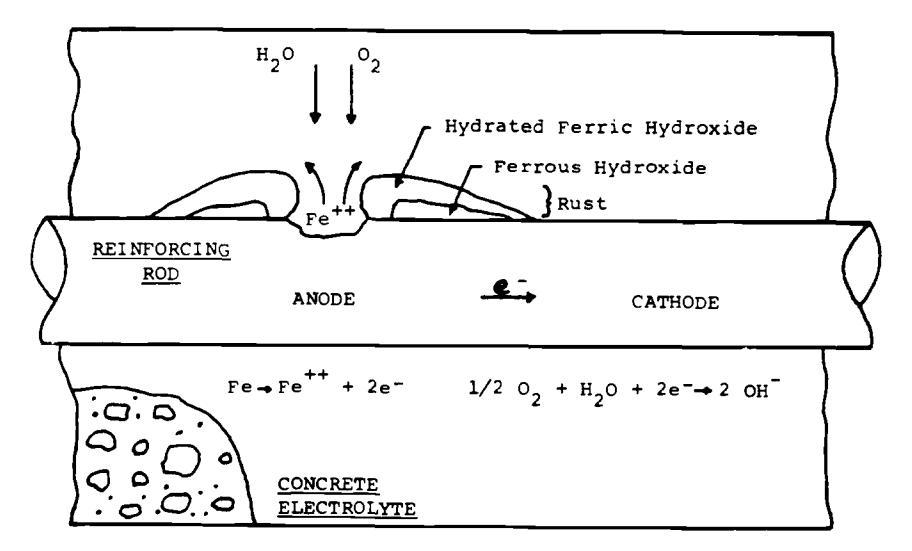
FIG. 1-Galvanic corrosion of concrete reinforcing steel. [19]

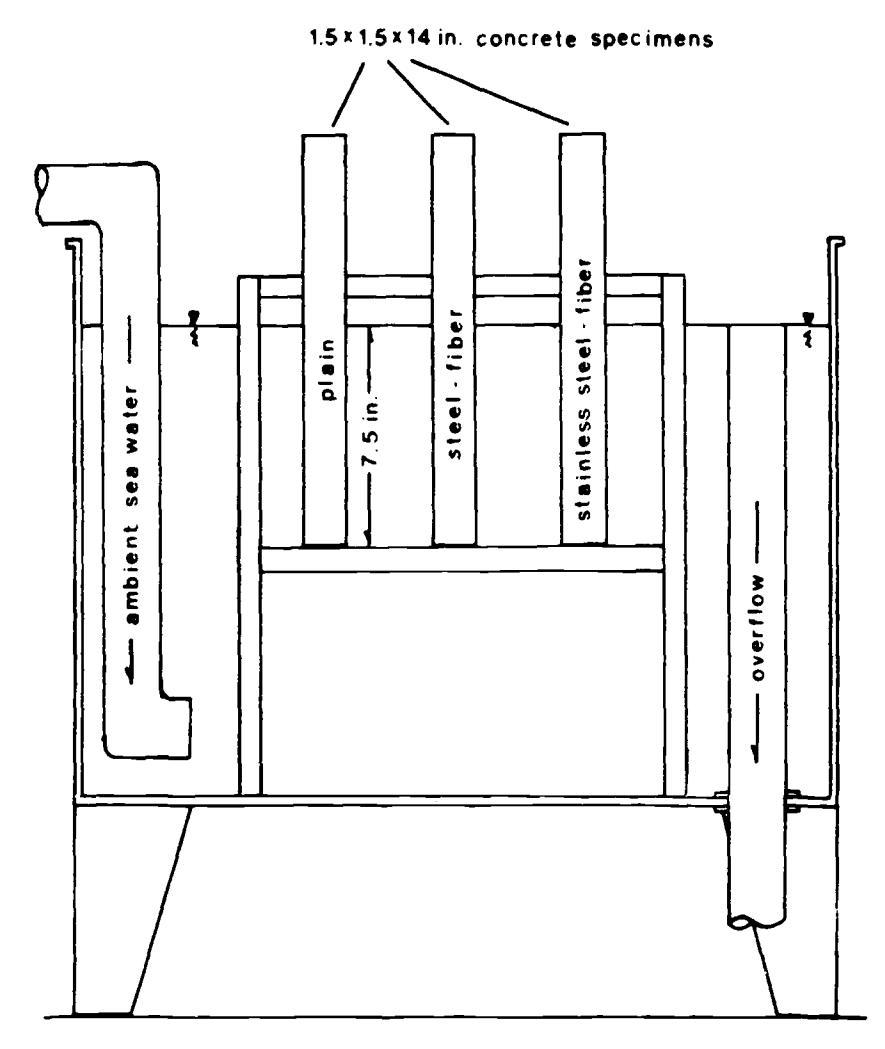
FIG. 2—Flow-through seawater exposure arrangement (1 in. = 2.54 cm).

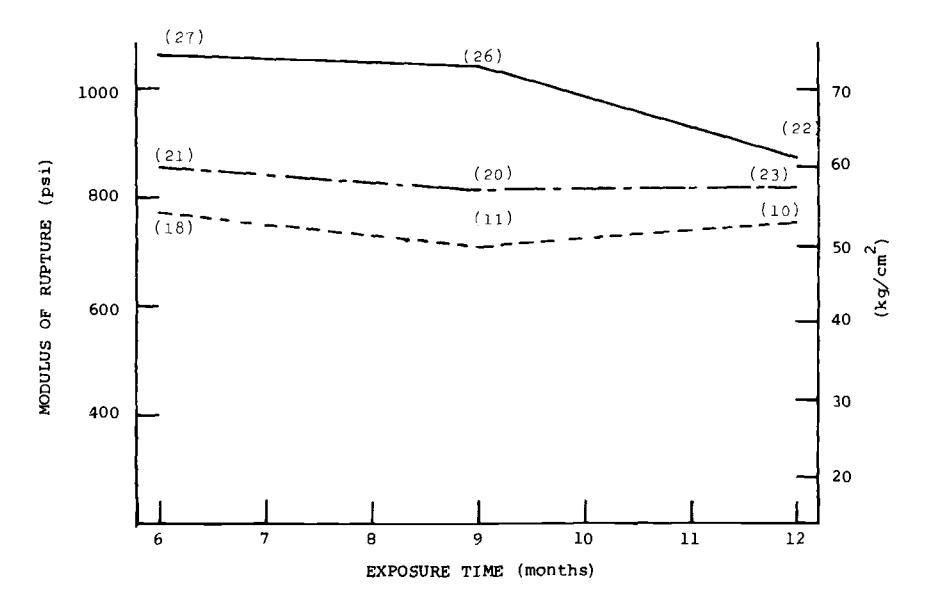
FIG. 3—Flexural strength of carbon steel fiber-reinforced beams [3.8 by 3.8 by 35.6 cm $(1\frac{1}{2} \text{ by } 1\frac{1}{2} \text{ by } 14 \text{ in.})$] exposed to flowing seawater. —break above waterline; — break at waterline; — break below waterline. Numbers in () are the number of fibers crossing the break below the neutral axis.

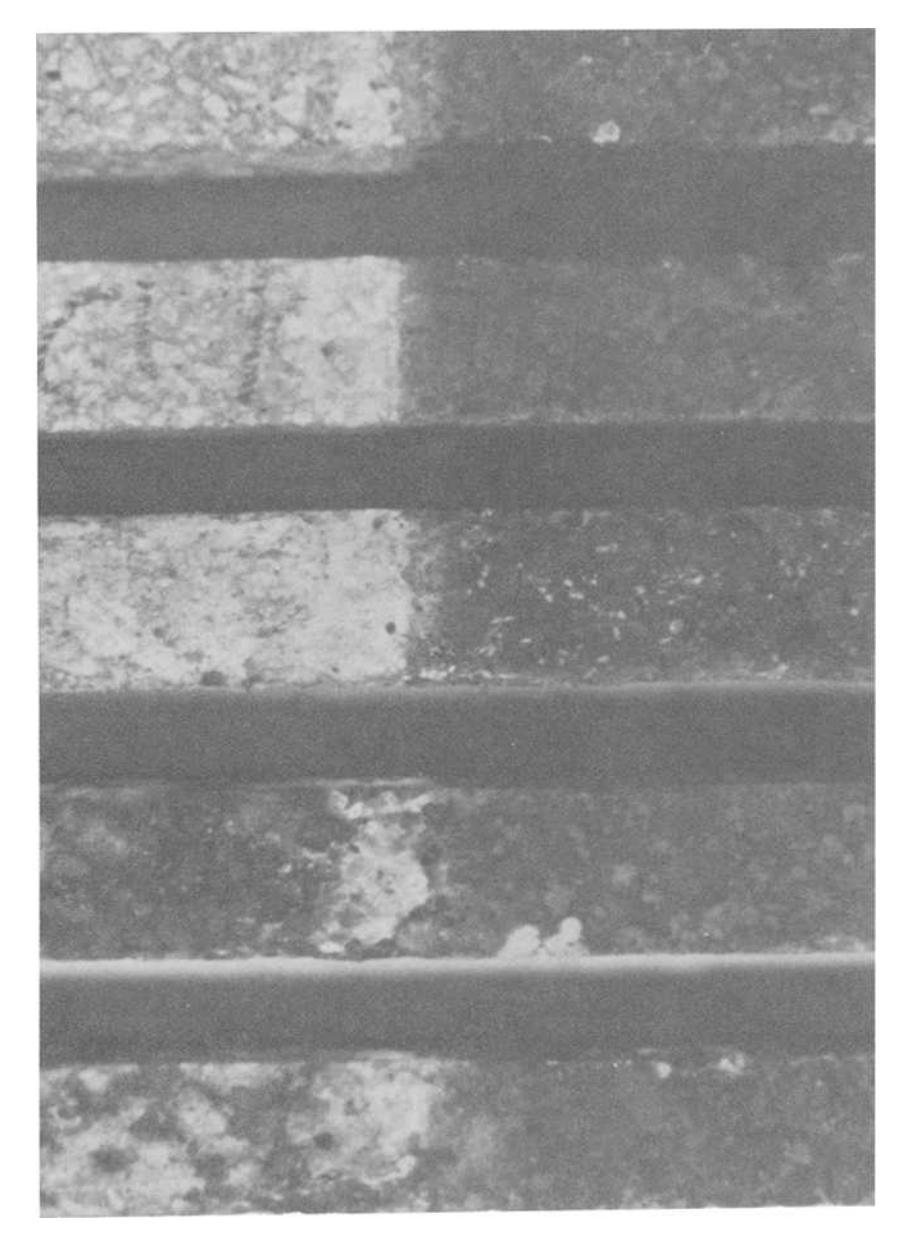
FIG. 4—Twelve-month flow-through seawater exposure specimens [3.8 by 3.8 by 35.6 cm $(1\frac{1}{2} \text{ by } 1\frac{1}{2} \text{ by } 14 \text{ in.})$]. Cut side up. From the top: stainless steel, plain, Meltex, carbon steel, and carbon steel fiber reinforced.

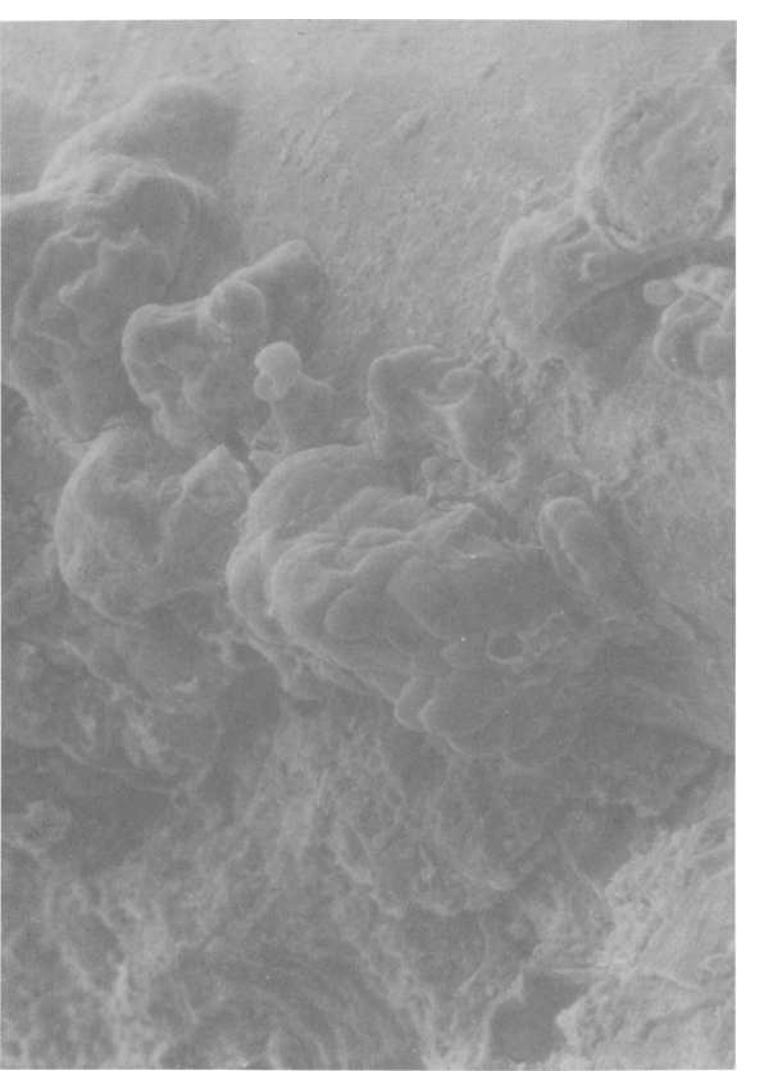
FIG. 5—Low-carbon-steel fiber from the surface of a concrete specimen exposed to seawater for six months. Smooth area to the right is the original wire: rounded shapes in the center are rust: grainy mass in the upper left contains calcium with some aluminum and calcium (×425).

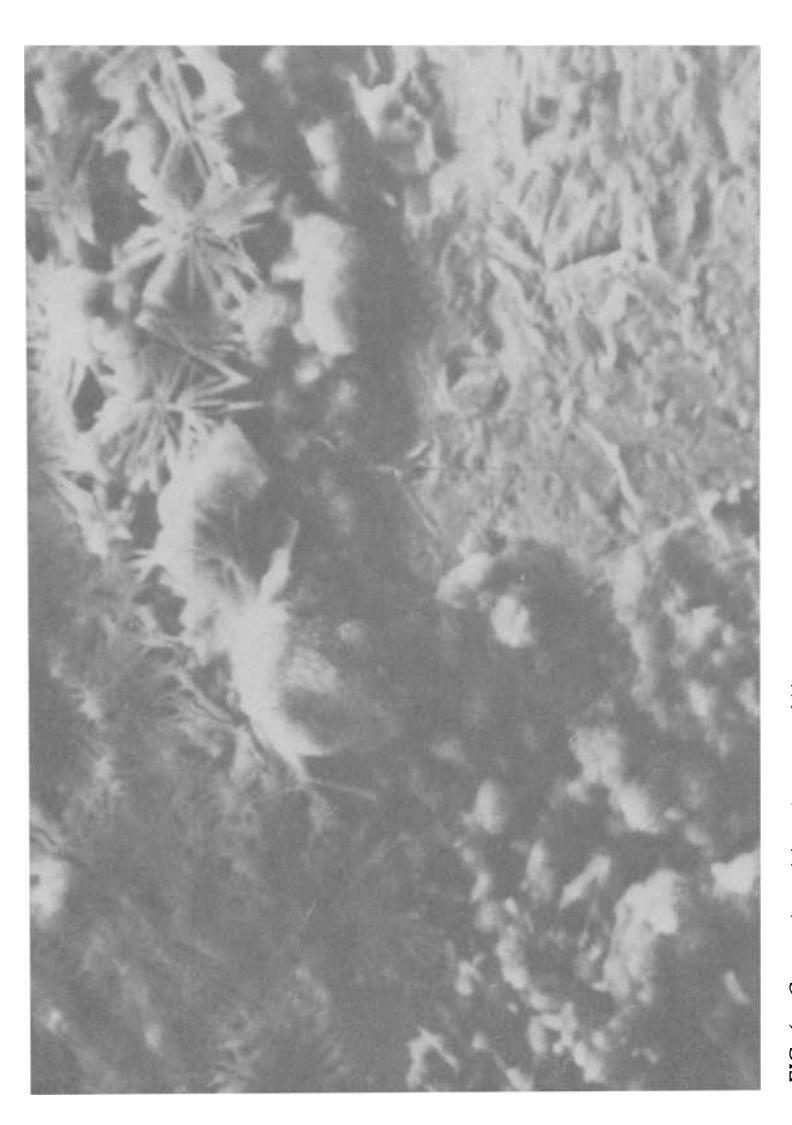
FIG. 6—Cement/metal interface on a 302 stainless steel fiber from the surface of a concrete specimen exposed to seawater for six months (×2550). Lower right area is base metal: rest of surface is covered with cement; needles are probably ettringite.

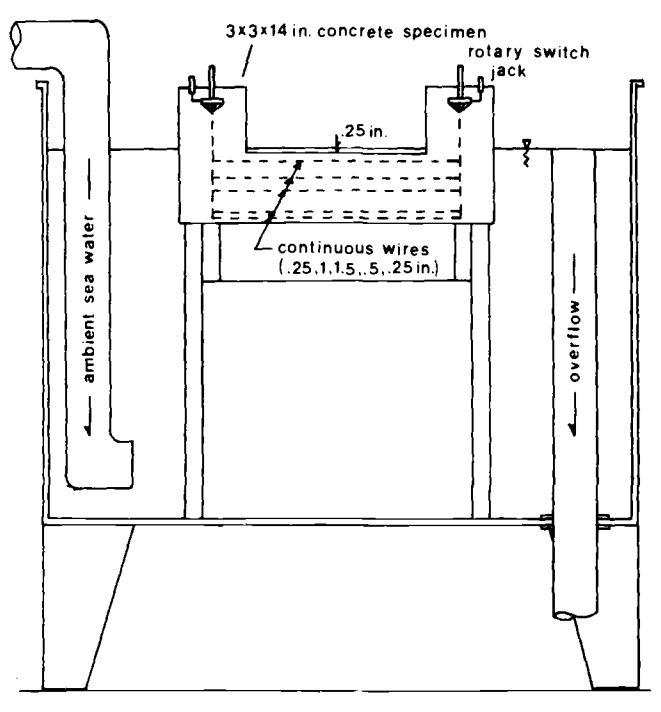
FIG. 7-Exposure arrangement for continuous wires used to measure corrosion rates electrically.

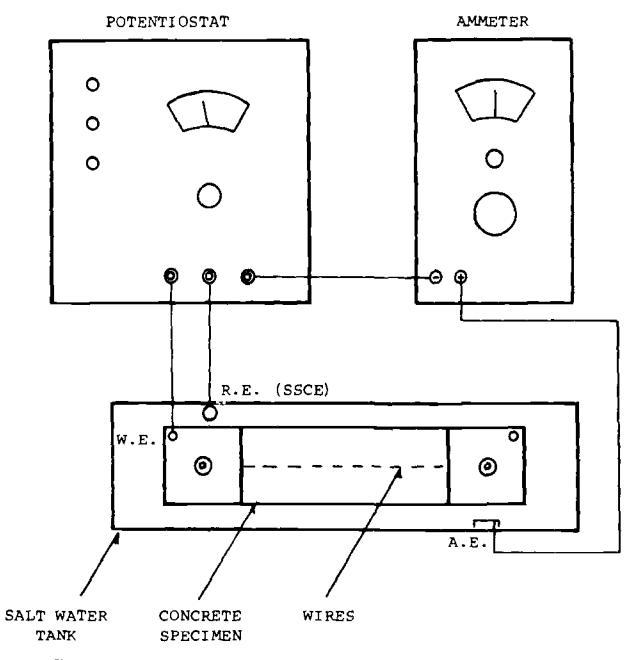
FIG. 8-Arrangement for making linear polarization measurements.

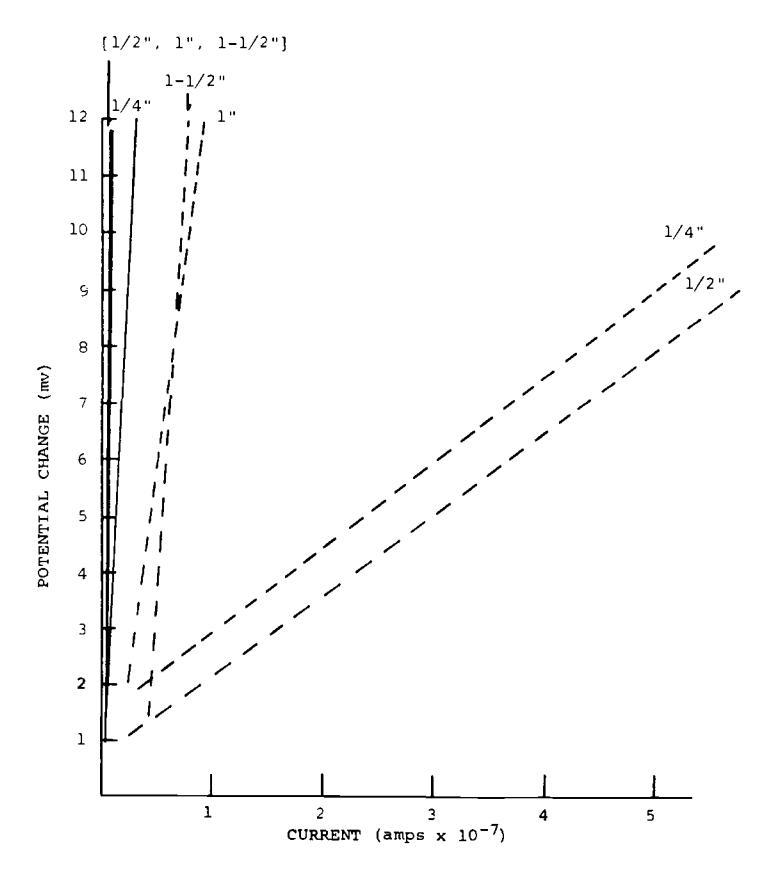
FIG. 9—Linear polarization data for carbon steel wires embedded in carbon steel fiberreinforced concrete (water/cement ratio = 0.6). Specimens exposed to ambient flowing seawater and wires identified by depth of concrete cover. Specimens --- exposed 196 days in unpainted concrete. Specimens — exposed 210 days in damp-proofed (painted) concrete.

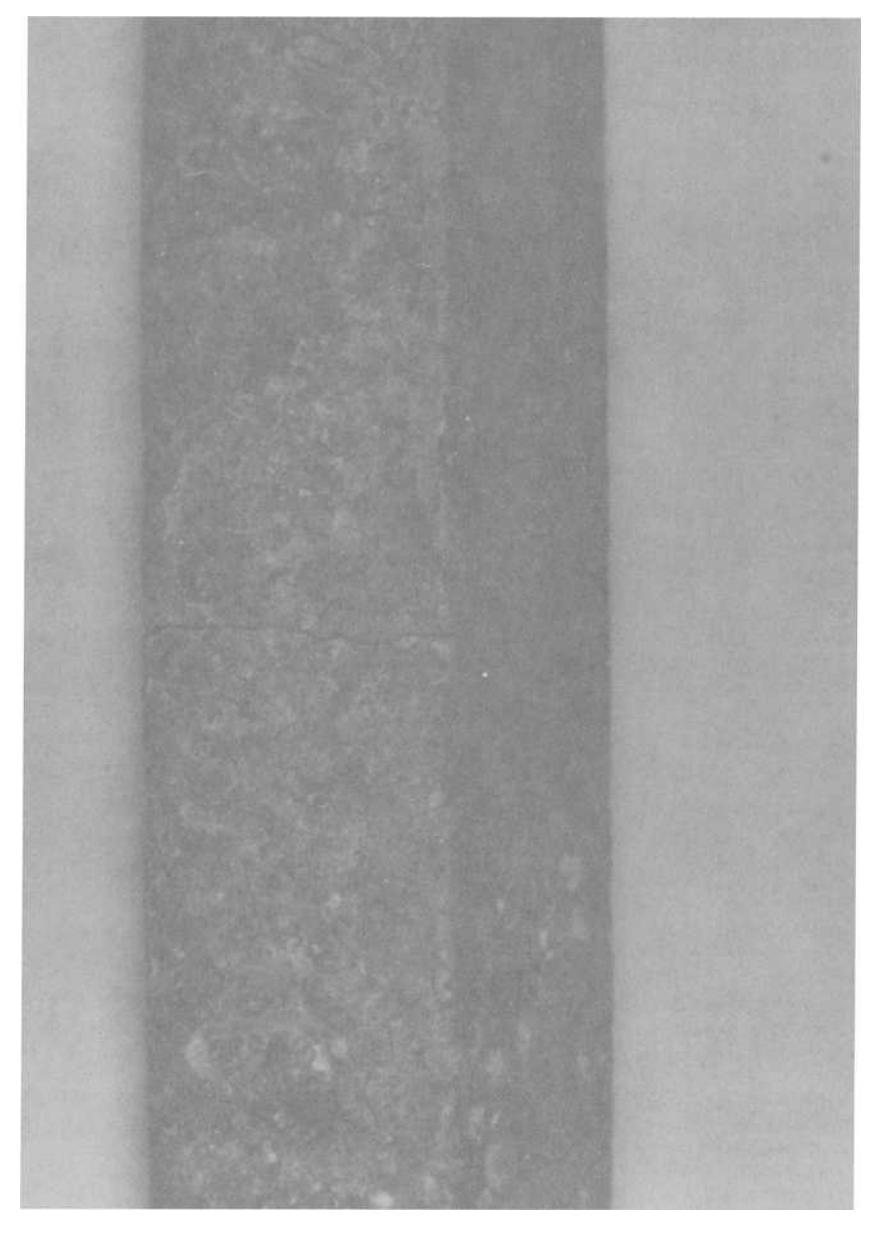
FIG. 10-7.6 by 7.6 by 106.7 cm (3 by 3 by 42 in.) stainless steel figer-reinforced beam after 12 months' exposure in Narragansett Bay. Left face exposed to waves.

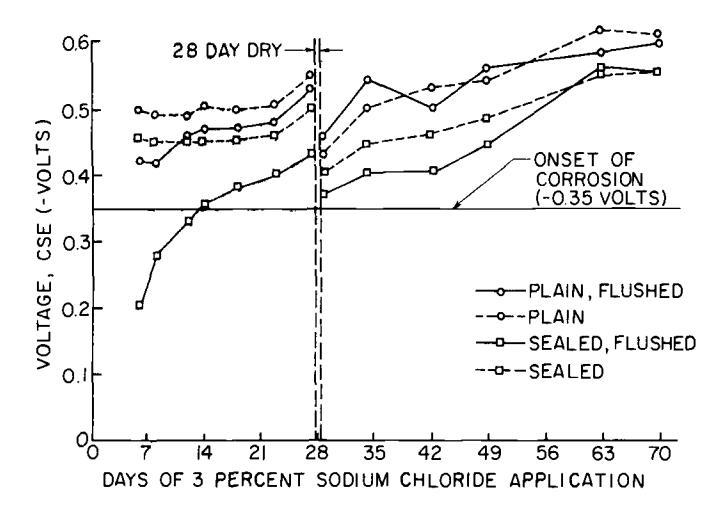
FIG. 1-Maximum half-cell potentials for the repeatedly loaded beams.
