CORROSION OF REINFORCING STEEL IN CONCRETE

A symposium sponsored by ASTM Committee G-1 on Corrosion of Metals AMERICAN SOCIETY FOR TESTING AND MATERIALS Bal Harbour, Fla., 4-5 Dec. 1978

ASTM SPECIAL TECHNICAL PUBLICATIONS 713 D. E. Tonini, American Hot Dip Galvanizers Association, Inc., and J. M. Gaidis, W. R. Grace & Co., editors

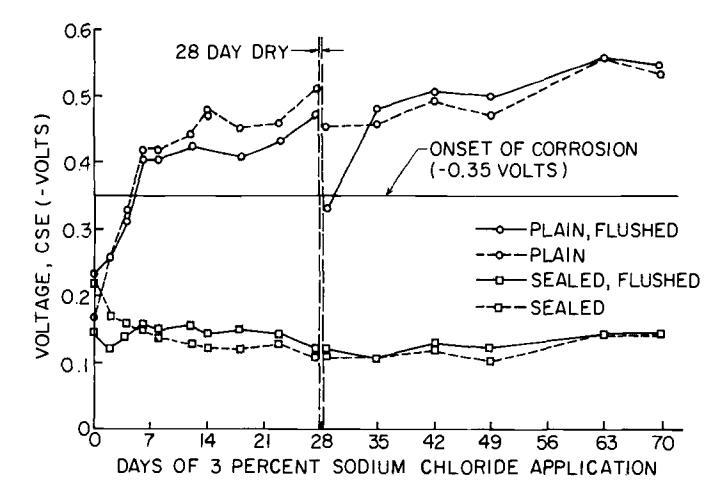
FIG. 2-Maximum half-cell potentials for the statically loaded beams.

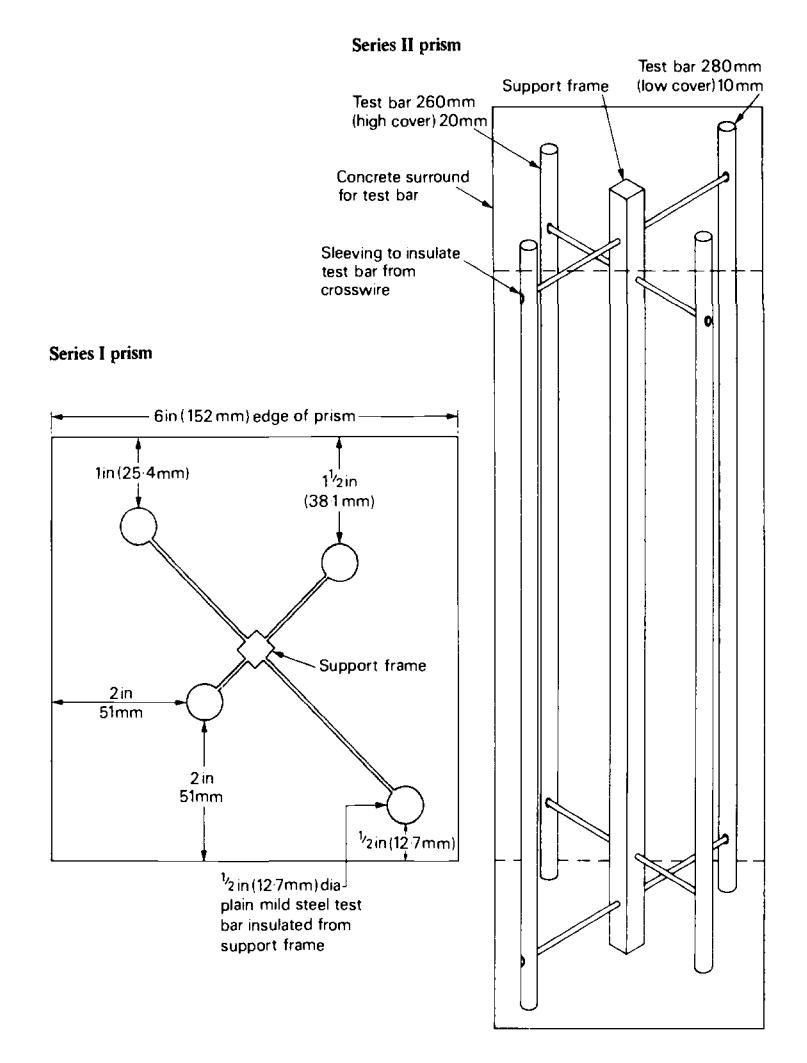
FIG. 1—Arrangement of steel on support frame for Series I and II prisms.

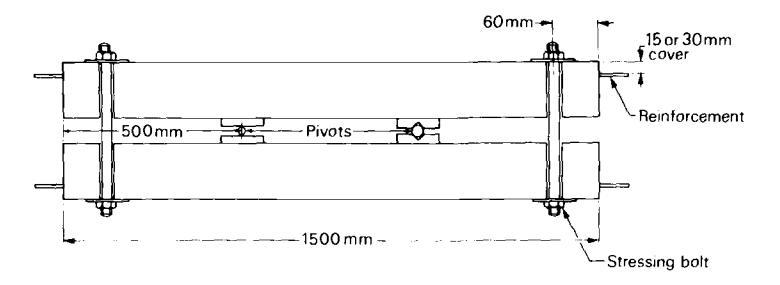
FIG. 2-Assembly of stressed beams.

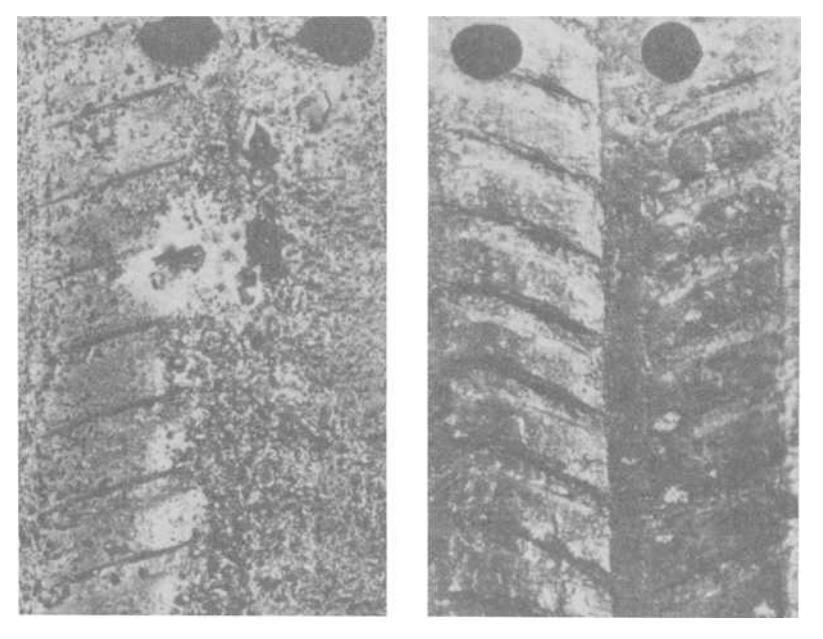
FIG. 3—Reinforcement from Series II prisms after five years' exposure. Magnification $\times 1.5$; pictures taken with a periphery scanning camera.

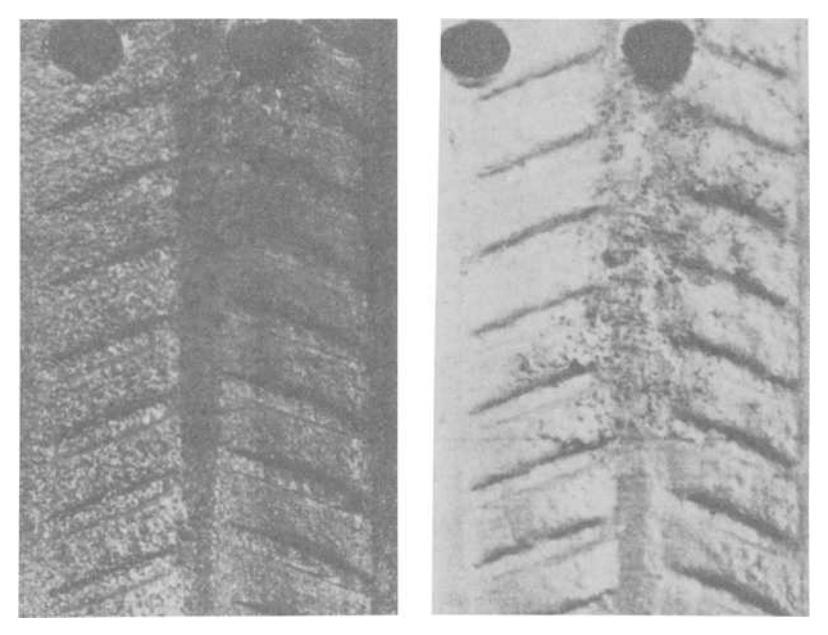
FIG. 4—Reinforcement from Series II prisms after five years' exposure. Magnification $\times 1.5$; picture taken with a periphery scanning camera.

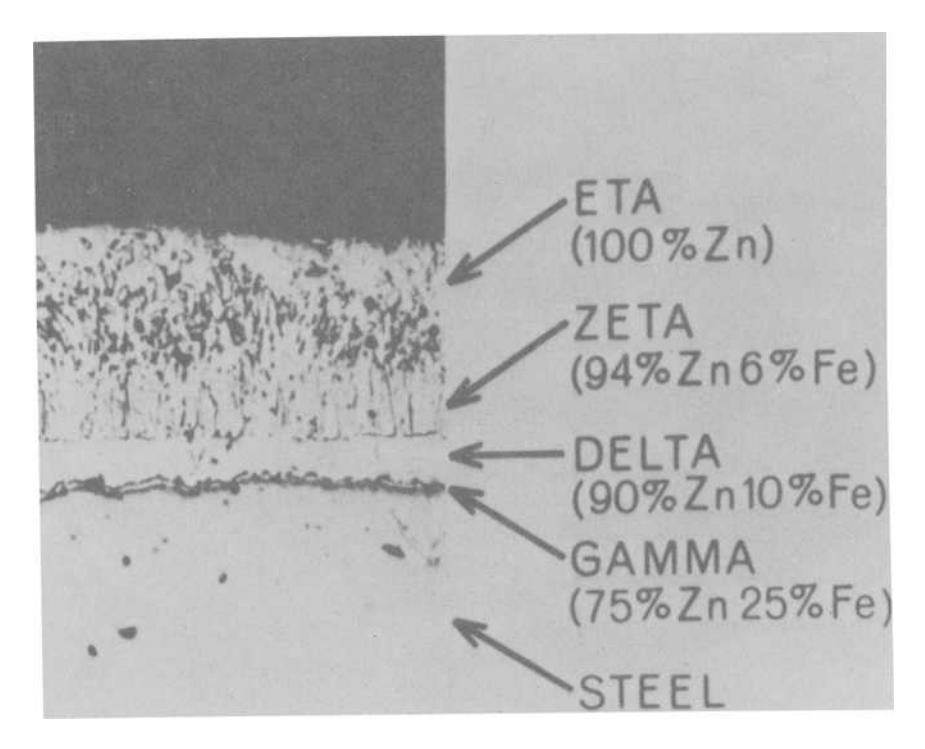
FIG. 1-Illustration of a typical uncorroded galvanized coating on reinforcing steel.

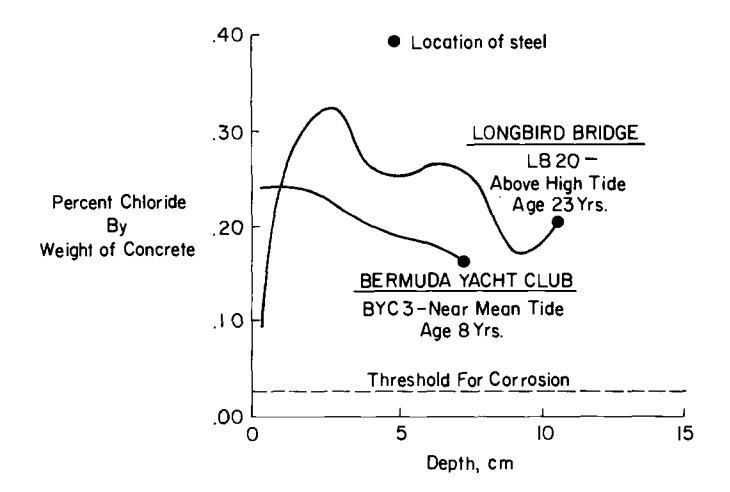
FIG. 2—Chloride concentrations in concrete adjacent to galvanized reinforcing steel in the Longbird Bridge abutment and the Royal Bermuda Yacht Club jetty.

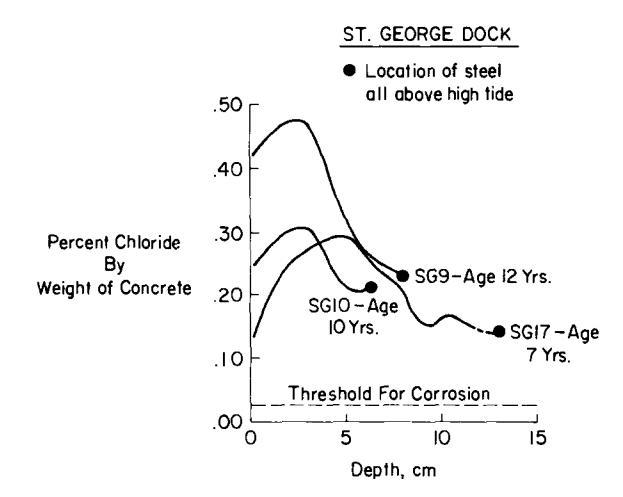
FIG. 3—Chloride concentrations in concrete adjacent to galvanized reinforcing steel in St. George Dock.

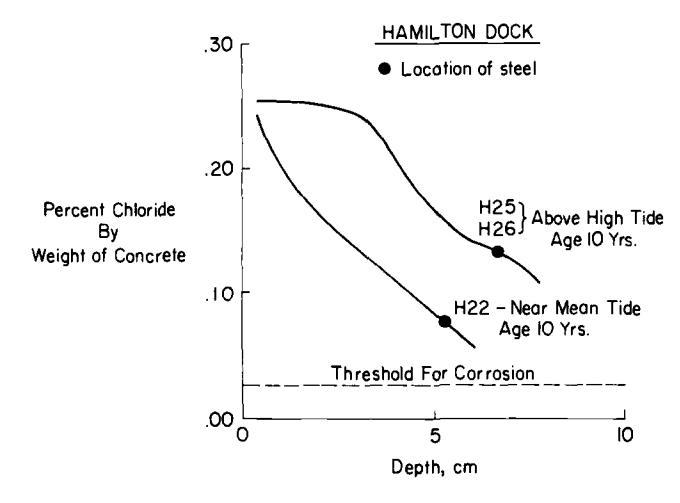
FIG. 4—Chloride concentrations in concrete adjacent to galvanized reinforcing steel in Hamilton Dock.

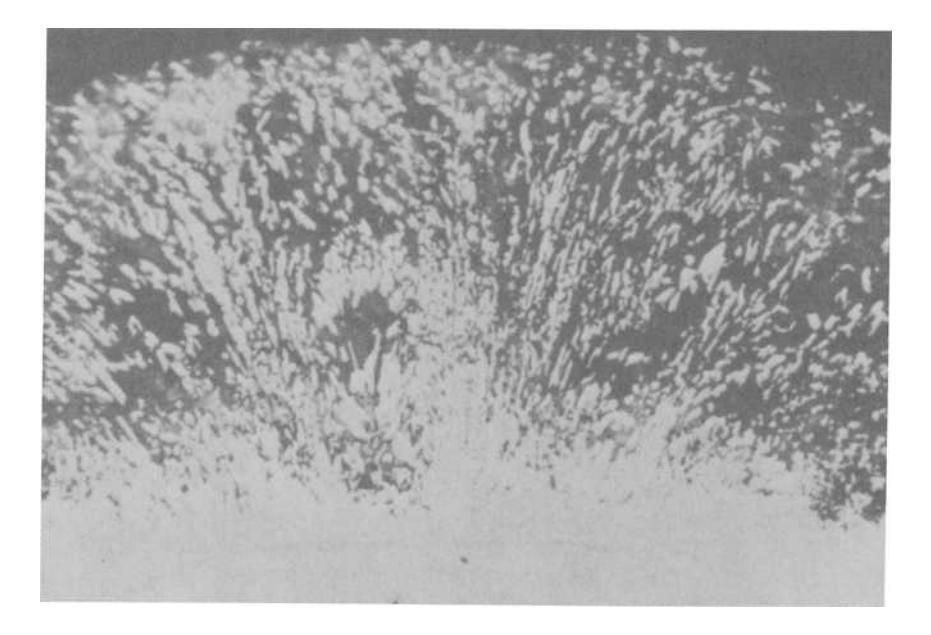
FIG. 5—Photomicrograph of galvanized coating on reinforcing bar in Core LB20 from the Longbird Bridge abutment (×250).

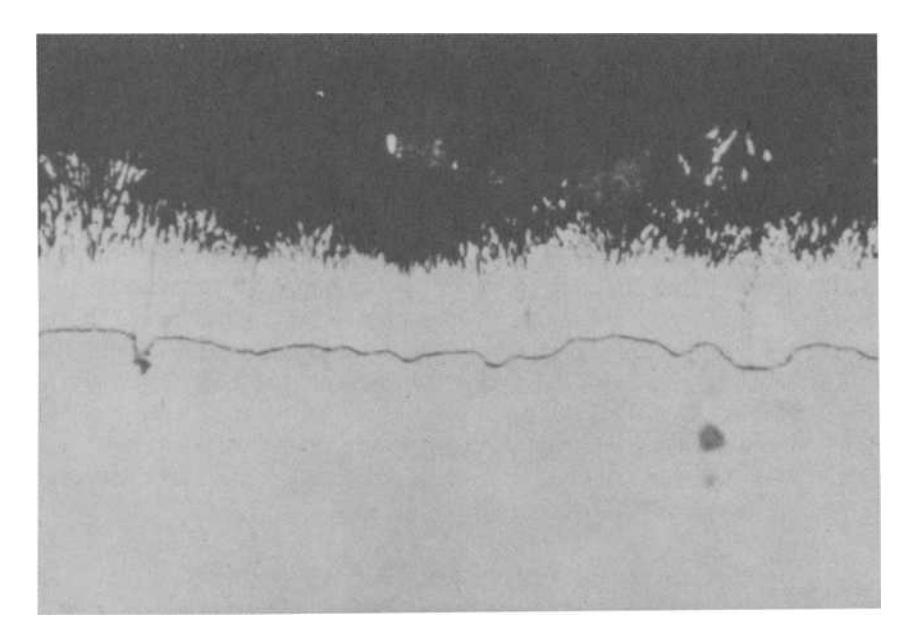
FIG. 6—Photomicrograph of galvanized coating on reinforcing bar in Core SG9 from St. George Dock (\times 240).

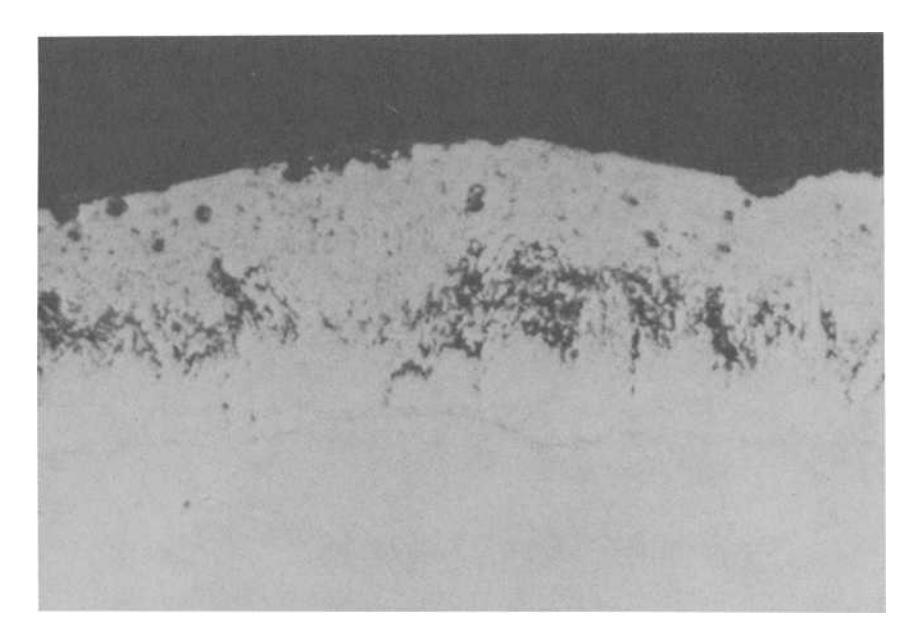
FIG. 7—Photomicrograph of galvanized coating on reinforcing bar in Core BYC3 from the Royal Bermuda Yacht Club jetty (\times 360).

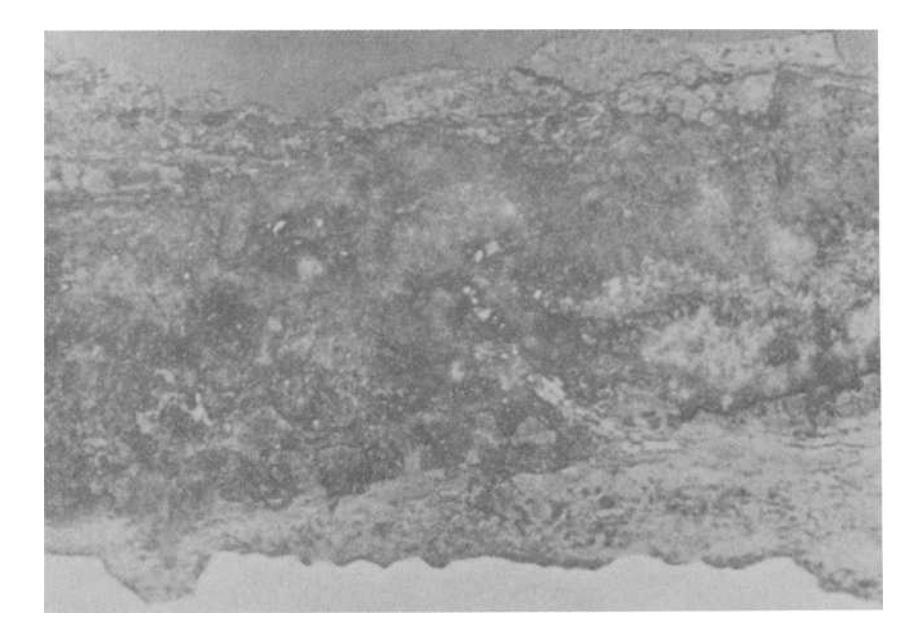
FIG. 8—Photomicrograph of reinforcing bar from the St. George Dock concrete where corrosion has progressed to the steel substrate at a porous cold joint in the seawall ($\times 220$).

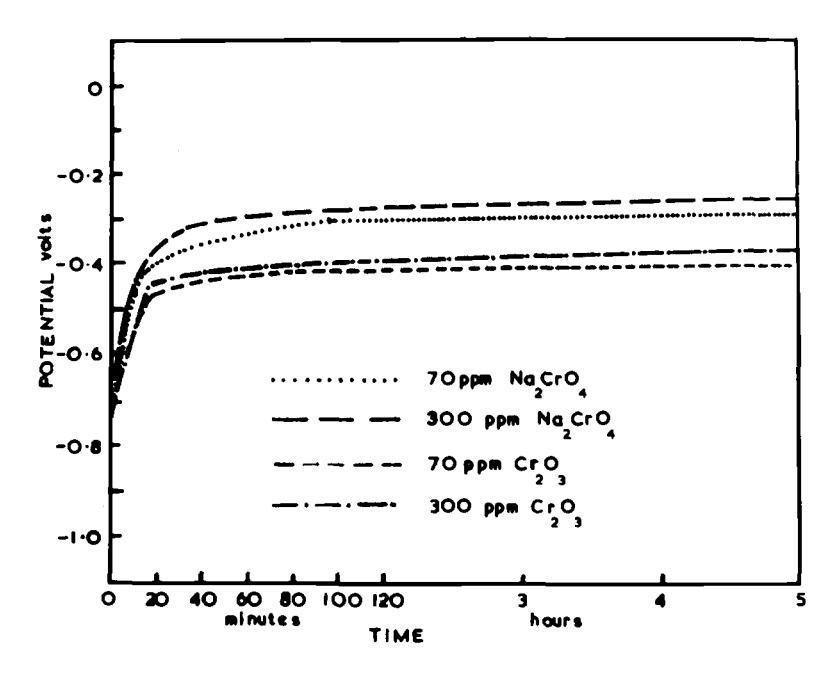
FIG. 1—Potential of zinc versus time in saturated calcium hydroxide solutions inhibited with sodium chromate and chromic oxide.

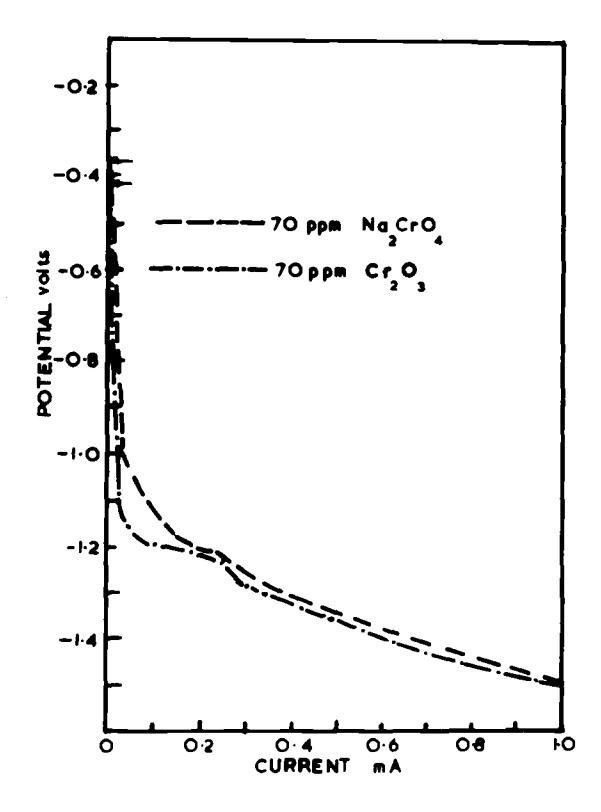
FIG. 2—Potential of passivated zinc versus current in saturated calcium hydroxide solutions inhibited with sodium chromate and chromic oxide.

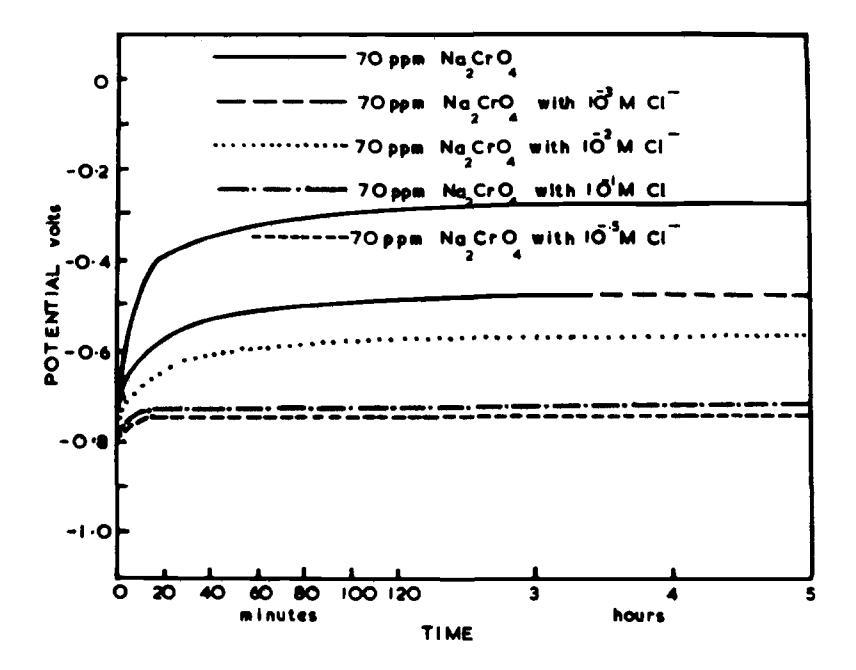
FIG. 3—Potential of zinc versus time in saturated calcium hydroxide solutions inhibited with 70-ppm sodium chromate for different sodium chloride additions.

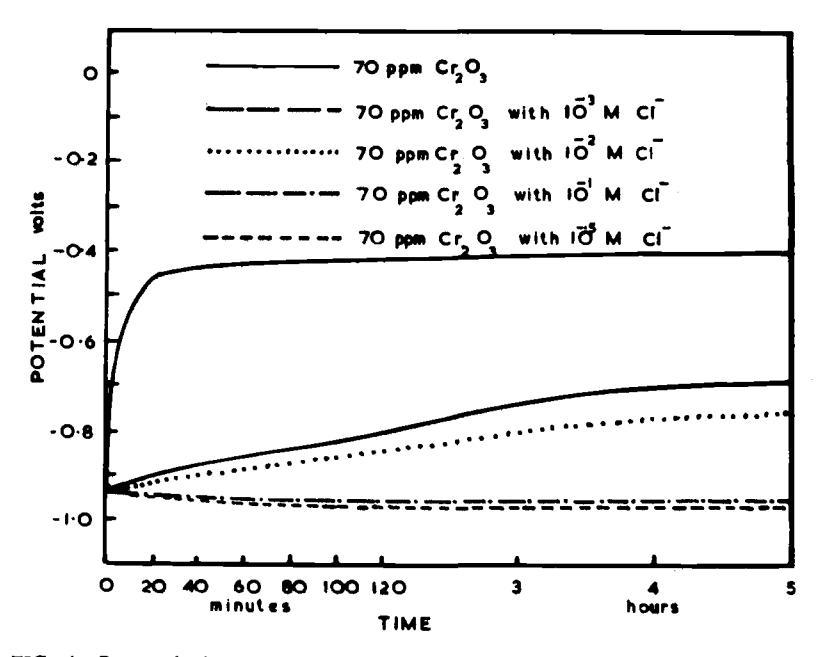
FIG. 4—Potential of zinc versus time in saturated calcium hydroxide solutions inhibited with 70-ppm chromic oxide for different sodium chloride additions.

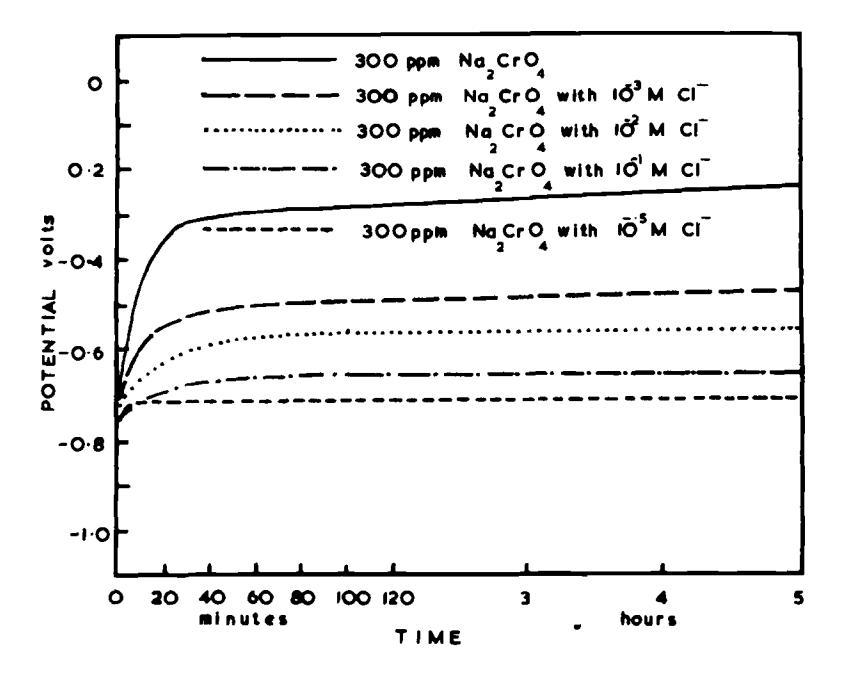
FIG. 5—Potential of zinc versus time in saturated calcium hydroxide solutions inhibited with 300-ppm sodium chromate for different sodium chloride additions.

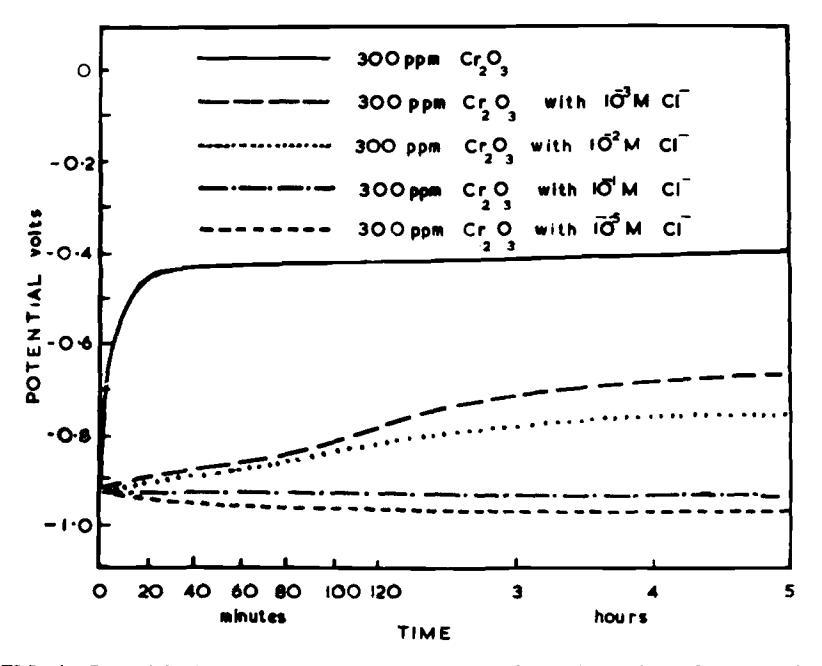
FIG. 6—Potential of zinc versus time in saturated calcium hydroxide solution inhibited with 300-ppm chromic oxide for different sodium chloride additions.

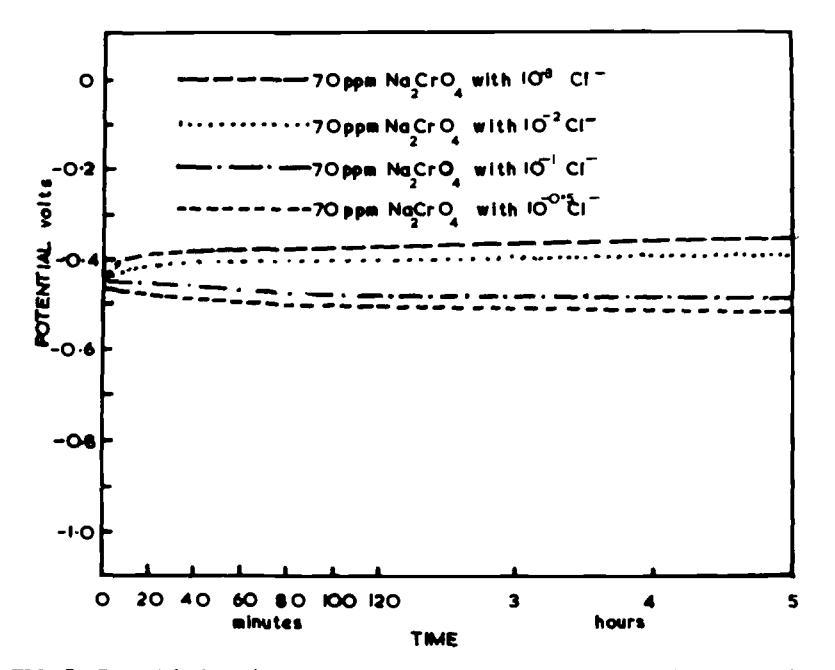
FIG. 7—Potential of passivated zinc versus time in saturated calcium hydroxide solutions inhibited with 70-ppm sodium chromate for different additions of sodium chloride.

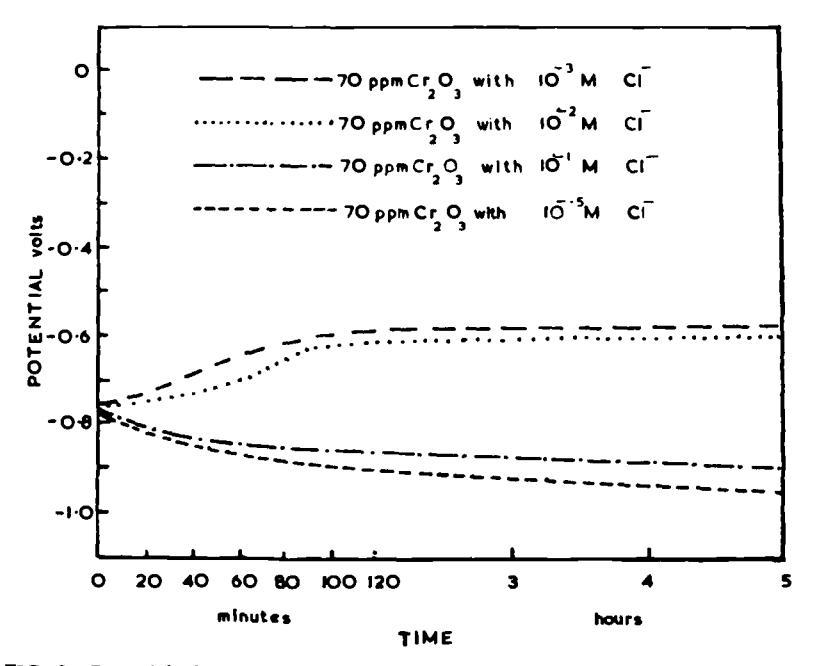
FIG. 8—Potential of passivated zinc versus time in saturated calcium hydroxide solutions inhibited with 70-ppm chromic oxide for different additions of sodium chloride.

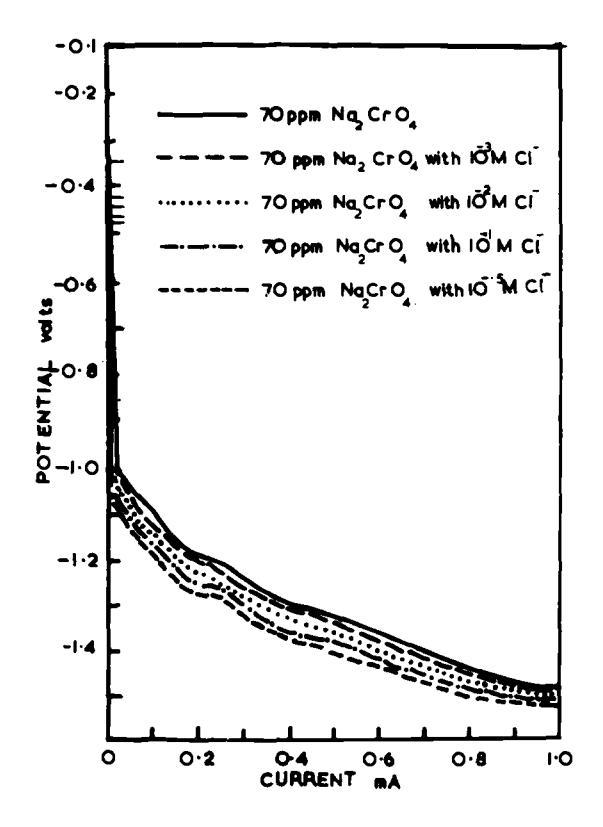
FIG. 9—Potential of passivated zinc versus current in a saturated calcium hydroxide solution inhibited with 70-ppm sodium chromate for different sodium chloride additions.

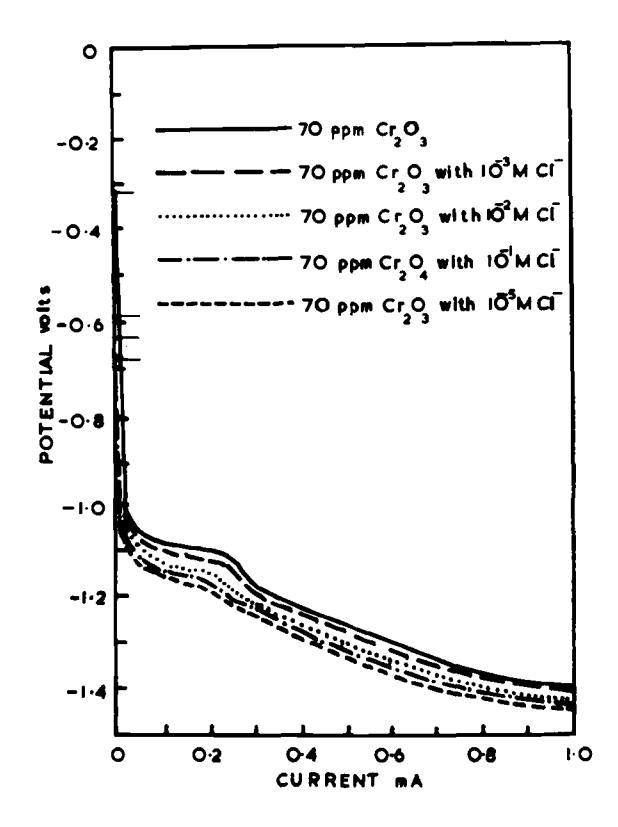
FIG. 10—Potential of passivated zinc versus current in a saturated calcium hydroxide solution inhibited with 70-ppm chromic oxide for different sodium chloride additions.

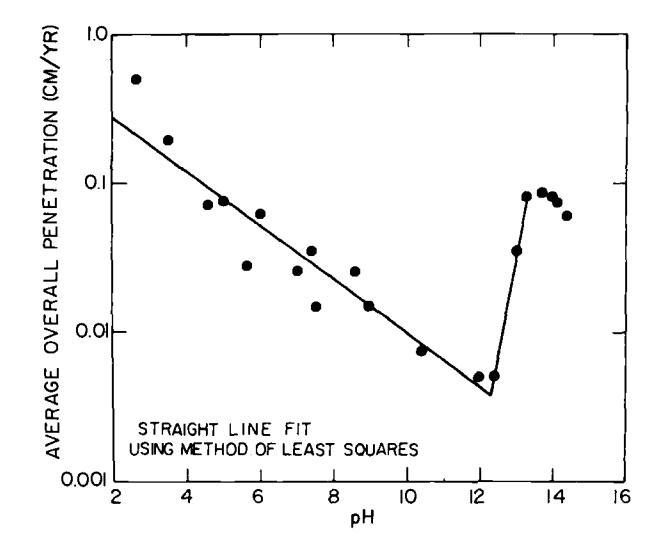
FIG. 1-Corrosion of zinc in agitated aerated solutions of hydrochloric acid and sodium hydroxide [28].

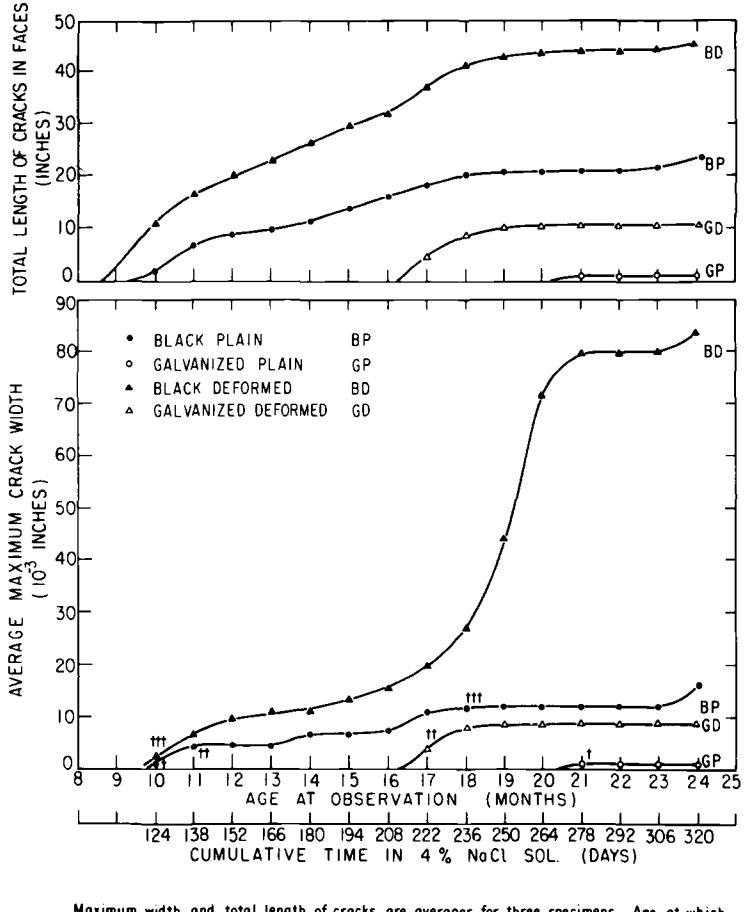
Maximum width and total length of cracks are averages for three specimens. Age at which different specimens cracked and total number of specimens cracked are shown by t : one specimen t, two tt, three ttt in lawer figure only.

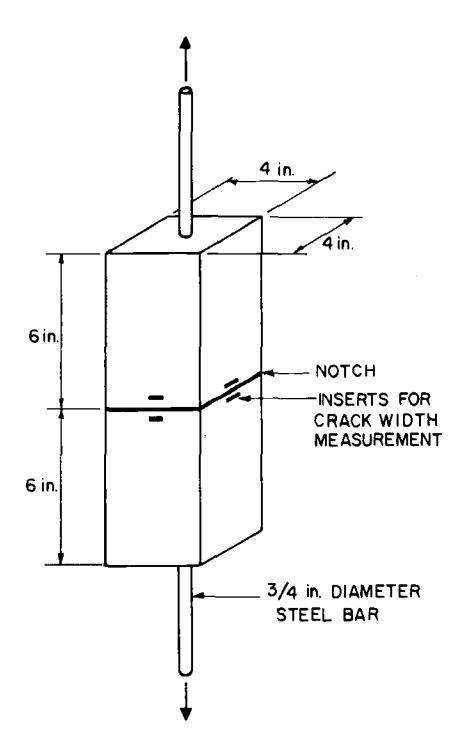
FIG. 3—Corrosion specimen details (1 in. = 2.54 cm).

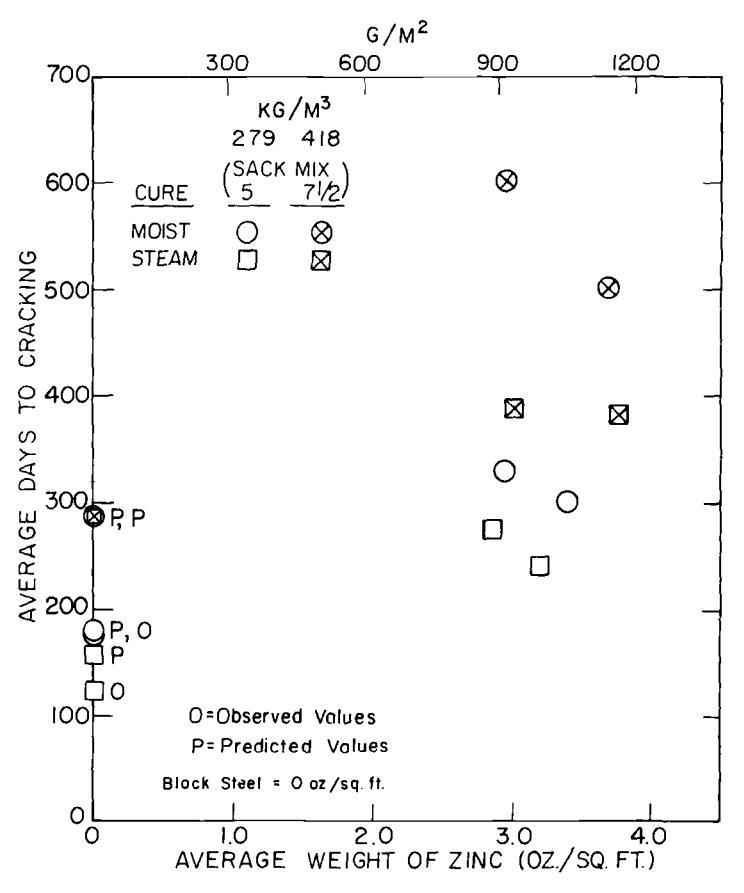
FIG. 4—Time-to-cracking versus weight of zinc. Data predictions of Table 4 are shown above. For galvanized: each observed point represents 10 specimens. For black: each observed point represents 20 specimens. Data by Hill et al [24] ($1 \text{ kg/m}^3 = 1.685 \text{ yd}^3$; $1 \text{ oz/ft}^2 = 0.3051 \text{ kg/m}^2$).
Only seven out of 20 black steel specimens had cracked when testing was terminated, and no data are given for when those cracked. To permit detailed analysis, it is necessary to refer back to an earlier, 1968, report by Spellman and Stratfull [23].

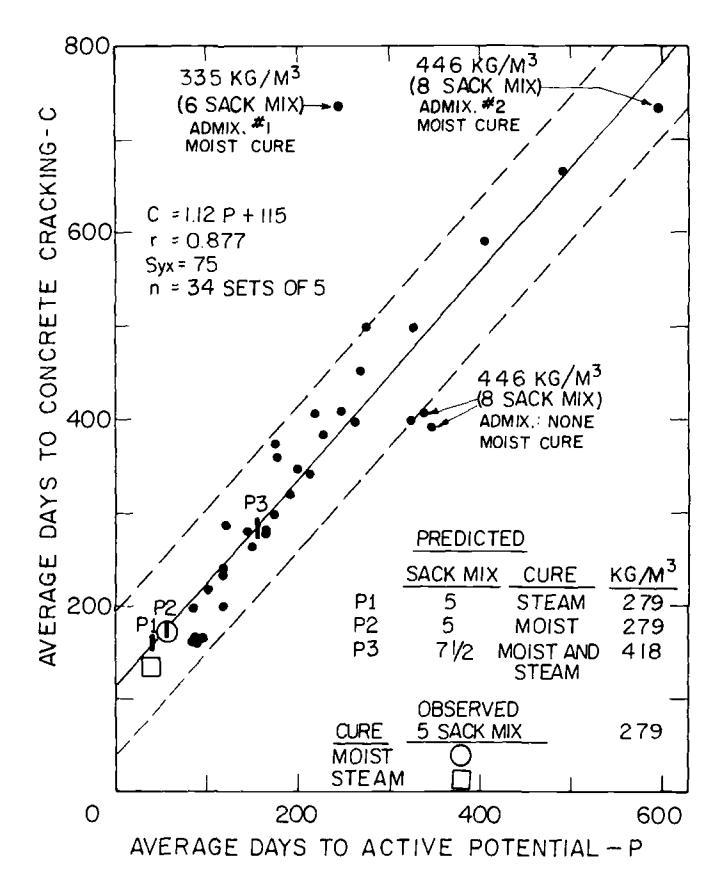
FIG. 5—Days to concrete cracking versus days to active potential—black steel. Data and predictions of Table 4 are superposed on Fig. 3 of Spellman and Stratfull [23]. Laboratory corrosion test of steel in concrete. Active potential = -0.35 V saturated calomel electrode (SCE) (1 kg/m³ = 1.685 lb/yd³).
