ADDENDA

SCHEMATIC DIAGRAM CHANGE MODELS HA-410 & HA-460 AMATEUR TRANSCEIVERS

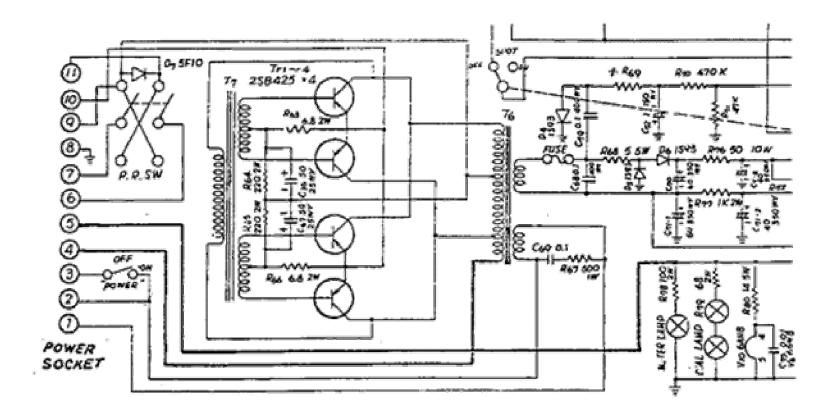
There has been an error in printing the schematic diagram of the power socket connections on the above mentioned units. The diagram below shows the power socket connections as it should appear. It will be noted on the corrected diagram below that pins 4 and 5 of the power socket are reversed from that shown on the original schematic diagram.
