SHORT STIRLING

in action

By Ron Mackay

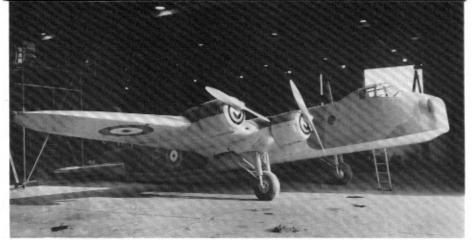
The S31/M4 was a half scale Stirling prototype used to test the aircraft's aerodynamics. The single stage undercarriage fitted to the S31 was later replaced with a two stage undercarriage that was adapted for the second prototype and all production Stirlings.

The single stage landing gear leg was discarded due to the increased length of the undercarriage rods which proved too long to be retracted into the engine nacelle wheel wells. A two stage undercarriage was built which retracted vertically and then backward into the nacelle. The undercarriage retraction motors were originally located inside the nacelle, but were later relocated inside the fuselage to allow for manual retraction in the event of motor failure. The manual undercarriage system required some 740 turns of the crank handle to lower or raise the undercarriage. To handle the aircraft's weight, the tail wheel was comprised of twin wheels rather than the more common single wheel unit found on most bombers.

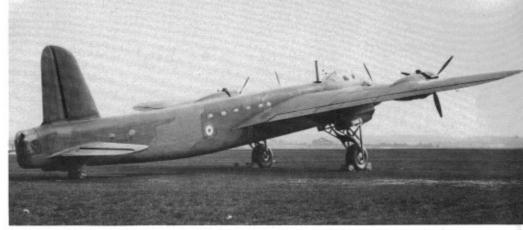
The Stirling prototype (L7600) reveals the high landing gear that became hallmark of the Stirling. National markings carried by the prototype were confined to Type A wing and fuselage roundels. On 14 May 1939, the aircraft made its maiden flight and suffered an undercarriage failure on landing, ending its career.

Given the RAF serial number L7600, the prototype made its maiden flight on 14 May. After a graceful takeoff and short test flight the prototype suffered an undercarriage failure on landing and was damaged beyond repair. The failure was traced to the light alloy undercarriage back arch braces which were replaced on succeeding aircraft by stronger tubular steel units.

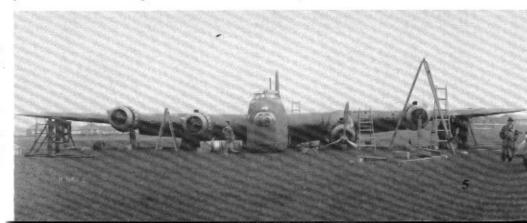
The first Stirling (L7600) sets on its belly after the undercarriage failed on its first flight. The number 2 engine has been twisted out of its mounting and workmen have removed the propellers from the other engines. The aircraft never flew again and was scrapped.

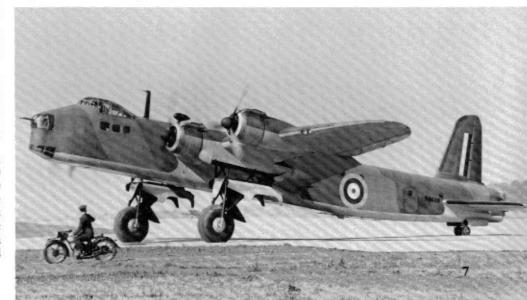
The fourth production Stirling Mk I taxles along the taxlway at Rochester, Short's main production facility. The bomber carries an extended fin flash on the vertical stabilizer, which was a common marking on early Stirling Mk Is. The Black areas on the fin and stabilizer leading edges are rubber deicing boots.

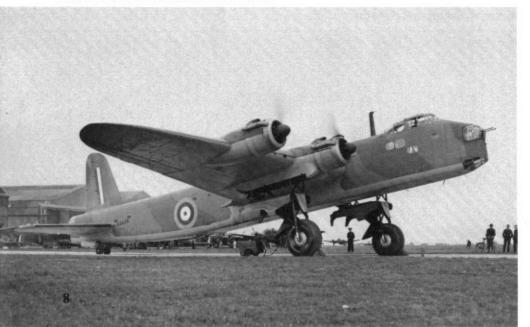
An early production Stirling Mk I Series I of No 7 Squadron shares the ramp with a Supermarine Spitfire at RAF Oakington, home base for No 7 Squadron. Early Stirling Mk Is had the engine exhausts of the port engines mounted high on the port side cowling edge.

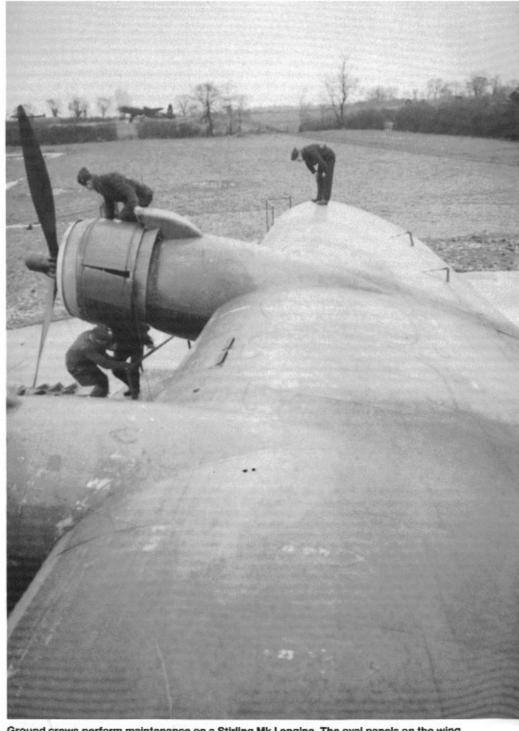
Ground crews perform maintenance on a Stirling Mk I engine. The oval panels on the wing upper surface are the fuel tank covers which were a carry over from the Sunderland flying boat. The two angled posts near the wing trailing edge are the twin alteron control link cables and rods.

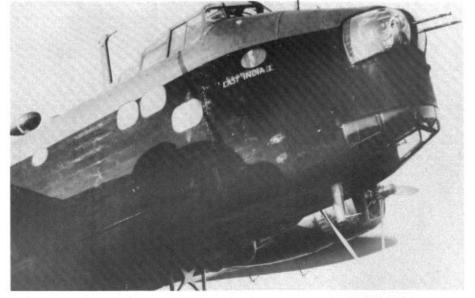
EAST INDIA 1 reveals the starboard side fuselage window layout and frameless FN5A nose turret. The FN5A was armed with two .303 Browning machine guns and remained the standard nose turret carried by all Stirling bombers. The twin pitot tube masts just behind the bomb aimer's windows were also a standard fitting to the Stirling Mk I.

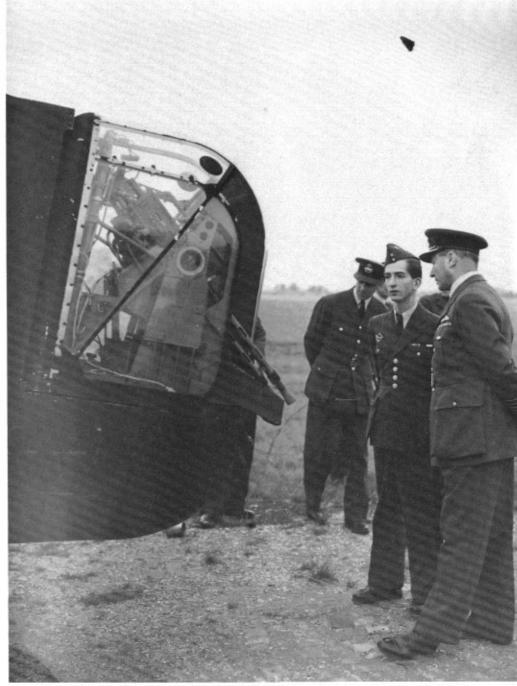
King Peter of Yugoslavia (middle) inspects the tall turret of a Stirling Mk I. The Frazer Nash FN20A rear turret was unique to the Stirling. In their fully depressed position, the barrels of the four .303 machine guns barely protrude beyond the cartridge ejection chutes on the bottom of the turret.

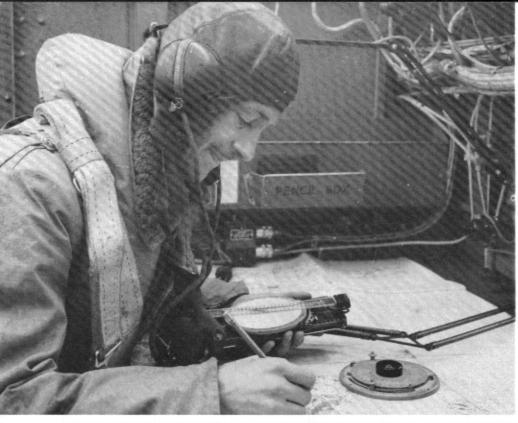
The navigator's position in the Stirling was just behind the port pilot's seat, with navigator facing to port, and was equipped with a plotting table and light. This navigator is plotting a course using a Dalton's Computer, the type issued to all RAF navigators.

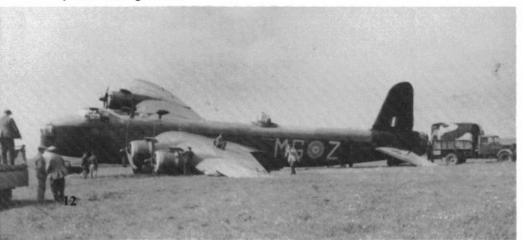
Outer wing sections were probably the most replaced part on the Stirling because they were often damaged beyond repair when the aircraft suffered an undercarriage failure. This Stirling Mk I Series III of No 7 Squadron had the port undercarriage fail on landing and dug in the port outer wing section.

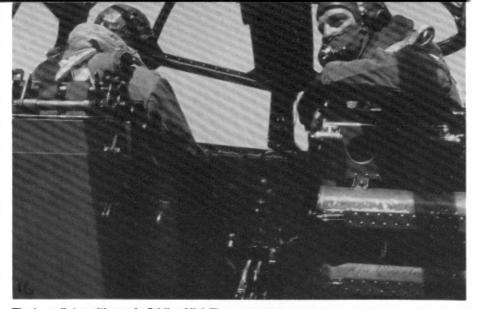
The two pilot positions of a Stirling Mk I. The seat harness straps on the port (pilot's) seat are visible just at the top of the armored seat. The containers behind the starboard (co-pilot's) seat are probably used to hold signal flares. The crew complement of the Stirling was later changed to a single pilot, reducing the crew to seven.

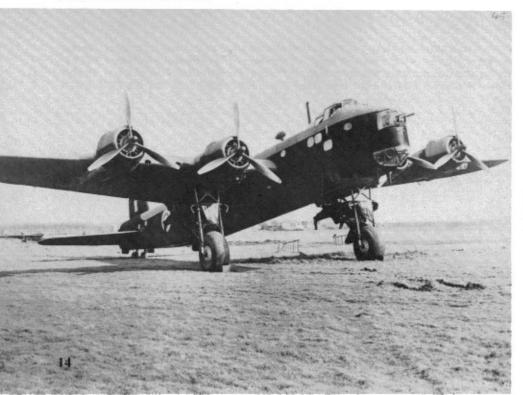
The second Mk II prototype parked on the grass at Boscombe Down during March of 1942. The engine exhausts are located on the lower port side of the cowling. The Mk II project was cancelled and this aircraft (N3711), like the first prototype, never entered service and was retired on 30 November 1944.

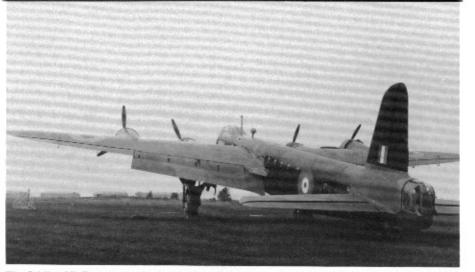
The Stirling Mk II prototype had revised engine cowlings to house the American built Wright Cyclone engines and had the upper carburetor air intakes deleted. The aircraft (N3657) never entered squadron service and was ultimately Struck Off Charge (SOC) on 16 September 1945.

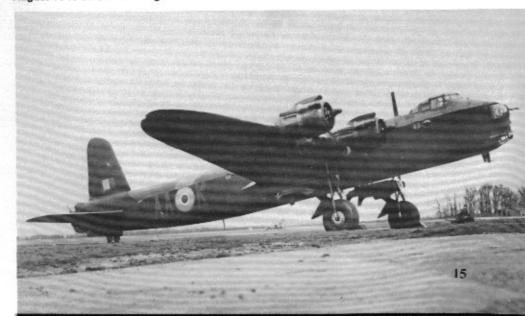
The crew conducts engine run ups on a Stirling Mk III (EF465) of No 75 (New Zealand) Squadron, while the aircraft is chocked on the grass at Mepal. The Mk III had a revised cowling with an enlarged air intake and longer barbed exhausts. EF465 was listed as missing on 23/24 August 1943 on a mission against Berlin.

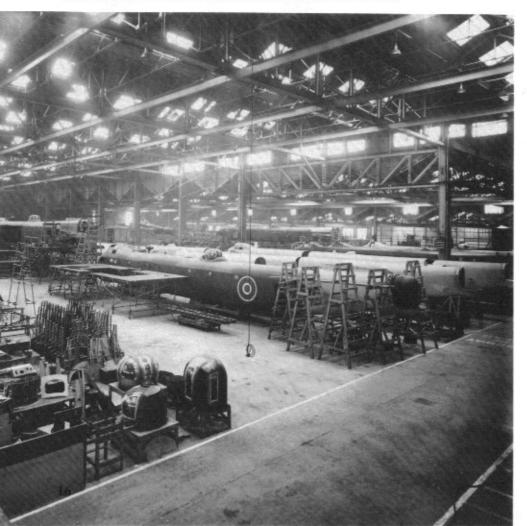
Four Stirling Mk III fuselages on the production line await installation of various internal components, while three Frazer Nash turrets (nose, upper and tail) are positioned for mounting on their allotted airframe. A total of 2,368 Stirlings were produced.

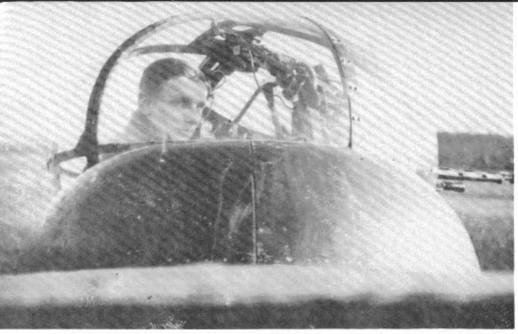
SGT Falconbridge of No 90 Squadron mans the FN50 upper turret on a Stirling Mk III. The fairing in front of the turret prevented the gunner from firing his weapons into the fuselage of his own aircraft. The FN50 turret replaced the earlier taller FN7 turret carried by Stirling Mk I Series III aircraft.

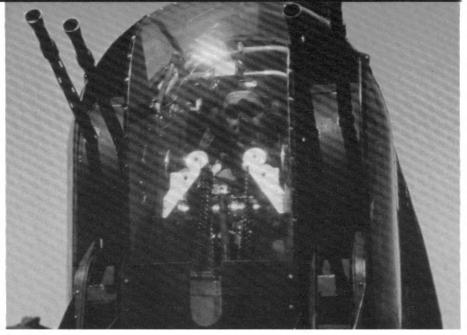
An RAF gunner mans the Frazer Nash rear turret of a Stirling. The ammunition belts were fed to the guns over rollers at the top of angled frames, which led to jams if the ammunition belts were out of alignment. The gun barrels of the four .303 machine guns were mounted in a staggered position.

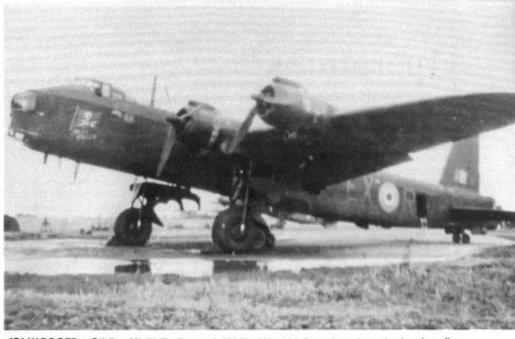
Mandrel Antennas

JOLLY ROGER also carried a single pitot tube mast under the nose and a bulged blister type nose observation window. The forward Mandrel antenna mast is located on the underside of the nose behind the pitot tube mast.

JOLLY ROGER, a Stirling Mk III (R - Roger, LJ525) of No 199 Squadron, is parked on her dispersal spot at North Creake. This Stirling was equipped with Mandrel electronic countermeasures equipment and was fitted with a ventral machine gun mounting (directly under the X aircraft code letter).

position (or just behind the fuselage bomb bay) for the bundles of WINDOW. The bulky Mandrel equipment was installed on the starboard side in the central fuselage and just behind the wireless operator's position with the operator facing the equipment.

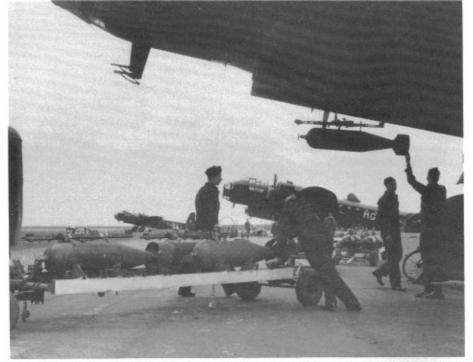
Ground crewmen hoist 500 pound bombs, fitted with extended nose fuzes, into a Stirling Mk I of No 7 Squadron. The pitot tube mast covers are still in place. A number of aircraft were lost due to failure to remove these covers before take off. With the covers in place, the pilot had no way of knowing his airspeed.

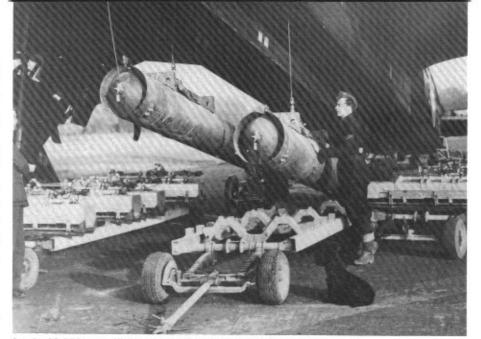
A pair of 2,000 pound light case bombs are hoisted into the narrow bomb bay of a Stirling Mk I of No 7 Squadron. The narrow width of the bomb bays limited the carriage of high explosive bombs to those of no more than 2,000 pounds, since larger weapons were too wide to fit in the bay. The cases on the bomb trolleys contain incendiary clusters.

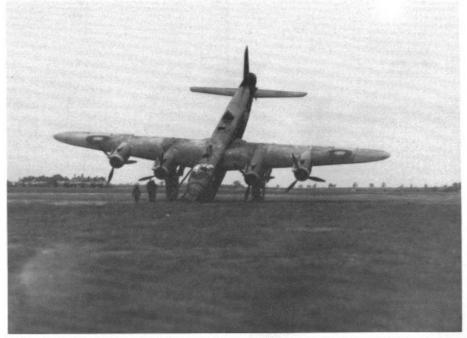
R-Robert (W7513) of No 15 Squadron nosed over at the end of the runway on return from the second 1,000 bomber raid against Essen on 1/2 June 1942. The upper wing surfaces are streaked and scuffed by the ground crew's boots. The Stirling was repaired and later served with Nos 149 and 75 Squadrons before being declared missing on a mining mission over Kiel Bay on 29 April 1943.

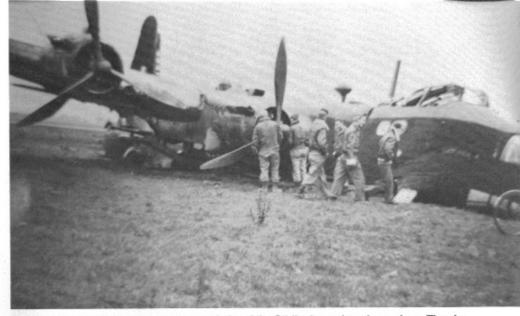
This Stirling Mk I (BK601) was one more victim of the Stirling's weak undercarriage. The alrcraft had been on active service with Nos 214 and 149 Squadrons, before being assigned to No 1657 HCU. The alrcraft was on a visit to the USAAF 94th Bomb Group base at Rougham on 28 January 1944, when the accident occurred.

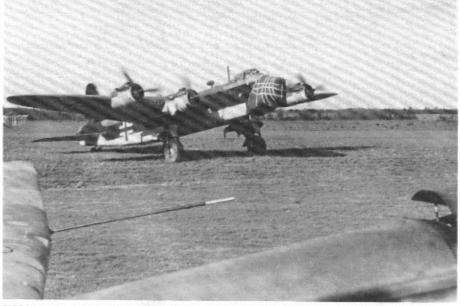
N3705 taxies out on its delivery flight to the Rechlin Test Center, repainted in full German markings. The Yellow undersurface color extended about a third of the way up the fuselage sides. The escort aircraft for the delivery flight was a Ju 88.

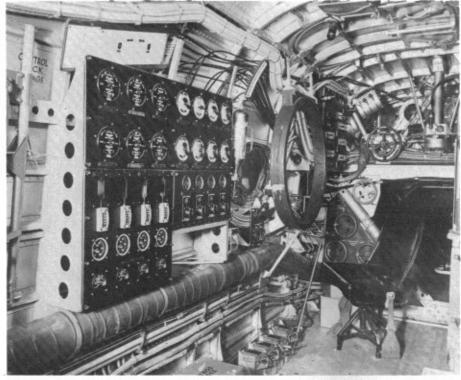
The flight engineer's station was equipped with a large main instrument panel. The circular valve controls for supercharger, carburetor, fuel tank and cabin heating regulation are behind the flight engineer's seat and extended to the port side of aircraft.

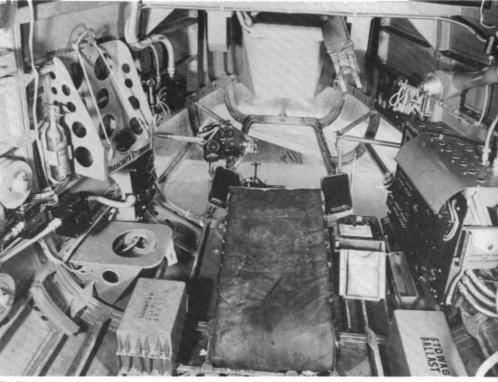
The Bomb-aimer's compartment was dominated by the flat optical bomb aiming panel in the nose, the main control box for the various functions of bomb fuse setting, bomb release and bomb bay door operation was on the starboard side, while a parachute stowage box was mounted on the port side.

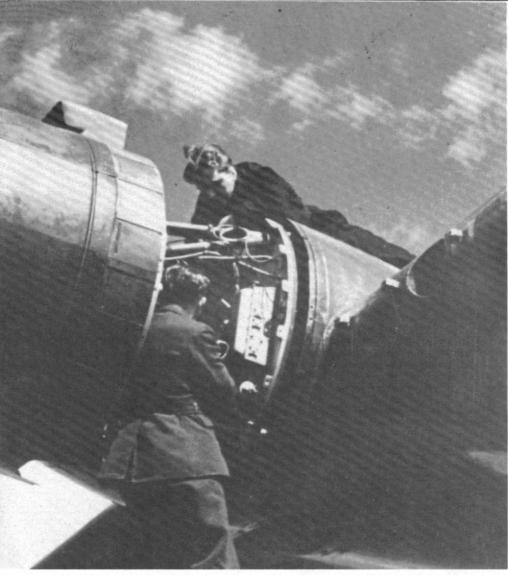
Ground crewmen perform maintenance on a the starboard outboard engine of a Stirling Mk I. The three square protruding shapes on the wing leading edge are barrage balloon cable cutters, while the circular intake in the wing leading edge is the oil cooler intake.

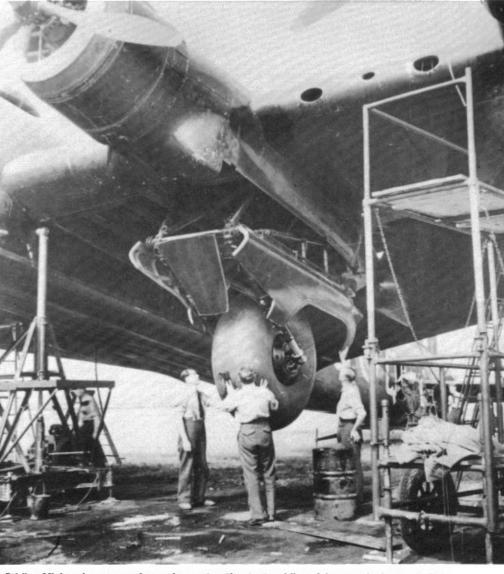
A Stirling Mk I undergoes undercarriage retraction tests while safely up on jack stands. The two stage undercarriage first retracted upwards, than forward to rest in the wheel well. The main wheel remained partially exposed when the undercarriage was fully retracted.

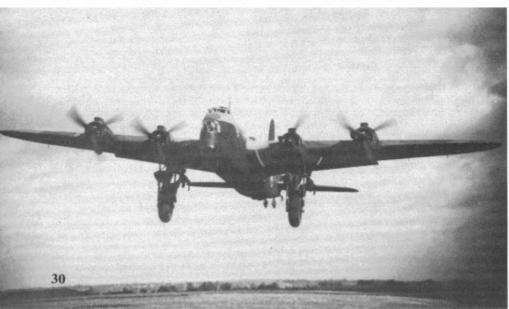
These early Mk Is Series III aircraft are assigned to No 15 Squadron at Wyton. The aircraft in the foreground appears to have had the pitot tubes removed from the under nose twin pitot masts and replaced by a single pitot tube mounted on the radio mast. The main wheel tires are covered to prevent dripping oil from damaging the tires.

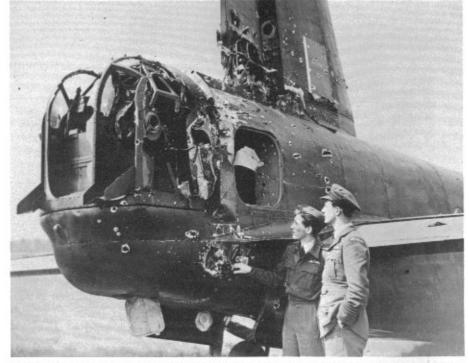
Pilot Officer Peter Buck (Royal New Zealand Air Force, left) inspects the damage to the tail turret and rudder of his Stirling Mk III of No 75 (New Zealand) Squadron. The perspex turret center section was completely shot away by enemy fire over Essen and the escape hatch cover just forward of the turret was jettisoned.

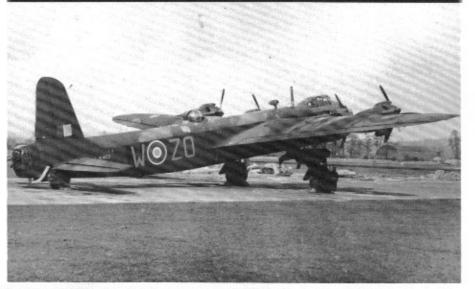
This Mk III (LK403) of No 196 Squadron Is fitted with a glider towing yoke installed under the rear turret as part of the tests conducted to determine if the Stirling could tow large gliders. The tests were successful and led to the Stirling Mk IV. This Stirling later ended its career at No 1665 HCU where it was written off after it crashed when the undercarriage falled.

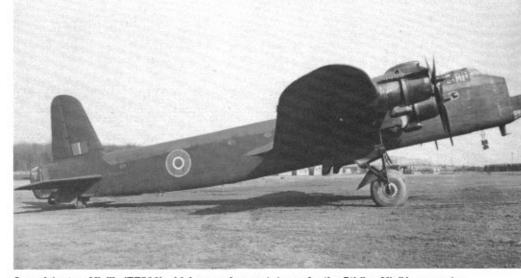
One of the two Mk Ills (EF506) which served as prototypes for the Stirling Mk IV conversion has had the mid-upper turret position faired over and the nose turret replaced by an unframed perspex cover. The device under the nose just behind the pitot tube masts is a test camera installation. This Stirling did not enter front line service and was SOC on 5 June 1945.

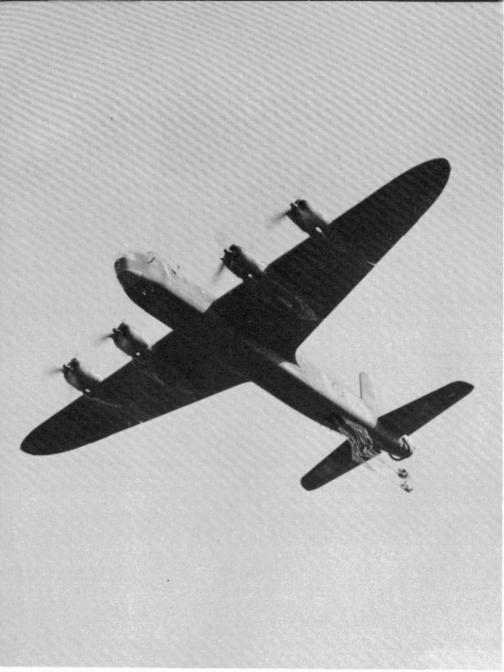
This Stirling Mk IV has just dropped a supply container from the under fuselage six foot by three foot hatch. The strop guard on the tail is in its lowered position to protect the fuselage from damage.

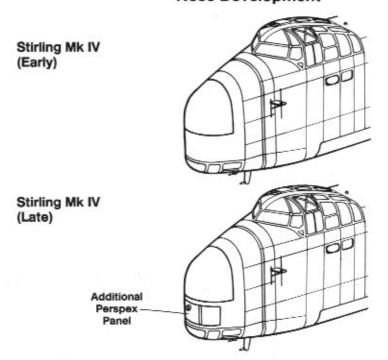
V8-F of No 570 Squadron has been modified with an additional Perspex panel installed in the nose below the nose cap to enhance forward visibility. The D-Day stripes have been overpainted and the 8 in the squadron code has been changed to a square style. Rebecca blind landing aid antennas are carried on the fuselage ahead of cockpit.

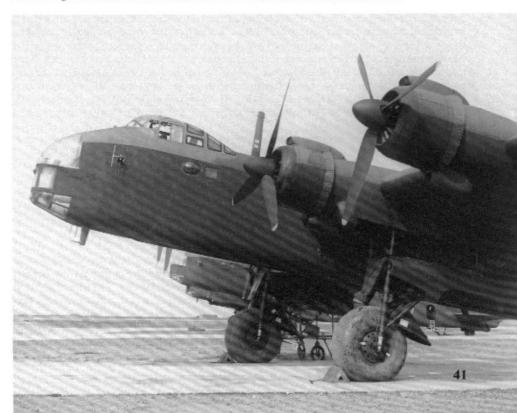
Stirling Mk IV (Early) Stirling Mk IV (Late) Propeller Spinner Engine Fan Engine Fan

Because of the possibility of overheating the engines while towing heavy glider loads, a number of Stirling Mk IVs were equipped with cooling fans and propeller spinners. This aircraft is also configured with the late nose section with its additional perspex panels.
