Standard Practice for Thermographic Inspection of Insulation Installations in Envelope Cavities of Frame Buildings¹

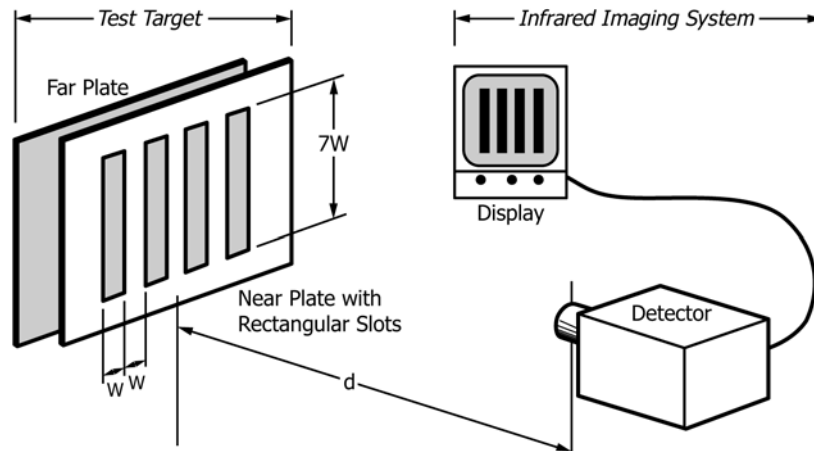
FIG. X1.1 Test for Minimum Resolvable Temperature Difference (MRTD) of Infrared Imaging System

NOTE 1—A test pattern, consisting of four rectangular slots, permits a comparison of the temperature of the near plate of the test target with the far plate. The plates are initially at the same temperature. Someone increases the temperature difference between plates until an observer announces when the test pattern comes into view on the display. The difference in temperature at this point is the MRTD for that test condition.

X1.1.4.3 *Test Target Pattern*—The test target shall consist of two plates with controlled, known temperatures, located at the criterion distance, d , in front of the imaging system. The near plate shall have a four-bar test pattern of $w = (s/2)/\text{cycle}$ and a 7:1 aspect ratio. The dimension, s , is the same value as in X1.1.2, defined as the width of a single piece of framing. Other size patterns of the same aspect ratio may be used as long as w/d remains constant. See Fig. X1.1 for an illustration of the MRTD experimental set-up.

X1.1.4.4 *MRTD Test Procedure*—Someone slowly increases the temperature difference between the two plates of the target without communicating with the observer of the display on the imaging system. The observer announces when the test pattern comes into view. The difference in temperature at this point is the MRTD for that test condition.
