**Gas cylinders — Refillable seamless  
steel — Performance tests —**

Part 3:  
**Fracture performance tests — Cyclical  
burst tests**

Reference number  
ISO/TR 12391-3:2002(E)

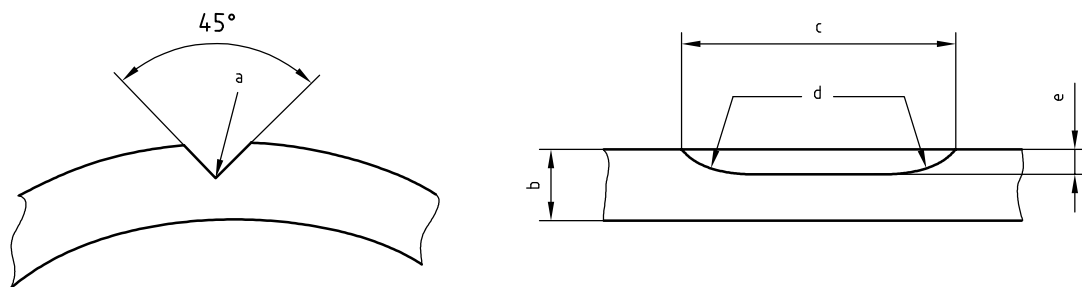
- a Tip radius
- b Design wall thickness
- c Flaw length
- d Radius
- e Flaw depth

**Figure 1 — Flaw geometry used in the flawed-cylinder burst test**

In the flawed-cylinder cyclical burst test, the fracture performance of the cylinder is evaluated by cyclically pressurizing a cylinder with a designated type (shape and sharpness) and size (length and depth) of surface flaw until failure occurs. Failure occurs either by leaking or by fracturing.

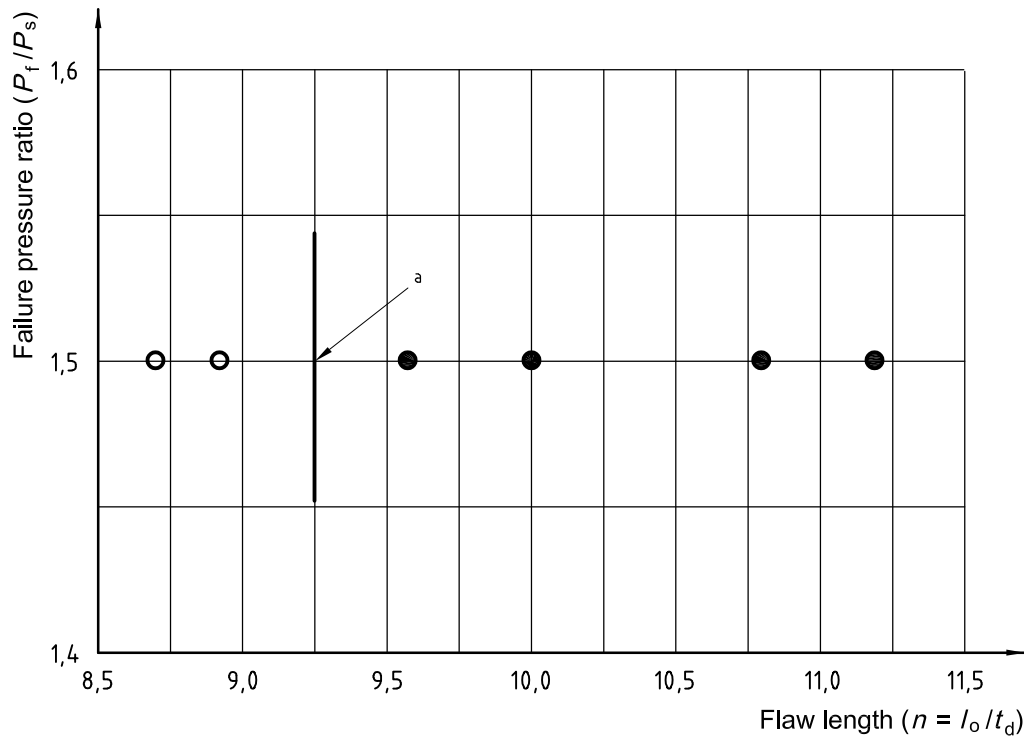
- Fracture
- Leak
- a Boundary

**Figure 2 — Defining the leak-fracture boundary**

The overall fracture performance of the cylinder is determined with the flawed-cylinder cyclical burst test by empirically determining the “leak-fracture boundary” for the specified maximum cycling pressure. This requires that a series of cylinders with different flaw lengths be tested. The “leak-fracture boundary” for a specified maximum cycling pressure is defined as the average of the longest flaw length at which a leak occurs and the shortest flaw length at which a fracture occurs.

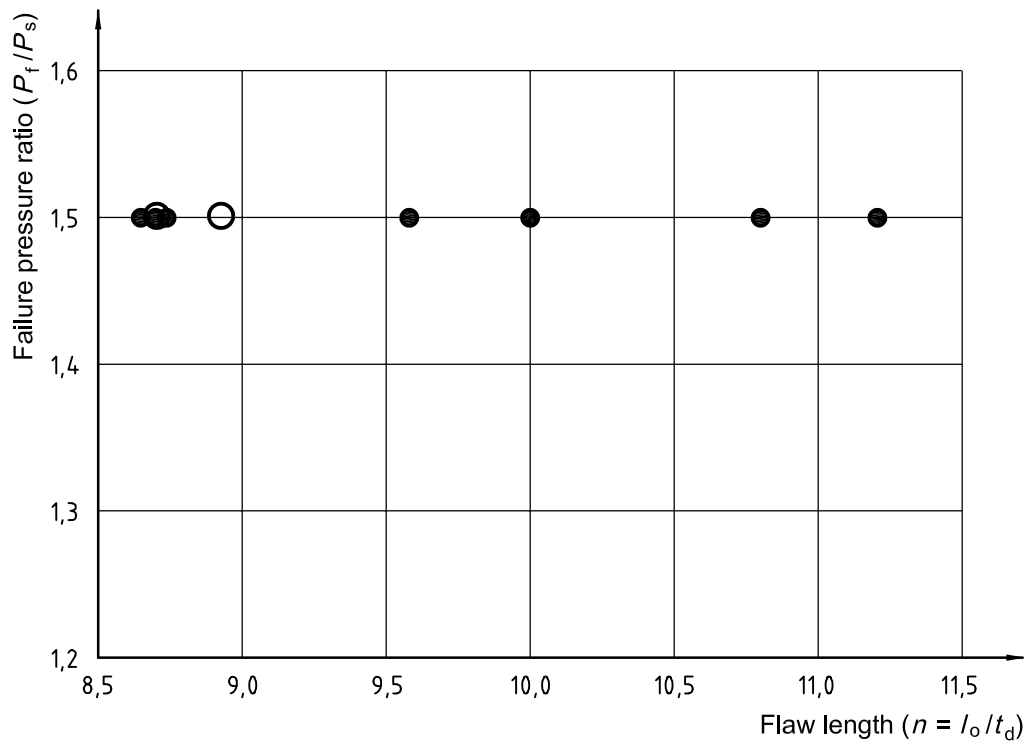
**Figure 3 — Flawed-cylinder burst test results for B-1 material**

Eleven cylinders from material subgroup B-1 were tested. The results of these tests are shown in Table 7. The cylinders in material subgroup B-1 were all tested at a maximum cyclical pressure of  $1,5 \times$  the design service pressure, i.e.  $P_f/P_s = 1,5$ . This is the normal pressure used for hydrostatically retesting these cylinders. The initial flaw length ranged from  $l_o = 8,6 \times t_d$  to  $l_o = 11,2 \times t_d$ . The initial flaw depth ranged from 31,3 % to 78,8 % of the design wall thickness,  $t_d$ , of the cylinders. Four of the test cylinders failed by leaking and seven of the cylinders failed by fracturing. As shown in Figure 3, the leak-fracture boundary for material subgroup B-1 cylinders is at a flaw length of  $l_o = 8,8 \times t_d$  at a failure pressure of  $1,5 \times$  the service pressure,  $P_s$ . Therefore, these cylinders should have an adequate level of fracture resistance according to the requirements of ISO 9809-2.

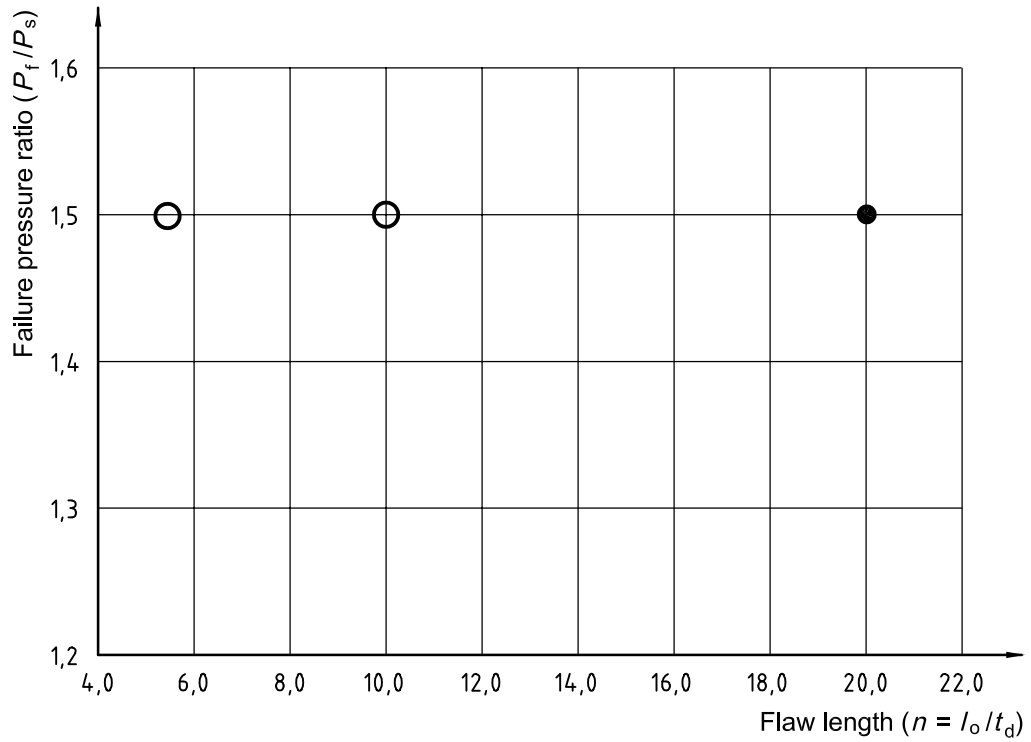
**Figure 4 — Flawed-cylinder burst test results for C-5 material**

Seven cylinders from material subgroup C-5 were tested. The results of these tests are shown in Table 8. The cylinders in material subgroup C-5 were all tested at a maximum cyclical pressure of  $1,5 \times$  the design service pressure, i.e.  $P_f/P_s = 1,5$ . This is the normal pressure used for hydrostatically retesting these cylinders. The initial flaw length ranged from  $l_o = 5,7 \times t_d$  to  $l_o = 20,0 \times t_d$ . The initial flaw depth ranged from 6,0 % to 23,0 % of the design wall thickness of the cylinders. Four of the test cylinders failed by leaking and three of the cylinders failed by fracturing. As shown in Figure 4, the leak-fracture boundary for material subgroup C-5 cylinders is at a flaw length estimated to be  $l_o = 15,0 \times t_d$  at a failure pressure of  $1,5 \times$  the service pressure,  $P_s$ . These tests were conducted using the conditions that generally satisfied the conditions for conducting the flawed-cylinder cyclical burst test specified in ISO 9809-2, except that the flaw depth was less than specified and the maximum test pressure was higher than that specified in ISO 9809-2. Therefore, these cylinders exceed the level of fracture resistance required by ISO 9809-2.

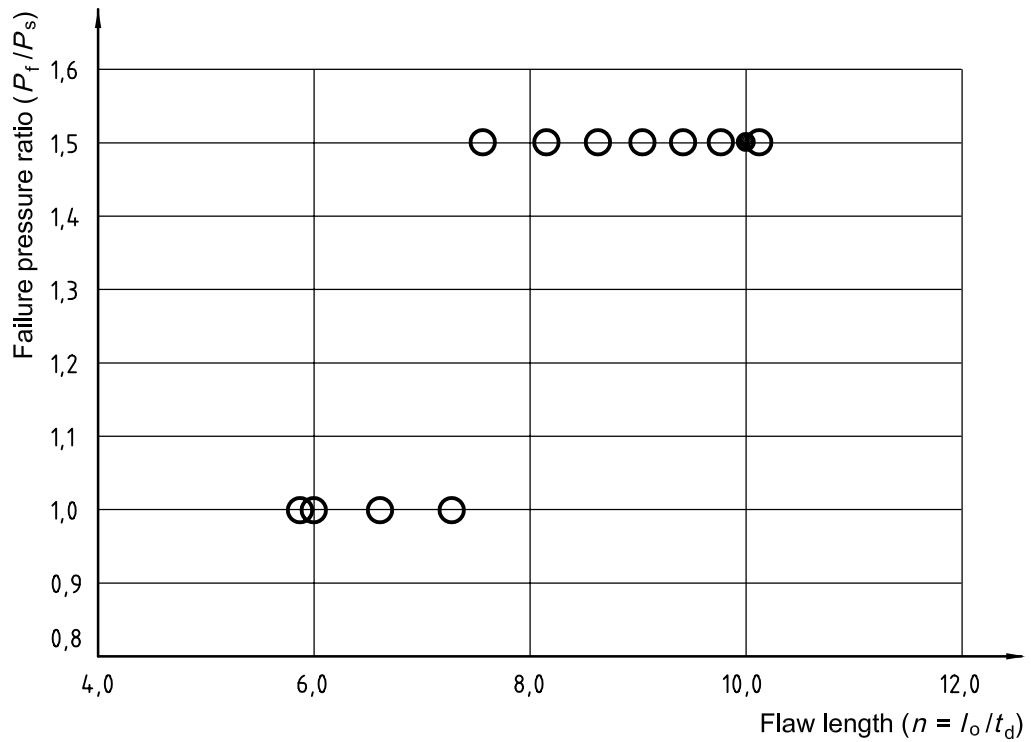
**Figure 5 — Flawed-cylinder burst test results for D-1 Material**

design service pressure, i.e.  $P_f/P_s = 1,0$  or  $1,5$ . This is either the normal service pressure or the normal pressure used for hydrostatically retesting these cylinders. The initial flaw length ranged from  $l_o = 6,0 \times t_d$  to  $l_o = 10,1 \times t_d$ . The initial flaw depth ranged from 9,8 % to 91,8 % of the design wall thickness,  $t_d$ , of the cylinders. Thirteen of the test cylinders failed by leaking when tested at a maximum cyclical pressure of  $1,0 \times$  or  $1,5 \times$  the service pressure,  $P_s$ , and one of the cylinders failed by fracturing when tested at a maximum cyclical pressure of  $1,5 \times$  the service pressure. As shown in Figure 5, the leak-fracture boundary for material subgroup D-1 cylinders is at a flaw length estimated to be  $l_o = 10,0 \times t_d$  at a failure pressure of  $1,5 \times$  the service pressure. These tests were conducted using the conditions that generally satisfied the conditions for conducting the flawed-cylinder cyclical burst test specified in ISO 9809-2, except that the flaw depth was less than specified and the maximum test pressure was higher than that specified in ISO 9809-2. Therefore, these cylinders exceed the level of fracture resistance to meet the requirements of ISO 9809-2.

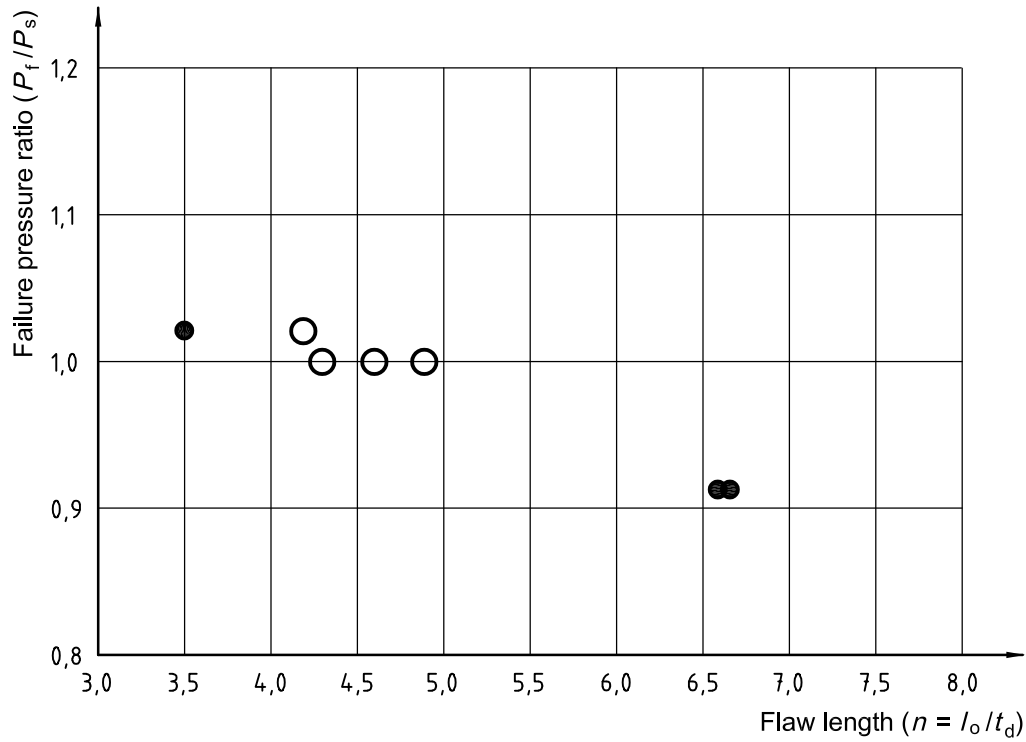
**Figure 6 — Flawed-cylinder burst test results for D-7 material**

Seven cylinders from material subgroup D-7 were tested by cyclical pressurization. These cylinders were tested at a maximum cyclical pressure of about  $1,0 \times$  the design service pressure, i.e.  $P_f/P_s = 1,0$ . This is the normal service pressure used for these cylinders. The initial flaw length ranged from  $l_o = 3,5 \times t_d$  to  $l_o = 6,7 \times t_d$ . The initial flaw depth was about 40 % of the design wall thickness,  $t_d$ , of the cylinders. As shown in Figure 6, the leak-fracture boundary for material subgroup D-7 cylinders is at a flaw length estimated to be  $l_o = 4,0 \times t_d$  at a failure pressure of  $1,0 \times$  the service pressure,  $P_s$ . Three of the cylinders failed by fracturing and four of the cylinders failed by leaking. These tests were conducted using the conditions that generally satisfied the conditions for conducting the flawed-cylinder cyclical burst test specified in ISO 9809-2 except that the initial flaw length was shorter than that required by the ISO standard. Because the initial flaw length was considerably shorter than that required by ISO 9809-2 and some of the cylinders failed by fracturing, these cylinders would not meet the level of fracture resistance required by ISO 9809-2.

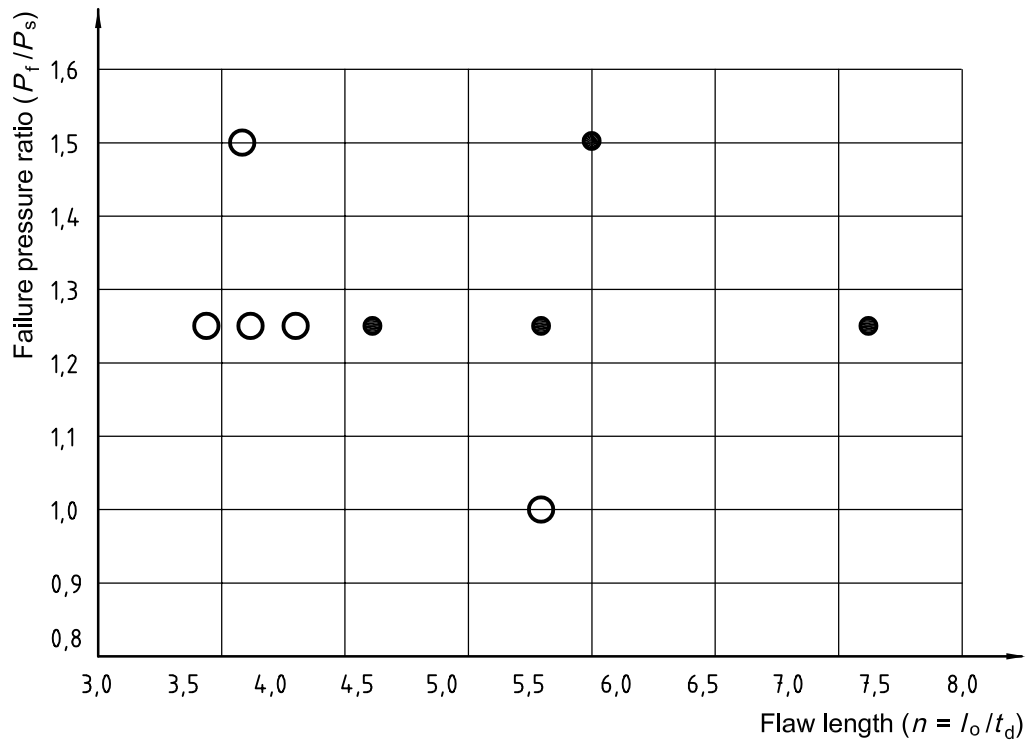
**Figure 7 — Flawed-cylinder burst test results for D-12 material**

Fourteen cylinders from material subgroup D-12 were tested by cyclical pressurization. These cylinders were tested at a maximum cyclical pressure ranging from  $1,0 \times$  to  $1,5 \times$  the design service pressure, i.e.  $P_f/P_s = 1,0$  to  $1,5$ . The initial flaw length ranged from  $l_o = 7,8 \times t_d$  to  $l_o = 18,6 \times t_d$ . The initial flaw depth ranged from 27 % to 47 % of the design wall thickness,  $t_d$ , of the cylinders. Nine of the cylinders failed by leaking and five of the cylinders failed by fracturing. As shown in Figure 7 the leak-fracture boundary for material subgroup D-12 cylinders is at a flaw length estimated to be  $l_o = 10,5 \times t_d$  at a failure pressure of  $1,25 \times$  the service pressure,  $P_s$ . These tests were conducted using the conditions that generally satisfied the conditions for conducting the flawed-cylinder cyclical burst test specified in ISO 9809-2. Because the lowest failure pressure at which failure by fracturing occurred was greater than the service pressure, these cylinders exceed the level of fracture resistance required by ISO 9809-2.

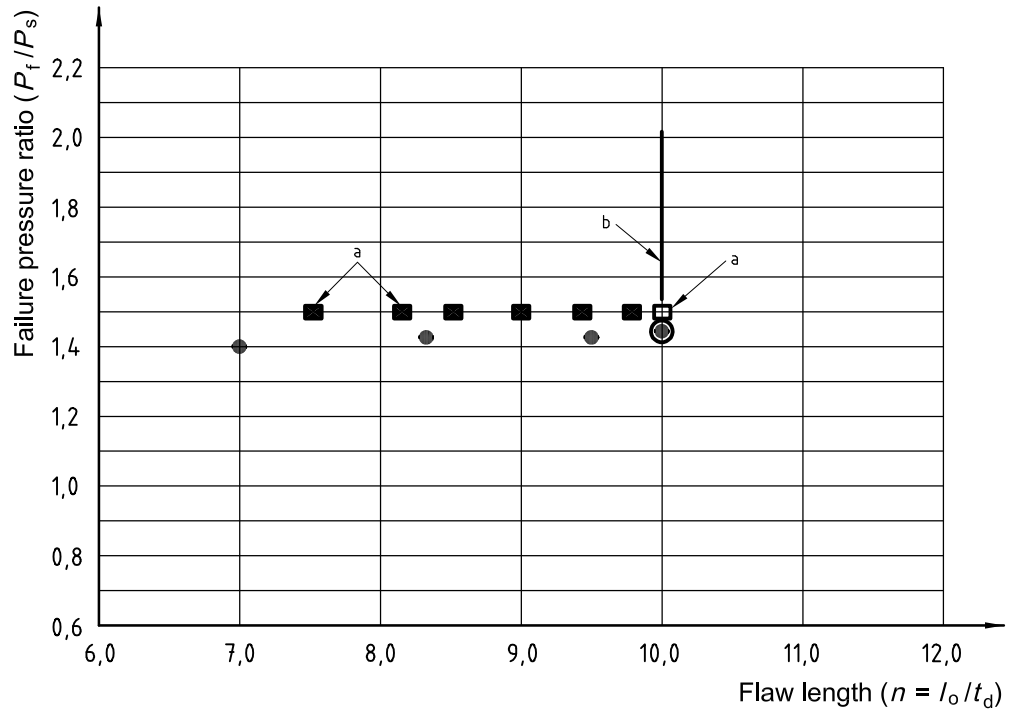
- Burst – leak
- Burst – fracture
- Cycle – leak
- Cycle – fracture
- a Cycle tests
- b Leak-fracture boundary

**Figure 11 — Cycle-burst data for CB-D-1 material and burst data for D-2 material**
